# Aviation Investigation Final Report

<b>Location:</b>	Oshkosh, Wisconsin	<b>Accident Number:</b>	CEN17FA287
<b>Date &amp; Time:</b>	July 27, 2017, 19:43 Local	<b>Registration:</b>	N1400P
<b>Aircraft:</b>	AEROFAB INC LAKE LA 4 250	<b>Aircraft Damage:</b>	Substantial
<b>Defining Event:</b>	Aerodynamic stall/spin	<b>Injuries:</b>	2 Fatal, 1 Minor
<b>Flight Conducted Under:</b>	Part 91: General aviation - Personal

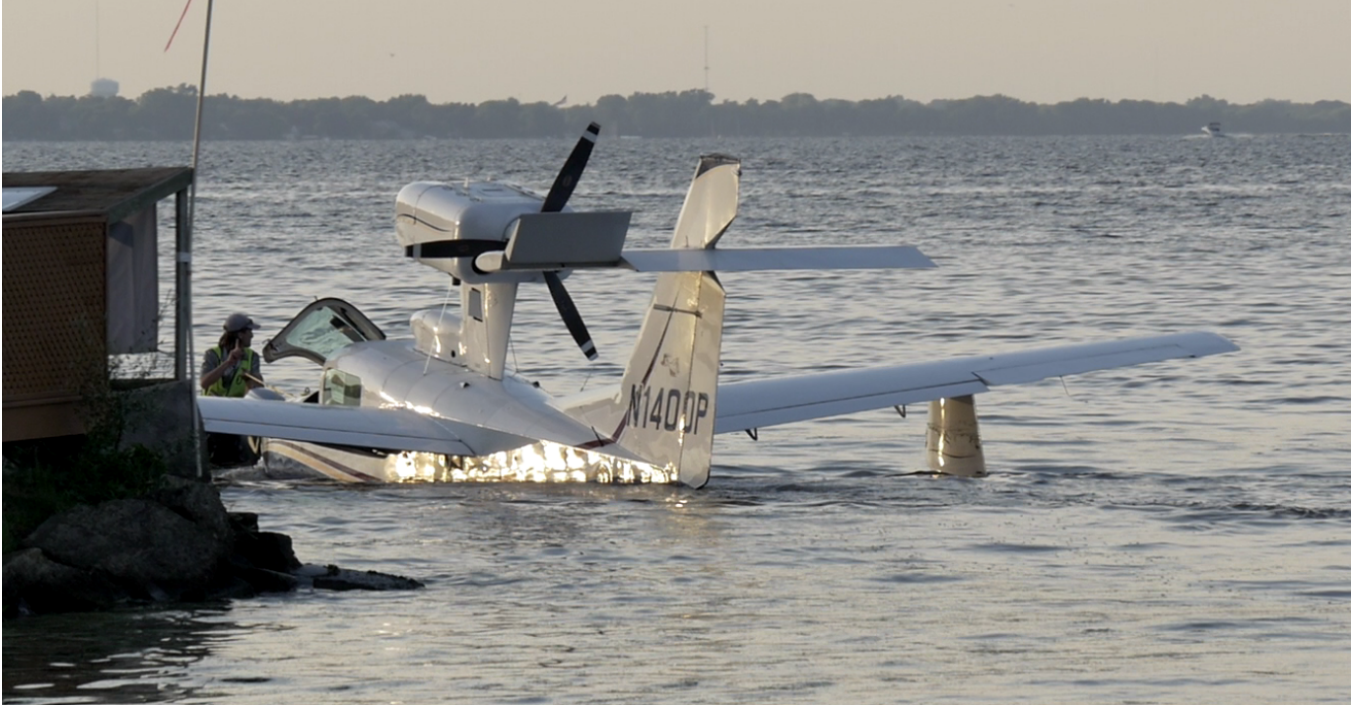
Figure 1 - Photo, extracted from unknown witness video

The airplane began its takeoff run with the wing flaps retracted from the bay toward the northwest immediately after the engine power increased. Video of the takeoff showed the airplane accelerate across the water for about 60 seconds before it porpoised up and down two to three times and the nose rose steeply out of the water (see figure 2). The airplane then rolled to the left and the left wing impacted the water. The airplane subsequently spun to the left and turned about 180°. The nose entered the water and the airplane subsequently started to sink. The pilot-rated passenger was able to egress the airplane; the other two occupants were extracted by first responders who saw the accident and responded immediately to the airplane.
