Aviation Investigation Final Report

Location:	Oshkosh, Wisconsin	Accident Number:	CEN17FA287
Date & Time:	July 27, 2017, 19:43 Local	Registration:	N1400P
Aircraft:	AEROFAB INC LAKE LA 4 250	Aircraft Damage:	Substantial
Defining Event:	Aerodynamic stall/spin	Injuries:	2 Fatal, 1 Minor
Flight Conducted Under:	Part 91: General aviation - Personal

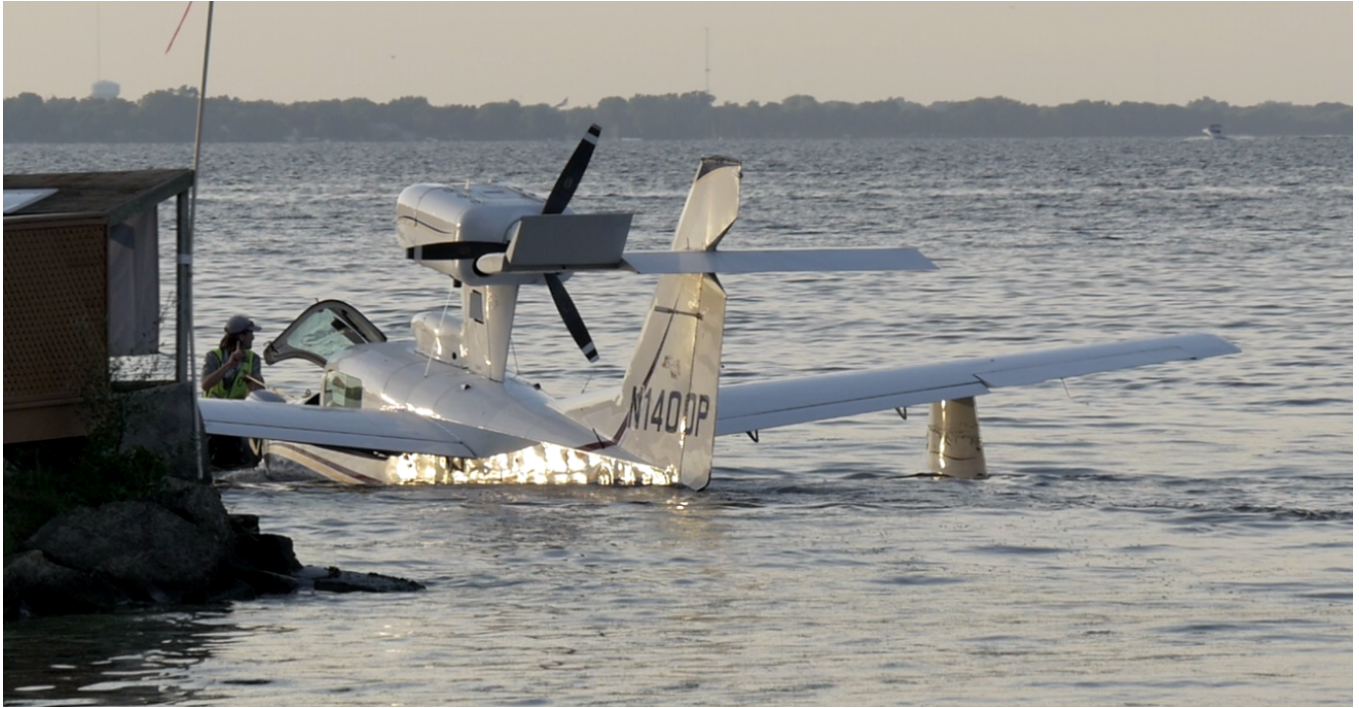
The airplane began its takeoff run with the wing flaps retracted from the bay toward the northwest immediately after the engine power increased. Video of the takeoff showed the airplane accelerate across the water for about 60 seconds before it porpoised up and down two to three times and the nose rose steeply out of the water (see figure 2). The airplane then rolled to the left and the left wing impacted the water. The airplane subsequently spun to the left and turned about 180°. The nose entered the water and the airplane subsequently started to sink. The pilot-rated passenger was able to egress the airplane; the other two occupants were extracted by first responders who saw the accident and responded immediately to the airplane.

Figure 1 - Photo, extracted from unknown witness video

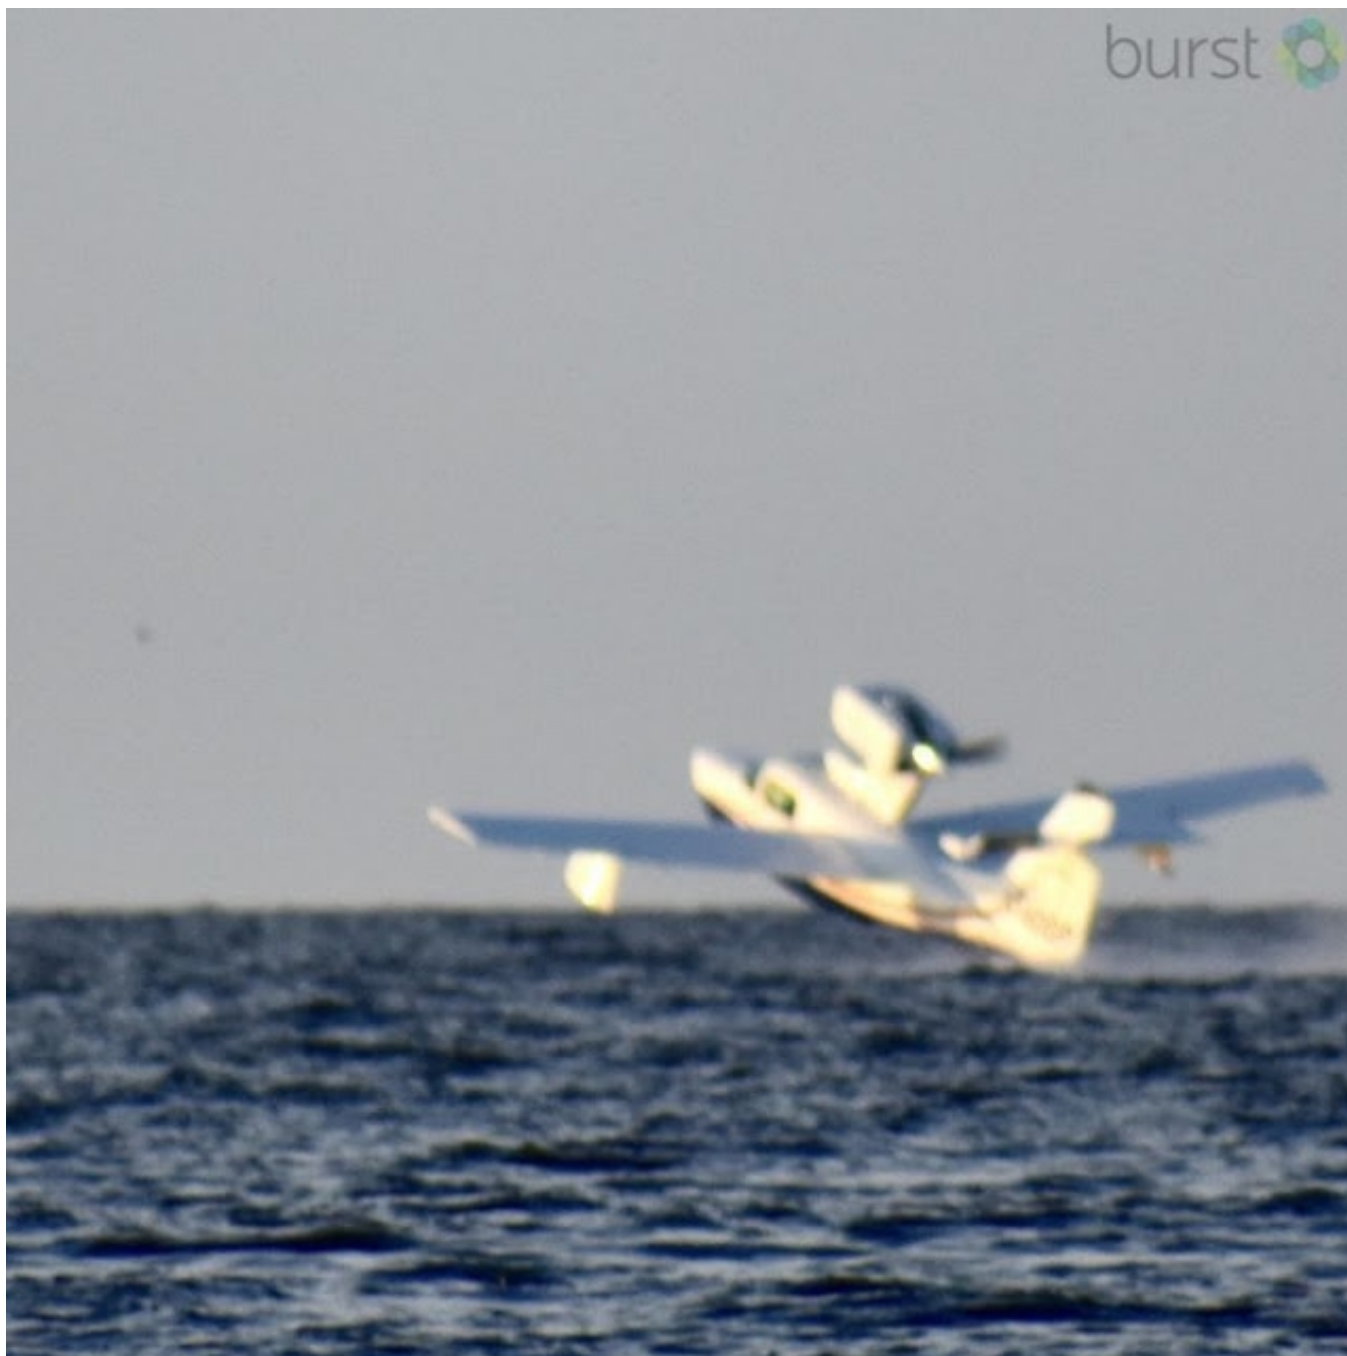
Figure 2 - Witness photo obtained from Kathryn's Report website
