# Aviation Investigation Final Report

<b>Location:</b>	Rio Linda, California	<b>Accident Number:</b>	WPR17FA179
<b>Date &amp; Time:</b>	August 3, 2017, 15:03 Local	<b>Registration:</b>	N420M
<b>Aircraft:</b>	Michaelian Lancair IV-TP	<b>Aircraft Damage:</b>	Substantial
<b>Defining Event:</b>	Loss of engine power (total)	<b>Injuries:</b>	1 Fatal
<b>Flight Conducted Under:</b>	Part 91: General aviation - Personal

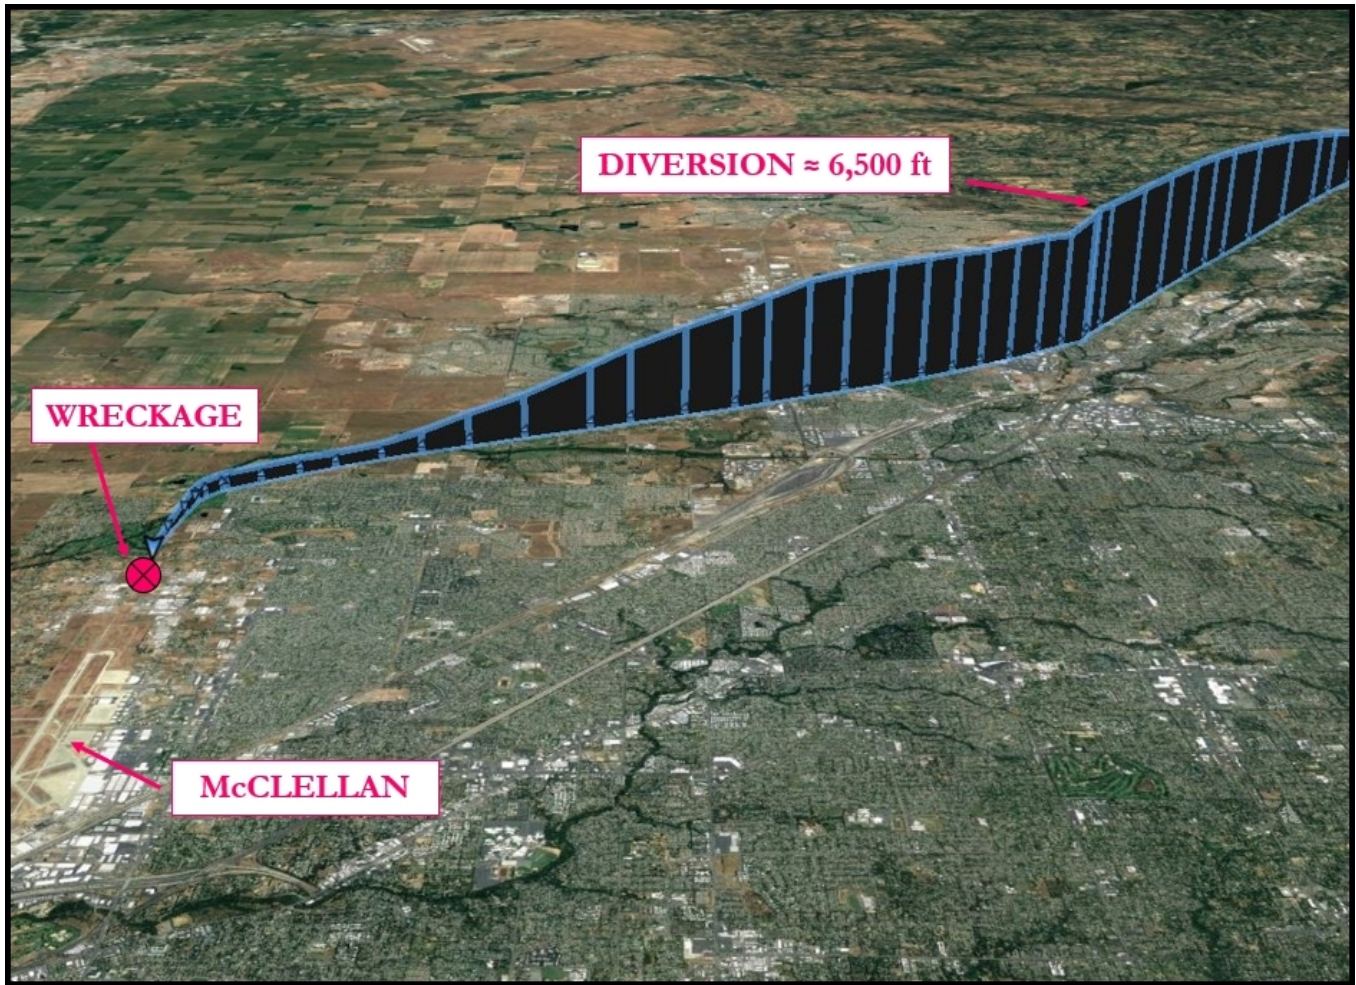
Figure 1: Flight Track Showing Diversion

An onboard GPS and avionics unit captured data from the accident flight; the airplane departed Auburn Municipal Airport (AUN), Auburn, California, about 1455. The pilot established the airplane on a heading of about 195° toward the destination of San Carlos, California and began to climb. The pilot contacted air traffic control and requested visual flight rules flight following to the destination, and when the controller advised the pilot that the airplane had been identified on radar, the pilot did not respond. The controller then saw the airplane turn and descend toward McClellan Airfield (MCC), Sacramento, California; no further communications were received from the accident pilot. (See Figure 1).

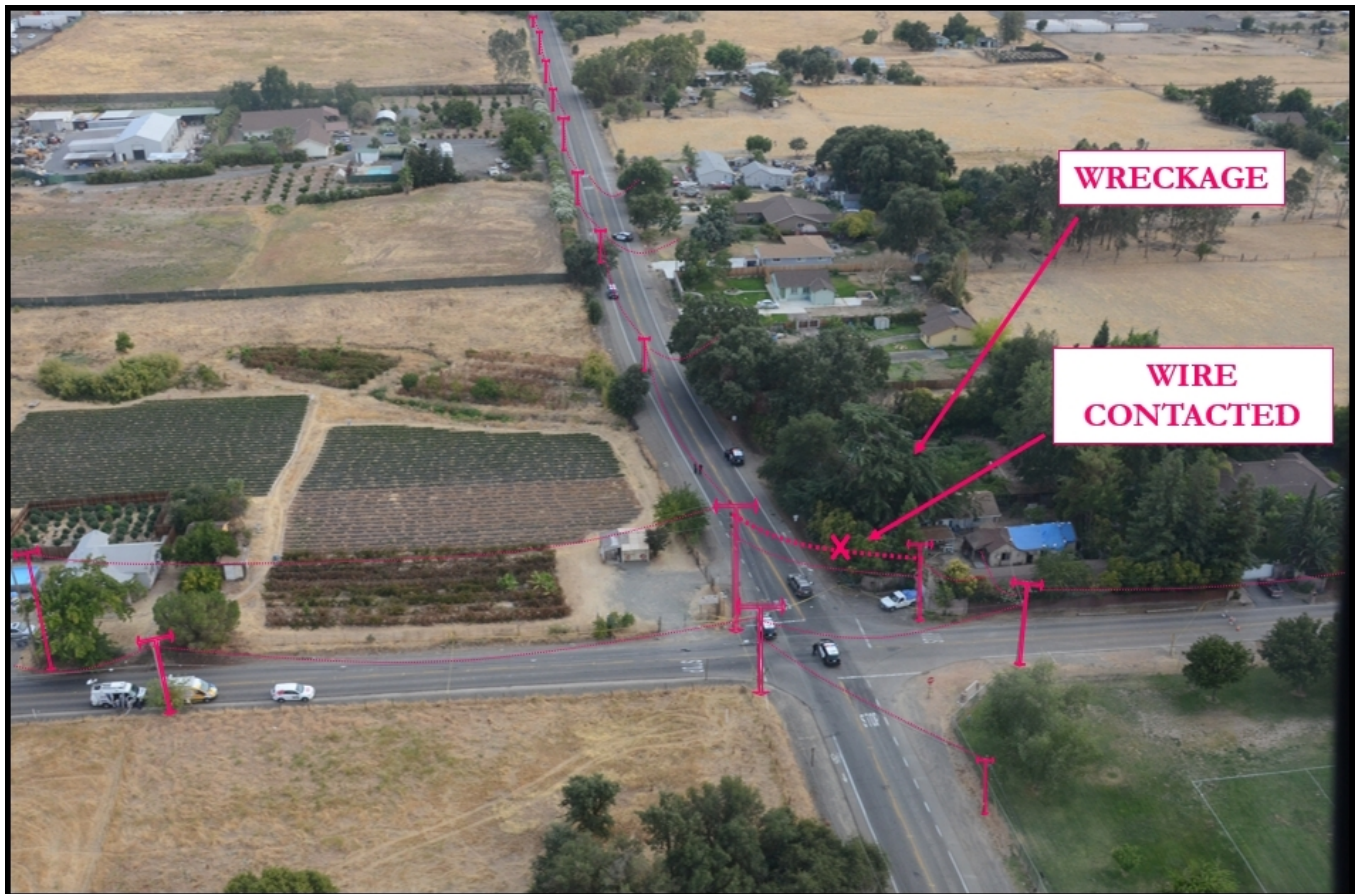
Figure 2: Accident Site

The accident site was in the back yard of a residence located at the corner of two streets. Powerlines were located 190 ft north of the wreckage with two support structures (wood poles) on both sides of the street about 73 ft apart. A powerline about 190 ft from the main wreckage exhibited several bends in the center area consistent with airplane impact. (See Figure 2)
