Aviation Investigation Final Report

Location:	Las Vegas, New Mexico	Accident Number:	CEN17FA315
Date & Time:	August 9, 2017, 10:25 Local	Registration:	N3664Z
Aircraft:	Piper PA 22-150	Aircraft Damage:	Substantial
Defining Event:	Aerodynamic stall/spin	Injuries:	1 Fatal
Flight Conducted Under:	Part 91: General aviation - Personal

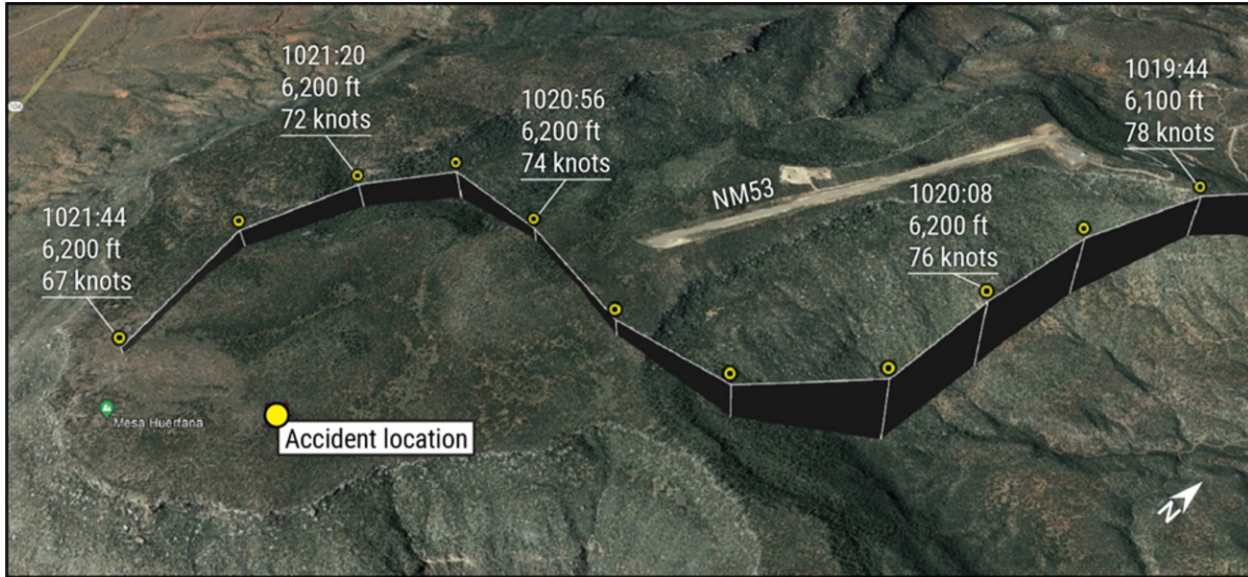
The airplane's flight track indicated that the pilot maneuvered the airplane into a "bowl" area that included the runway. Afterward, the pilot flew a right downwind leg and turned too closely onto the base leg to complete the base-to-final turn. As a result, the pilot made a 270° left turn inside the rim of the bowl area to align with the runway. As the pilot made the base-to-final turn, he again turned the airplane too closely to complete the turn, most likely because he

allowed the bowl area to define the dimensions of the turn. Because of the unnecessary tightness of the turn and the steep bank angle that was required to prevent overshooting the runway, the airplane's critical angle of attack was exceeded, resulting in an accelerated stall (which has load factors above 1 G and a stall speed higher than the airplane's 1-G stall speed) and a subsequent loss of control of the airplane.

Figure. Accident site in relation to flight track and runway.
