Aviation Investigation Final Report

Location:	Tyonek, Alaska	Accident Number:	ANC17FA049
Date & Time:	August 23, 2017, 22:45 Local	Registration:	N1905A
Aircraft:	Piper PA-18AS	Aircraft Damage:	Destroyed
Defining Event:	Loss of control in flight	Injuries:	1 Fatal
Flight Conducted Under:	Part 91: General aviation - Personal

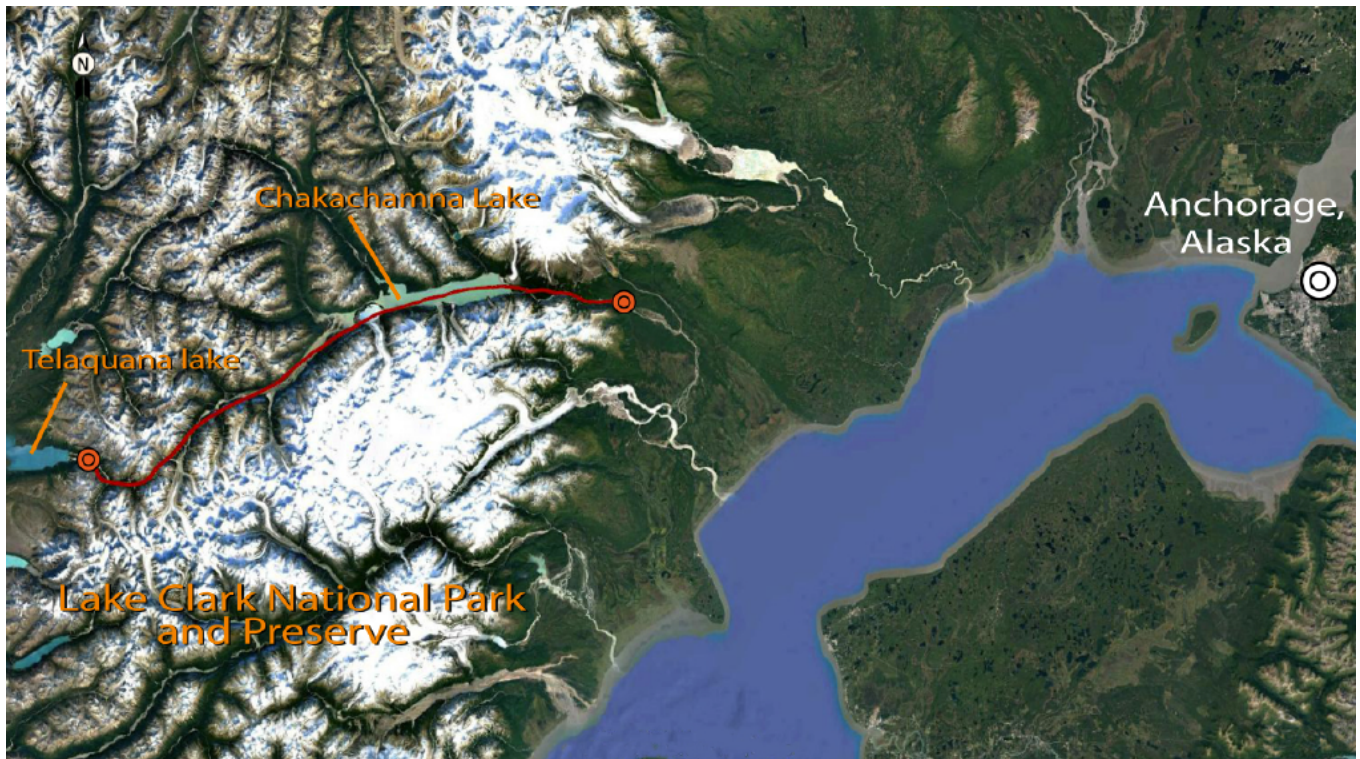
Upon departing from the airstrip and heading to the northeast, the route of flight was over mountainous terrain. Continuing east, the route was overwater as the airplane crossed Kenibuna Lake and Chakachamna Lake. Once past the mountainous terrain and continuing to the east, the area consisted mainly of hills before reaching the Cook Inlet and the Matanuska-Susitna Valley. An overview of the route of flight, along with the remote airstrip the pilot departed from, the accident site, and the destination airport is shown in figure 1. Figure 2 shows the last portion of the flight.

Figure 1 – Map of the route of flight, obtained from the onboard GPS unit (courtesy of the NTSB).

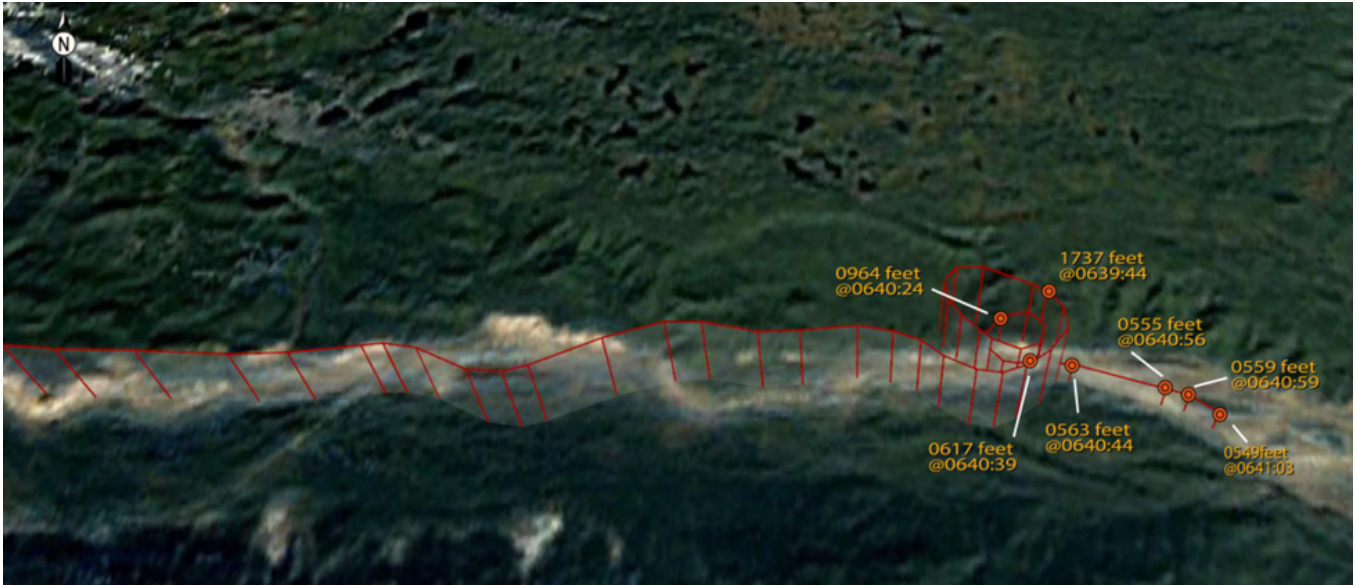
Data obtained from an onboard GPS unit for the last several minutes of flight showed the airplane conduct two descending, spiraling turns. The airplane continued to descend before the data terminated. The airspeed during the last several minutes of the flight ranged from 49 knots to 82 knots.

Figure 2 – Map of the last portion of the route of flight, obtained from the onboard GPS unit (courtesy of the NTSB).

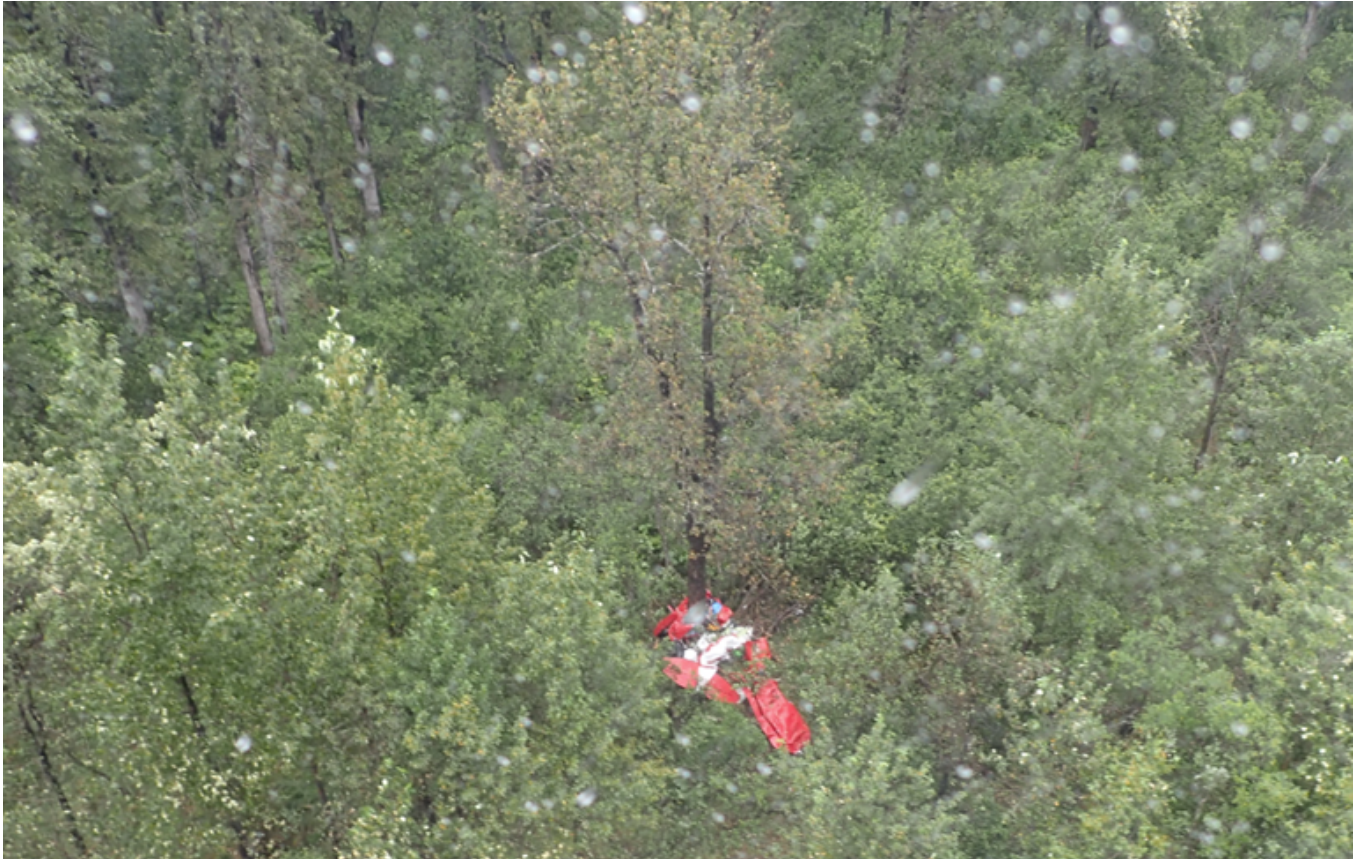
About 2245, the U.S. Air Force Alaska Rescue Coordination Center at Joint Base Elmendorf-Richardson, Alaska, received a 406 MHz emergency locator transmitter (ELT) signal from the airplane. The wreckage was located the next morning in remote, tree-covered terrain about 1/4 mile south of the Chakachamna River as shown in figure 4.

Figure 4 – Aerial view of the wreckage (courtesy of the NTSB).

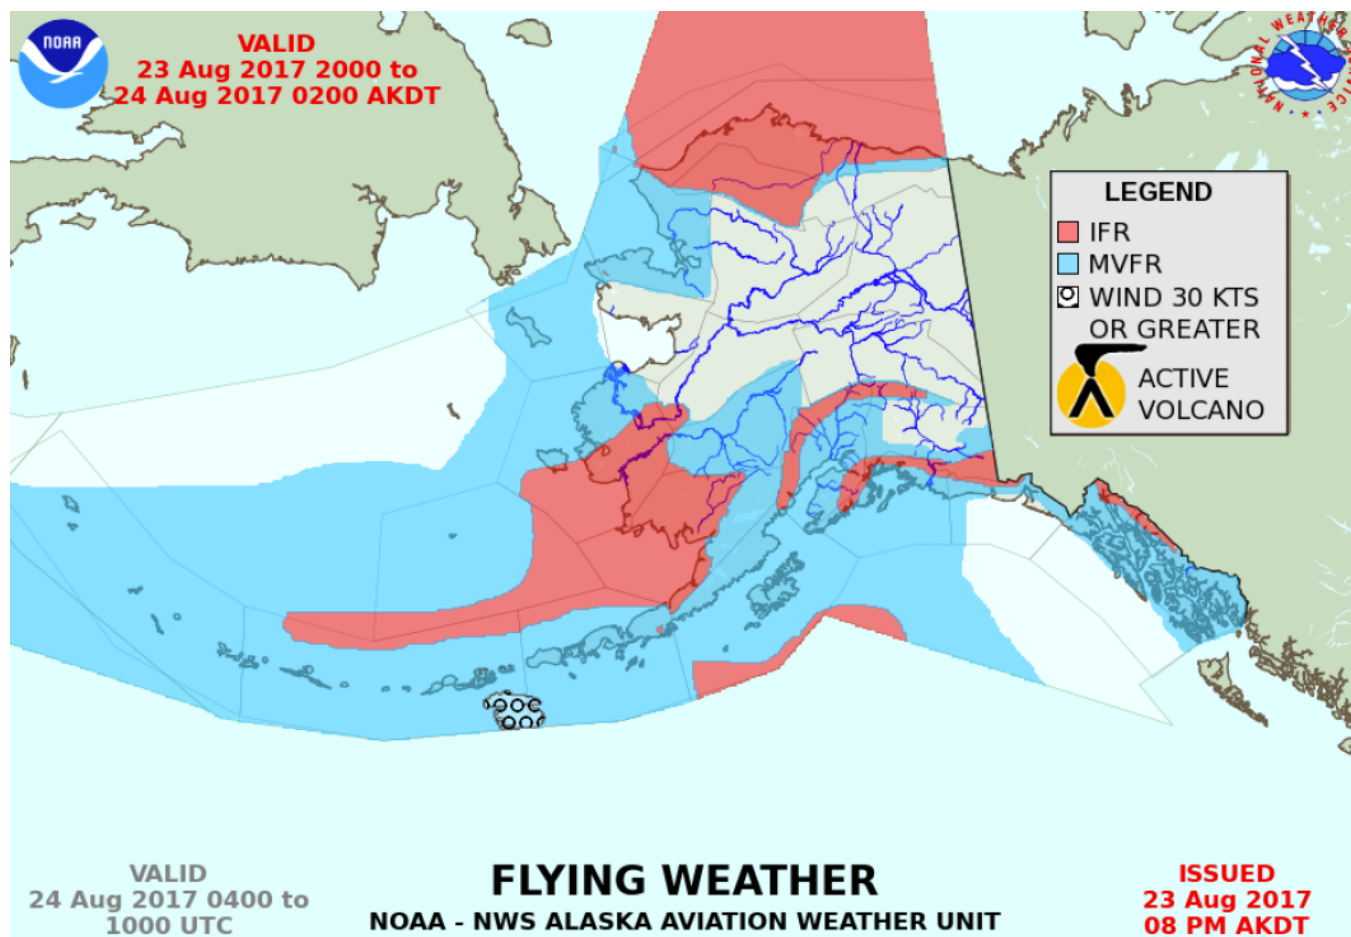
Various graphics were issued by the AAWU applicable to the accident time. The graphics identified IFR or MVFR conditions (as shown in figure 5), isolated moderate icing between 8,000 to 15,000 ft msl, isolated moderate turbulence below 6,000 ft msl, and light or moderate precipitation (as shown in figure 6) at the accident location, at or near the accident time.

Figure 5 – Flying weather graphic issued at 2000 and valid between 2000 on August 23, 2017, and 0200 on August 24, 2017 (courtesy of the AAWU).

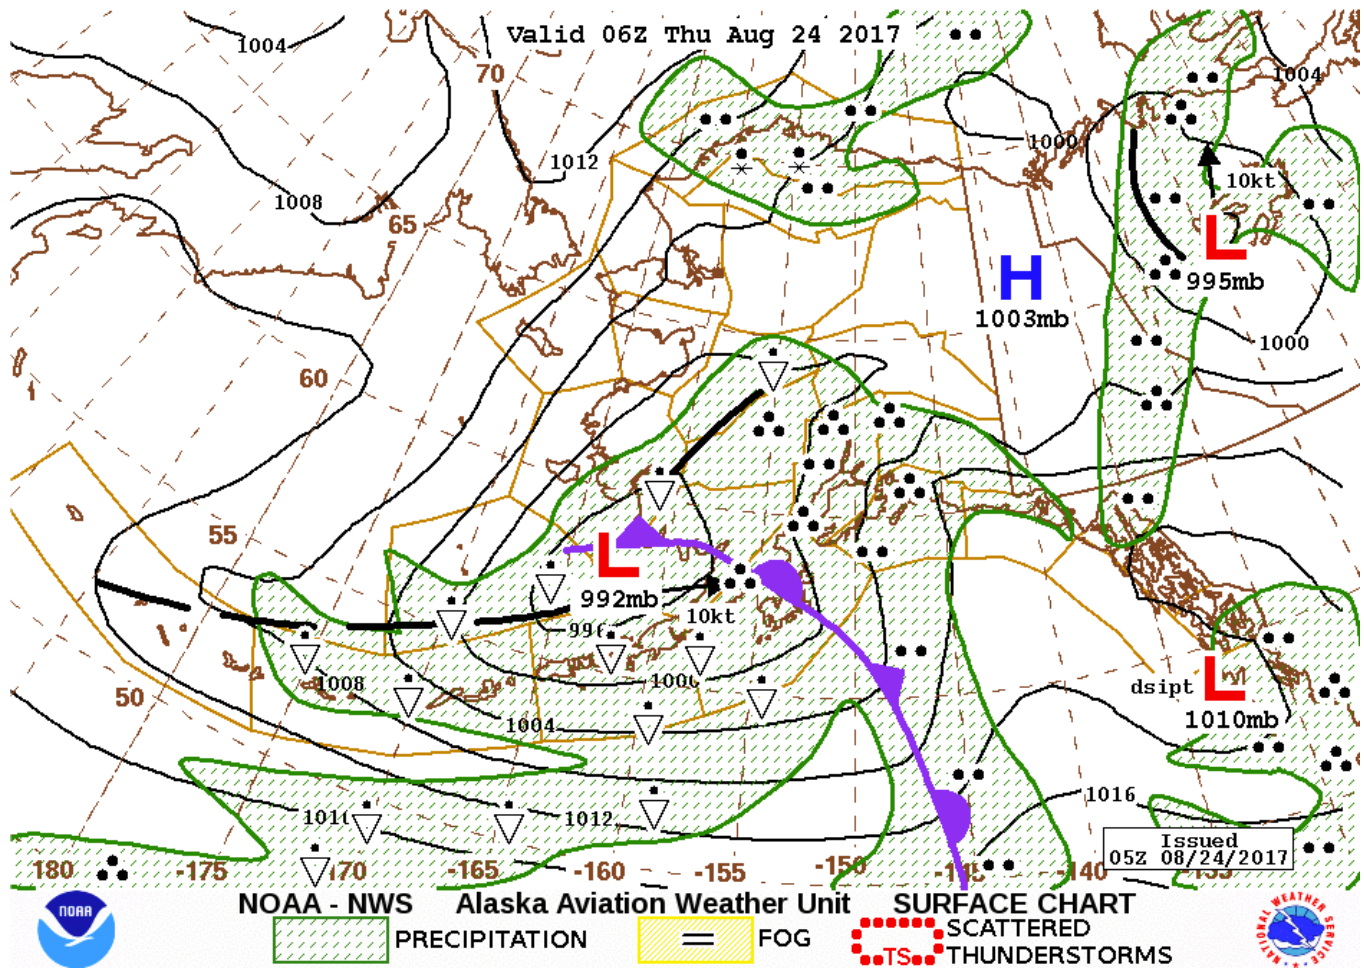
Figure 6 – Surface Chart issued at 2100 and valid for 2200 (courtesy of the AAWU).

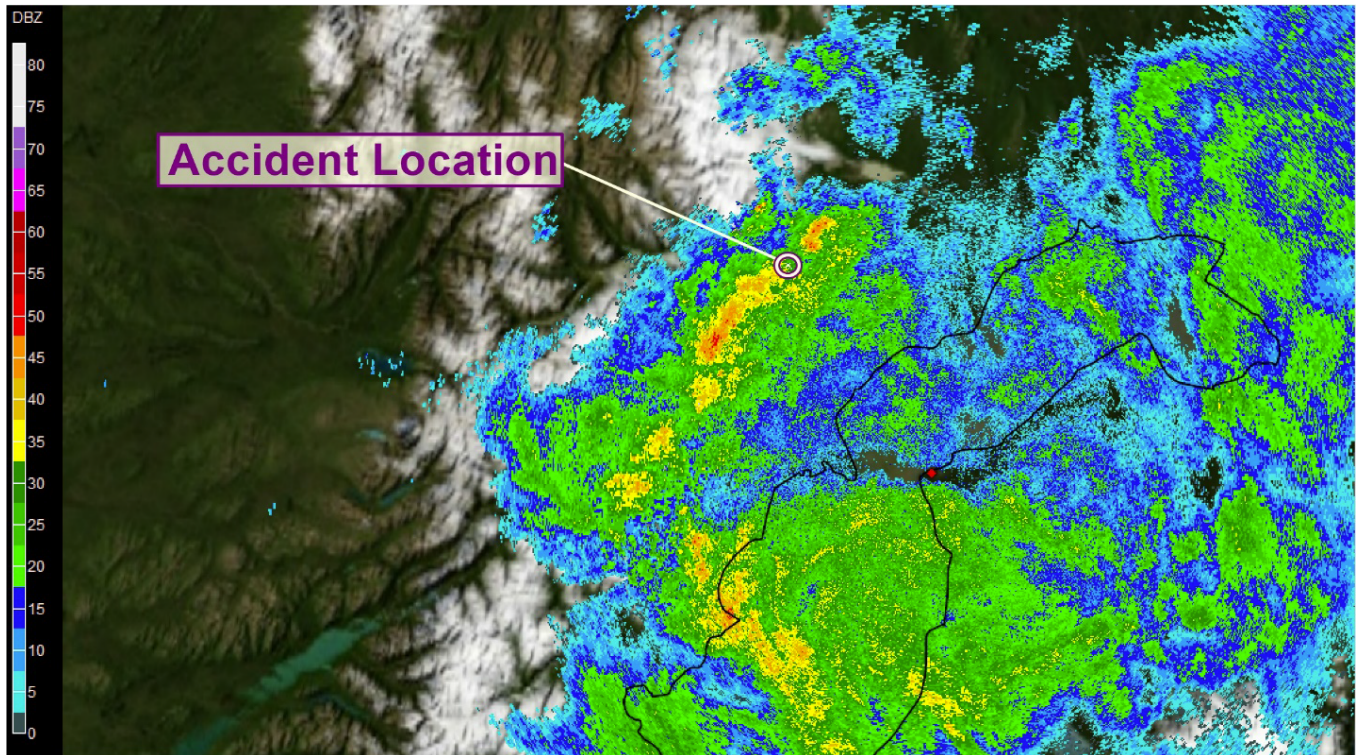
Based on the available radar weather and airplane track data, it is likely that the airplane flew into or came very close to an area of moderate or greater precipitation just before the accident; however, the extent to which the weather contributed to the pilot's spatial disorientation could not be determined.

WSR-88D Level-II weather radar imagery was obtained from near Kenai (PAHG). PAHG was located approximately 34 miles southeast of the accident site at an elevation of about 242 ft msl. Assuming standard refraction and considering the 0.95° beam width for the WSR-88D radar beam, the PAHG 1.4° tilt would have "seen" altitudes above the accident location of between about 4,300 and 7,800 ft msl. The PAHG imagery surrounding the accident period identified reflectivity features consistent with light to extreme intensities of precipitation in the region and adjacent to the accident site as shown in figure 7.

Figure 7 – PAHG 1.4° Level-II reflectivity product from a sweep initiated at 2245:47 (courtesy of the NTSB).

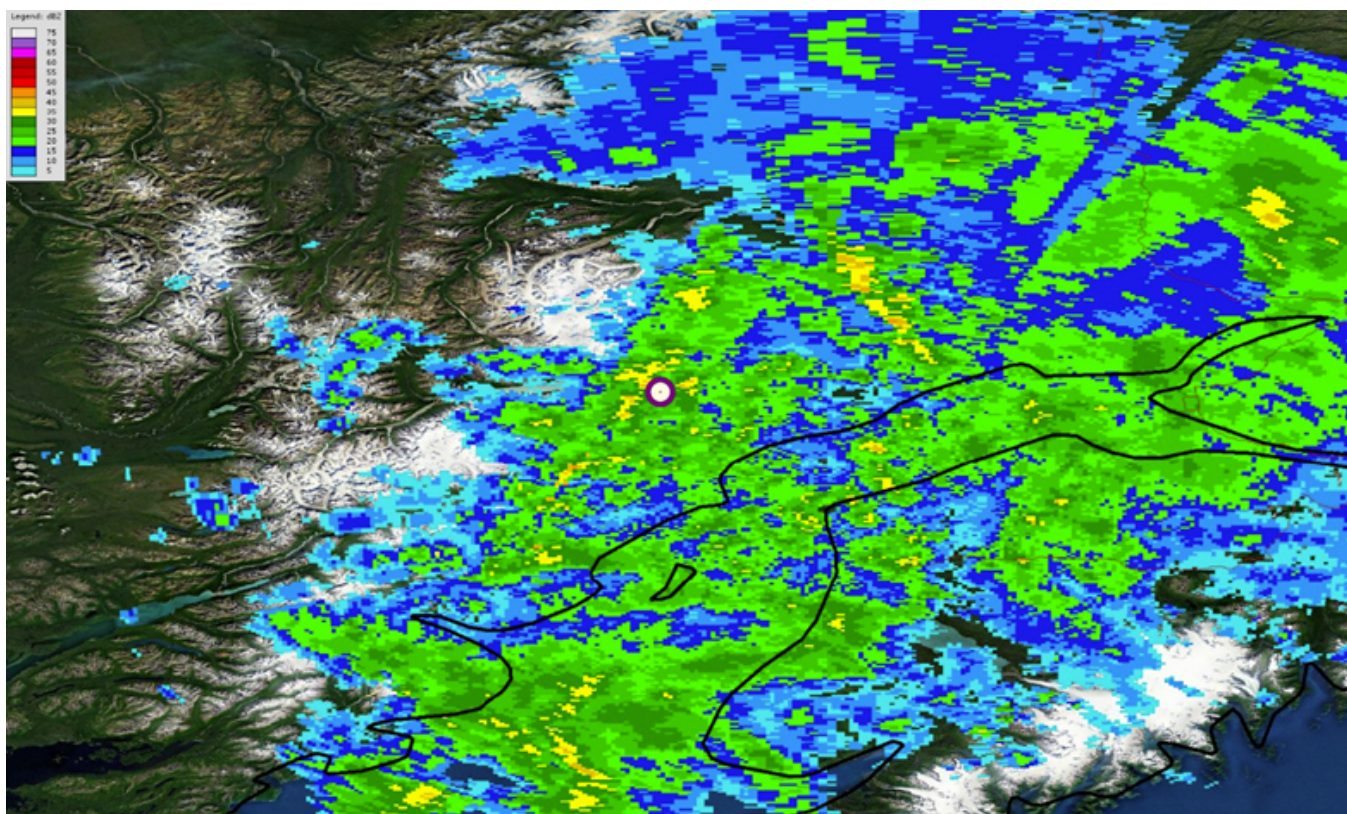
WSR-88D Level-III composite weather radar imagery from PAHG for the times surrounding the third Kenai FSS telephone weather briefing was obtained. This composite imagery identified an extensive area of reflectivity surrounding the accident location and extending east through the Anchorage area as shown in figure 8.

Figure 8 – PAHG Level-III composite reflective image, from a volume scan initiated at 2056 (courtesy of the NTSB). The white dot denotes the accident location.

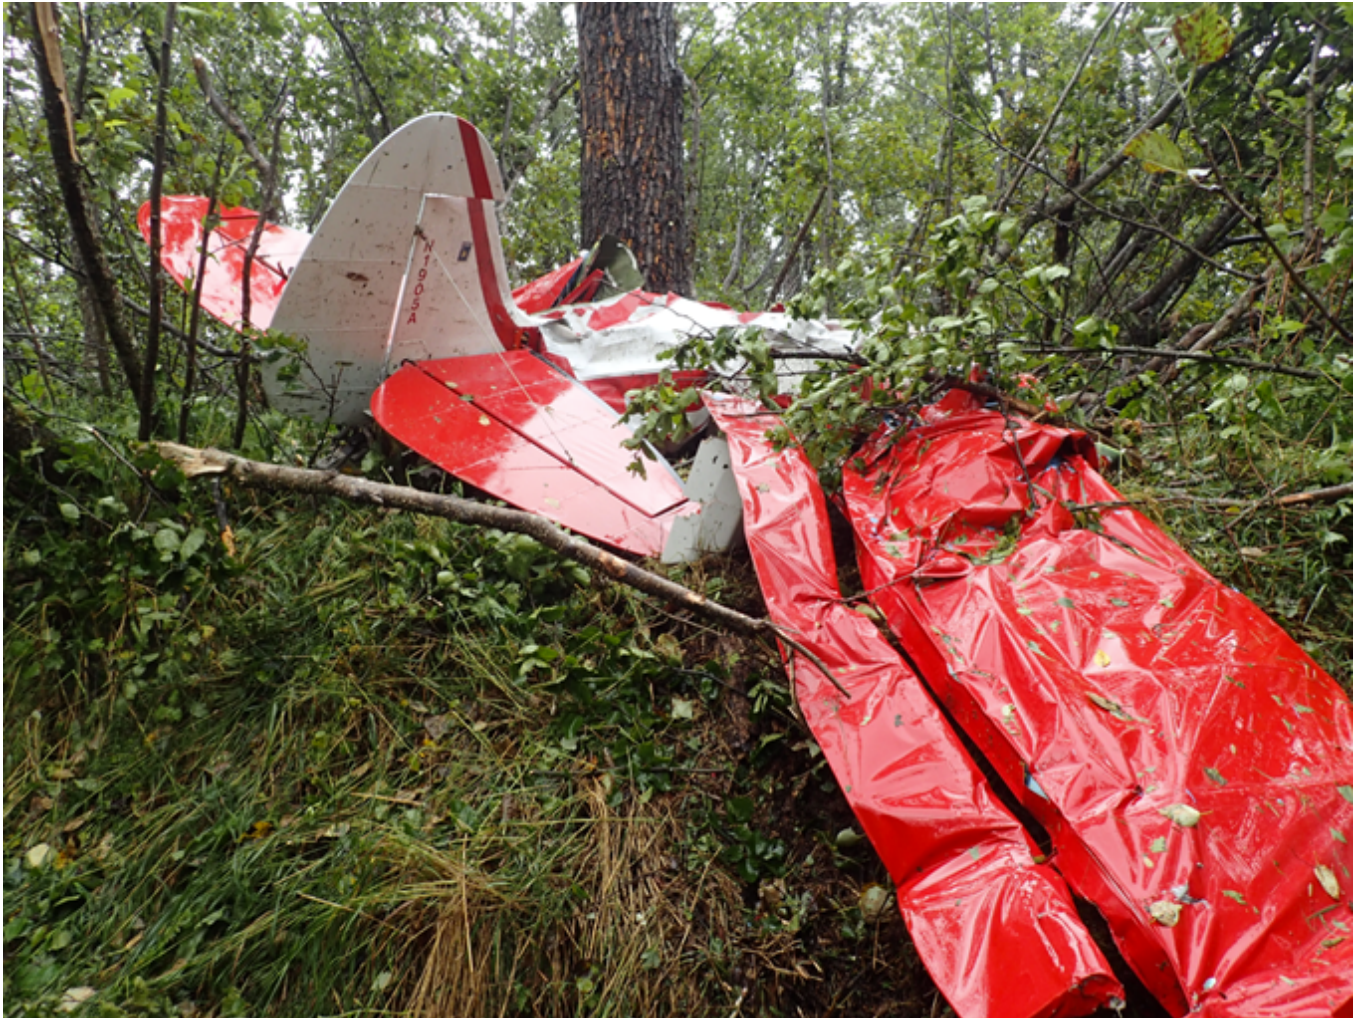
On August 24, the NTSB IIC and the Alaska State Troopers (AST) traveled to the accident site via helicopter. The wreckage was located at the base of a 100-foot-tall cottonwood tree at an elevation of about 455 ft msl as shown in figure 9.

Figure 9 – View of the empennage and the right wing (courtesy of the NTSB).

All portions of the airplane were accounted for at the wreckage site. The fuselage, both wings, and the cockpit were severely damaged with extensive deformation. Flight control continuity could not be established onsite due to extensive impact damage. The engine and propeller were buried underneath the airframe. Various hunting and camping gear were scattered throughout the wreckage.
