Aviation Investigation Final Report

Location:	Hertford, North Carolina	Accident Number:	ERA17MA316
Date & Time:	September 8, 2017, 11:20 Local	Registration:	N146DU
Aircraft:	EUROCOPTER DEUTSCHLAND GMBH MBB BK 117	Aircraft Damage:	Destroyed
Defining Event:	Loss of engine power (partial)	Injuries:	4 Fatal
Flight Conducted Under:	Part 135: Air taxi & commuter - Non-scheduled - Air Medical (Discretionary)

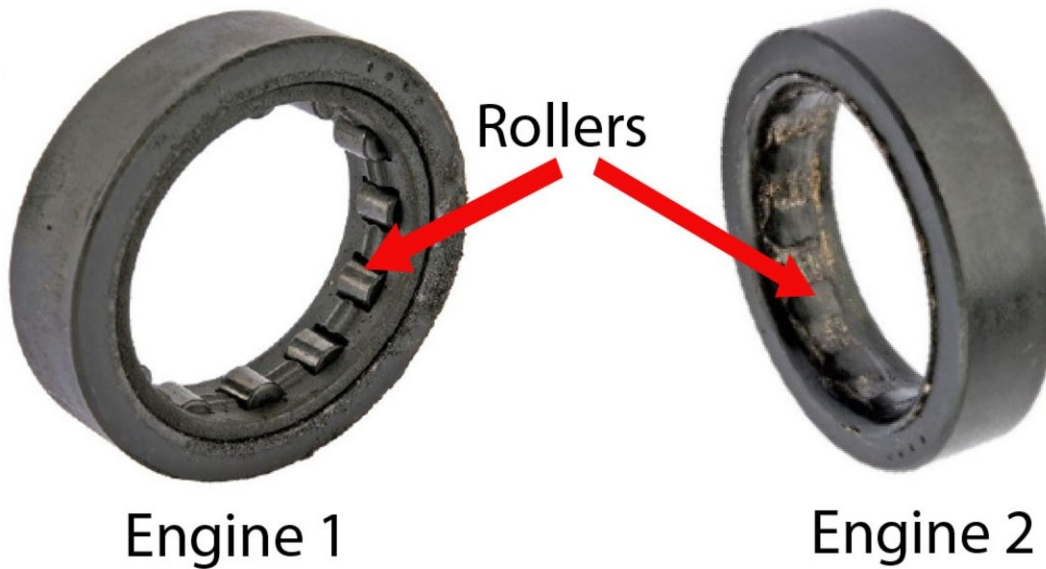
Figure 2 - Gas generator shaft rear bearings.

Detailed examination of the No. 2 engine revealed that its gas generator shaft rear bearing was seized and damaged. Specifically, all the roller elements were flattened and none of the roller elements would rotate. Several bearing components showed damage consistent with friction between the seized rollers and the inner race and ensuing overheating. These signatures were not observed in the No. 1 engine gas generator shaft rear bearing. The lack of rotation of the roller pins and the damage to the gas generator spool indicated that the No. 2 engine's rear bearing had failed during the accident flight.

The root cause of the No. 2 engine's bearing failure could not be determined due to the damage it sustained while continuing to operate before impact, and due to impact and subsequent post-crash fire damage.

The No. 2 engine disassembly revealed that the gas generator shaft rear bearing was mechanically damaged. A detailed examination of the bearing at the engine manufacturer's laboratory revealed that all of the bearing roller elements were found seized (that is, none of the roller elements would rotate), with the outer bearing race, and had rubbed against the inner rotating bearing race. The roller elements appeared ground down (flattened) and overheated.

Figure 2 compares the No. 2 engine rear bearing with the undamaged No. 1 engine rear bearing. Turbine components and the end of the No. 2 engine gas generator shaft exhibited rotational non-uniform damage. This damage was consistent with some continued rotation of the gas generator spool after the bearing had seized. (The turbine shaft supported by the rear bearing rotates at speeds up to 53,500 rpm.)

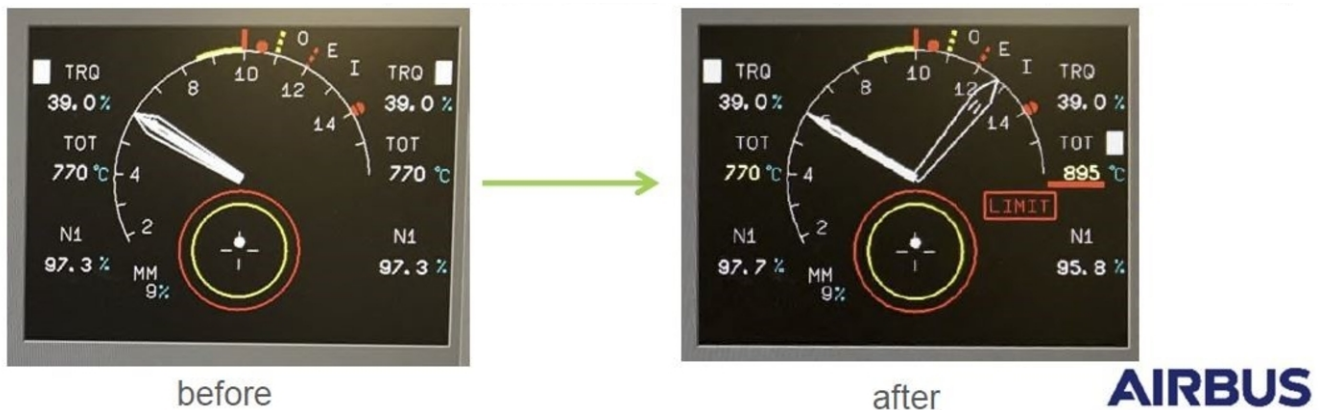
Figure 3 - Simulated FLI display before and during rear bearing seizure.

A simulation of the primary engine display instrument, the first limit indicator (FLI), revealed that as the bearing degraded, the FLI might have presented data in a way that was unfamiliar to the pilot, possibly causing confusion.

Specifically, as the bearing failed, the FLI needle for the No. 2 engine would have changed from indicating torque (TRQ), to indicating turbine outlet temperature (TOT) due to a sudden rise in TOT in the No. 2 engine. Such a switch would have been unusual, because the needles normally reflect TOT during engine start only. The change in the position of the No. 2 FLI needle would have resulted in a large split between both needles.

The left image of figure 3 shows the FLI with the engine operating normally, prior to a bearing seizure. Both FLI needles should depict TRQ because that would be the first limiting parameter for both engines in the flight conditions on the day of the accident. The needles would both indicate the same or nearly the same value for TRQ because both engines should produce about the same power, as the engines are TRQ balanced by the VARTOMS system. The simulation showed that, with a rear bearing seizure in the No. 2 engine, the engine's turbine outlet temperature would be elevated such that the TOT limit would be reached before the torque limit. Thus, an elevated turbine outlet temperature would result in the FLI changing to TOT for the No. 2 engine, as denoted by the white box for the No. 2 engine moving from the TRQ label (in the left image) to the TOT label (in the right image) and the position of the needle for the No. 2 engine changing. In addition, because TOT reached its limit, the digital value appeared with a red bar underneath it. The No. 1 engine would remain limited by TRQ, as indicated by the white box for the No. 1 engine next to the TRQ label (in the right image). As a result, a large split in the needles would occur because they would no longer indicate the same parameter for each engine, even though both engines would still be initially producing the same torque (39% in the figure).

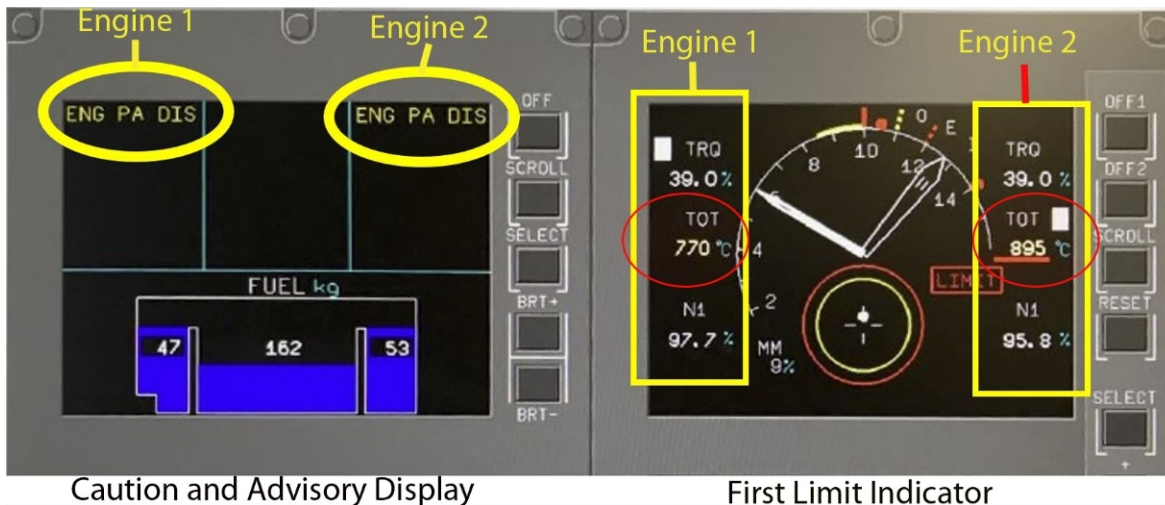
Figure 4 - Caution and advisory display panel (left) and FLI (right) showing affected engine and parameter.

The simulation also showed that an ENG PA DIS amber caution message may appear for both engines on the caution and advisory display panel, as shown in the left image of figure 4, due to the difference in TOT between engine Nos. 1 and 2. The ENG PA DIS caution message is displayed whenever a significant difference between each engine's TOT, TRQ, or N1 is detected, or when the signal from any of these parameters is lost. For TOT, the threshold to trigger the ENG PA DIS caution is a difference of greater than 80° C between engine 1 and engine 2. Even though the ENG PA DIS message appears in both engine columns on the CAD display, the CAD display does not indicate which parameter was detected or which engine was affected. As a result, the pilot would need to refer to the FLI parameters to determine which engine is affected, as shown in the right image of Figure 4. Figure 4 shows the TOT on the right engine is the limiting parameter, and during the event, it was likely to have appeared in the right (engine 2) column of the CAD (note that the "ENG CHIP" caution activation was not part of the simulation, and is not displayed in the figure). The FLM procedure for the ENG PA DIS message is "do not try and match needles, avoid using maximum power, compare the numeric values on the FLI to verify the affected parameter, and land as soon as practicable." The ENG PA DIS procedures do not request the pilot to shut down the engine.
