# Aviation Investigation Final Report

<b>Location:</b>	Hertford, North Carolina	<b>Accident Number:</b>	ERA17MA316
<b>Date &amp; Time:</b>	September 8, 2017, 11:20 Local	<b>Registration:</b>	N146DU
<b>Aircraft:</b>	EUROCOPTER DEUTSCHLAND GMBH MBB BK 117	<b>Aircraft Damage:</b>	Destroyed
<b>Defining Event:</b>	Loss of engine power (partial)	<b>Injuries:</b>	4 Fatal
<b>Flight Conducted Under:</b>	Part 135: Air taxi & commuter - Non-scheduled - Air Medical (Discretionary)

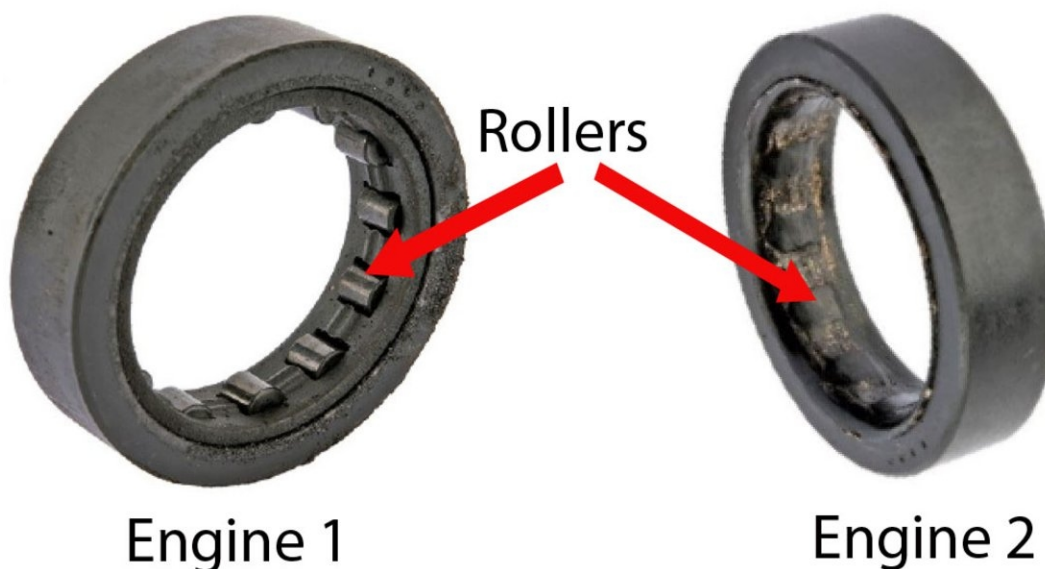
**Figure 2 - Gas generator shaft rear bearings.**

Detailed examination of the No. 2 engine revealed that its gas generator shaft rear bearing was seized and damaged. Specifically, all the roller elements were flattened and none of the roller elements would rotate. Several bearing components showed damage consistent with friction between the seized rollers and the inner race and ensuing overheating. These signatures were not observed in the No. 1 engine gas generator shaft rear bearing. The lack of rotation of the roller pins and the damage to the gas generator spool indicated that the No. 2 engine's rear bearing had failed during the accident flight.

The No. 2 engine disassembly revealed that the gas generator shaft rear bearing was mechanically damaged. A detailed examination of the bearing at the engine manufacturer's laboratory revealed that all of the bearing roller elements were found seized (that is, none of the roller elements would rotate), with the outer bearing race, and had rubbed against the inner rotating bearing race. The roller elements appeared ground down (flattened) and overheated.

Figure 2 compares the No. 2 engine rear bearing with the undamaged No. 1 engine rear bearing. Turbine components and the end of the No. 2 engine gas generator shaft exhibited rotational non-uniform damage. This damage was consistent with some continued rotation of the gas generator spool after the bearing had seized. (The turbine shaft supported by the rear bearing rotates at speeds up to 53,500 rpm.)

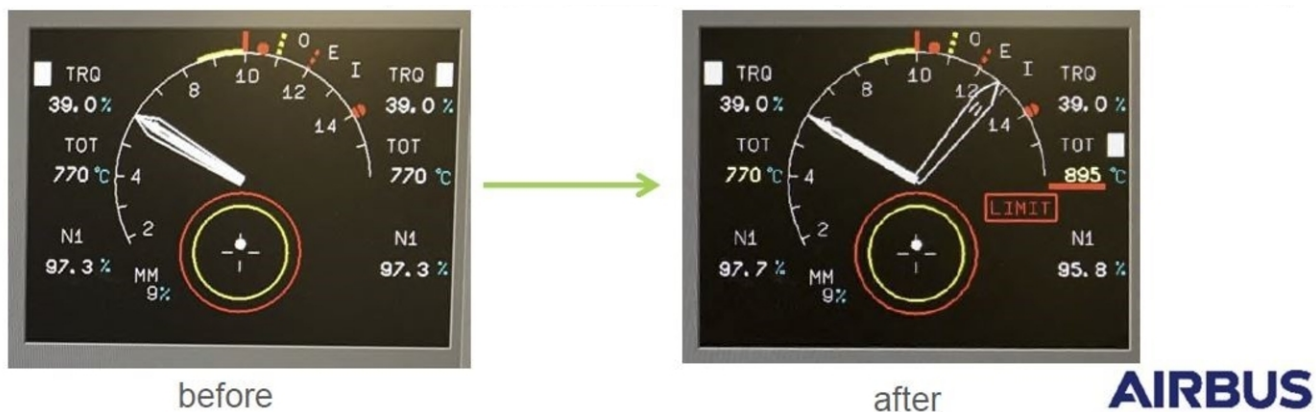
**Figure 3 - Simulated FLI display before and during rear bearing seizure.**

Specifically, as the bearing failed, the FLI needle for the No. 2 engine would have changed from indicating torque (TRQ), to indicating turbine outlet temperature (TOT) due to a sudden rise in TOT in the No. 2 engine. Such a switch would have been unusual, because the needles normally reflect TOT during engine start only. The change in the position of the No. 2 FLI needle would have resulted in a large split between both needles.

The left image of figure 3 shows the FLI with the engine operating normally, prior to a bearing seizure. Both FLI needles should depict TRQ because that would be the first limiting parameter for both engines in the flight conditions on the day of the accident. The needles would both indicate the same or nearly the same value for TRQ because both engines should produce about the same power, as the engines are TRQ balanced by the VARTOMS system. The simulation showed that, with a rear bearing seizure in the No. 2 engine, the engine's turbine outlet temperature would be elevated such that the TOT limit would be reached before the torque limit. Thus, an elevated turbine outlet temperature would result in the FLI changing to TOT for the No. 2 engine, as denoted by the white box for the No. 2 engine moving from the TRQ label (in the left image) to the TOT label (in the right image) and the position of the needle for the No. 2 engine changing. In addition, because TOT reached its limit, the digital value appeared with a red bar underneath it. The No. 1 engine would remain limited by TRQ, as indicated by the white box for the No. 1 engine next to the TRQ label (in the right image). As a result, a large split in the needles would occur because they would no longer indicate the same parameter for each engine, even though both engines would still be initially producing the same torque (39% in the figure).
