# Aviation Investigation Final Report

<b>Location:</b>	Prairie du Chien, Wisconsin	<b>Accident Number:</b>	CEN17LA344
<b>Date &amp; Time:</b>	September 9, 2017, 15:45 Local	<b>Registration:</b>	N299CA
<b>Aircraft:</b>	AVIAT AIRCRAFT INC A 1B	<b>Aircraft Damage:</b>	Substantial
<b>Defining Event:</b>	Flight control sys malf/fail	<b>Injuries:</b>	1 None
<b>Flight Conducted Under:</b>	Part 91: General aviation

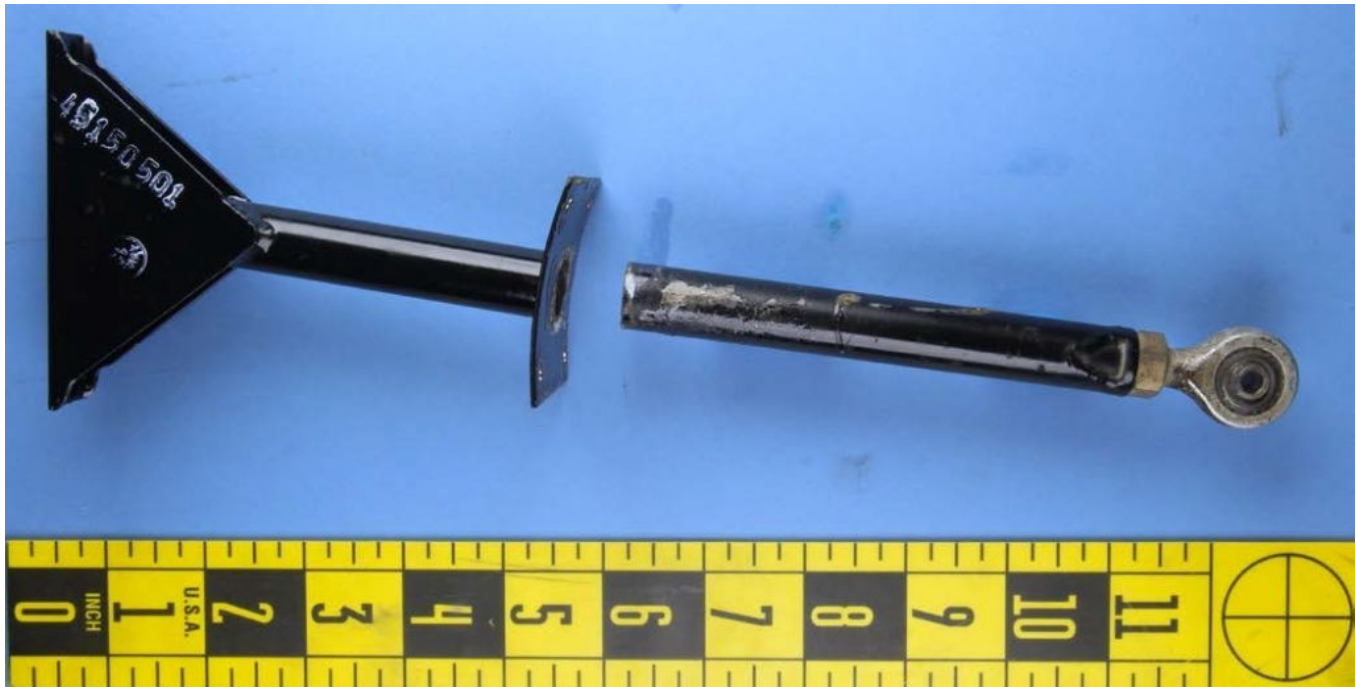
Figure 1 – Aileron Hinge Bracket

Metallurgical analysis of the aileron hinge bracket revealed two fatigue fracture origins that led to two regions of final overstress fracture. The fatigue fractures occurred under low stress over an extended period of time. No anomalies were noted in the origin regions and there was no specific evidence of bending at the fracture area. Since there was no specific evidence of bending, it could not be determined if the previous damage to the wing tip resulted in unidentified stress to the fracture area. Wing tip damage as a result of hangar rash could have resulted in residual tension in the aileron tube and precipitated the low-stress fatigue fracture; however, the severity of previous damage to the wing tip and whether the aileron was affected could not be determined.

The fatigue failure of the aileron hinge bracket tubing for reasons that could not be determined based on the available evidence.

The aileron hinge bracket was removed and sent to the NTSB Materials Laboratory for a detailed examination. The examination revealed that the main tube exhibited a complete circumferential fracture just aft of the mounting flange (figure 1).

The fracture surface on the flange side was examined with a scanning electron microscope, which revealed two fatigue fracture origins that led to two regions of final overstress fracture. The fatigue fractures occurred under low stress over an extended period of time. No anomalies were noted in the origin regions. The fractures did not occur at the welds and no anomalies were noted with the welds. The examination did not find any specific evidence of bending at the fracture area.
