# Aviation Investigation Final Report

<b>Location:</b>	Aniak, Alaska	<b>Accident Number:</b>	ANC17LA052
<b>Date &amp; Time:</b>	August 18, 2017, 14:00 Local	<b>Registration:</b>	N92DC
<b>Aircraft:</b>	Cessna A185	<b>Aircraft Damage:</b>	Substantial
<b>Defining Event:</b>	Part(s) separation from AC	<b>Injuries:</b>	4 None
<b>Flight Conducted Under:</b>	Part 91: General aviation

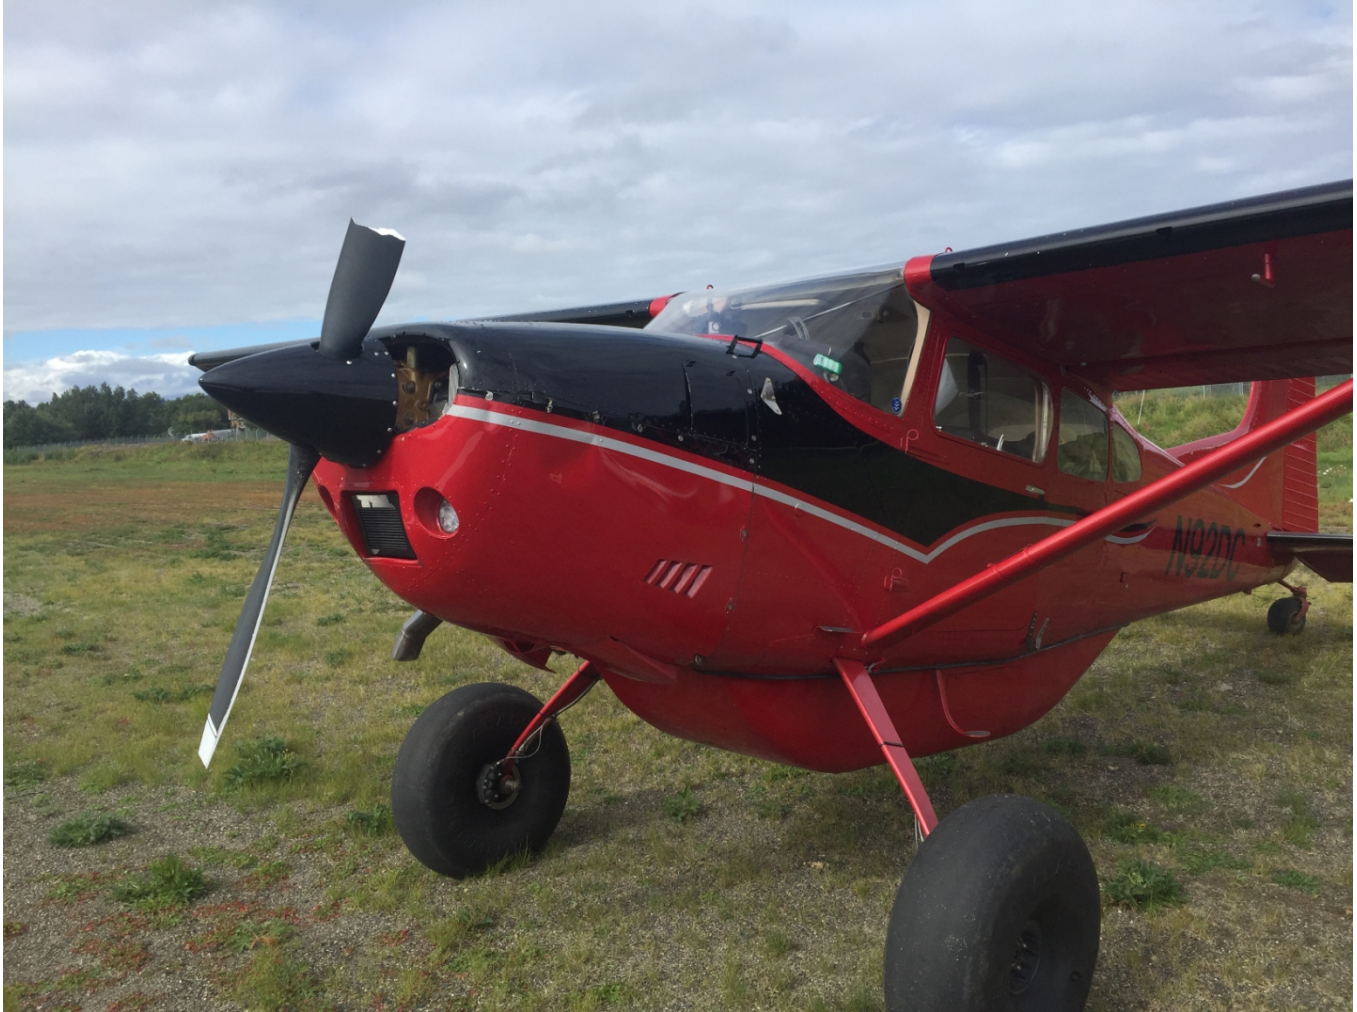
The pilot reported the purpose of the flight was to depart from ANI and take the three passengers on a remote guided hunting operation south of Aniak, Alaska. While the airplane was taxiing for takeoff at about 15 mph and about 2,700 rpm, a blade from the metal two blade propeller separated. After the separation, the pilot was able to maintain control of the airplane and shutdown the airplane without further incident as shown below in figure 1. No injuries to personnel on the ground occurred after the propeller blade separation.

Figure 1 – View of the airplane after it was shutdown (courtesy of the pilot).

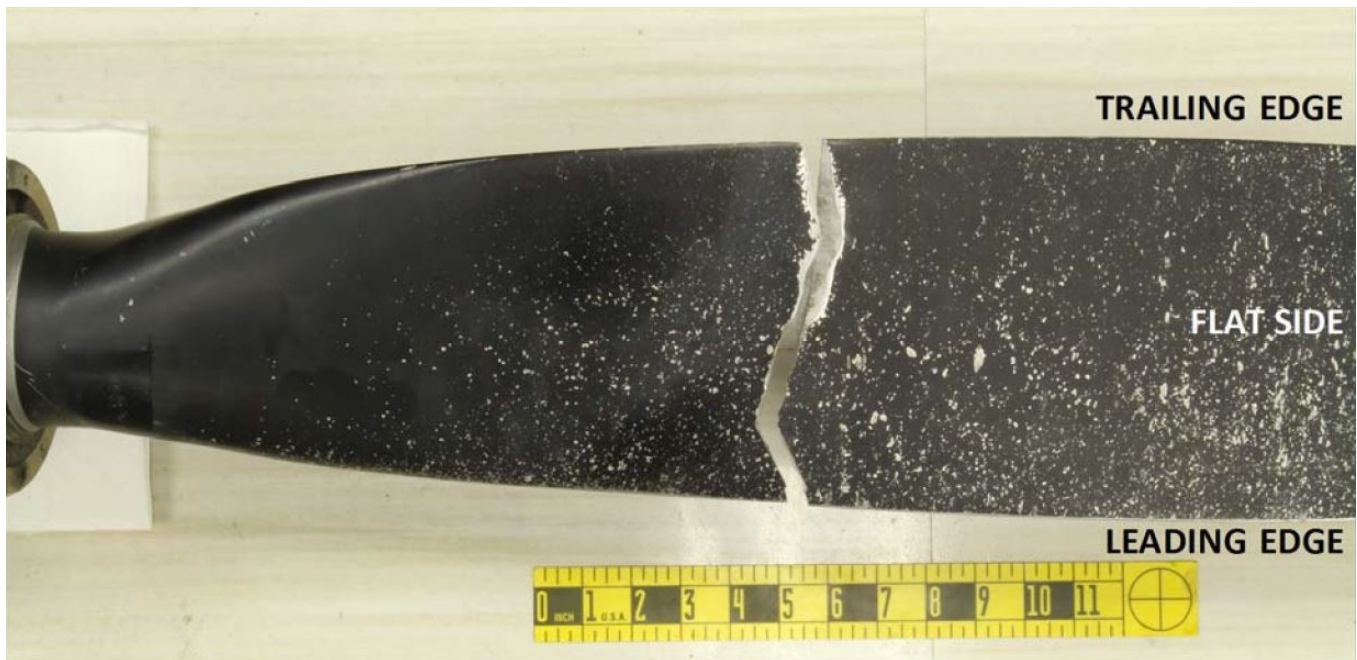
The #2 blade of the submitted propeller separated into two pieces as shown below in figure 3. The separation was located approximately a third of the blade length from the root of the blade. The crack extended from the leading edge and was roughly v-shaped along the chord of the blade. The blades were disassembled from the hub.

Figure 3 – View of the separated blade (blade #2).

The fracture surface was sectioned from the root half of the blade. There was a distinct thumbnail-shaped pattern emanating from a small nick in the leading edge of the blade.

The size of the nick measured approximately 0.07 inches by 0.08 inches, with a maximum depth of roughly 0.02 inches. A long grain was observed on the fracture surface adjacent to the forward side of the blade. The orientation of the long grain likely contributed to the v-shape of the crack path along the chord length of the blade.

The nick exhibited no signs of a prior field repair. It could not be determined when the fatigue crack was initiated.

The fracture surface was examined using a Zeiss Auriga 40 field emission scanning electron microscope. The fracture surface had transgranular features consistent with fatigue. Crack arrest lines on the fracture surface indicated the fatigue emanated from a corner of deformed material that resulted from the nick in the leading edge.
