Aviation Investigation Final Report

Location:	Aniak, Alaska	Accident Number:	ANC17LA052
Date & Time:	August 18, 2017, 14:00 Local	Registration:	N92DC
Aircraft:	Cessna A185	Aircraft Damage:	Substantial
Defining Event:	Part(s) separation from AC	Injuries:	4 None
Flight Conducted Under:	Part 91: General aviation

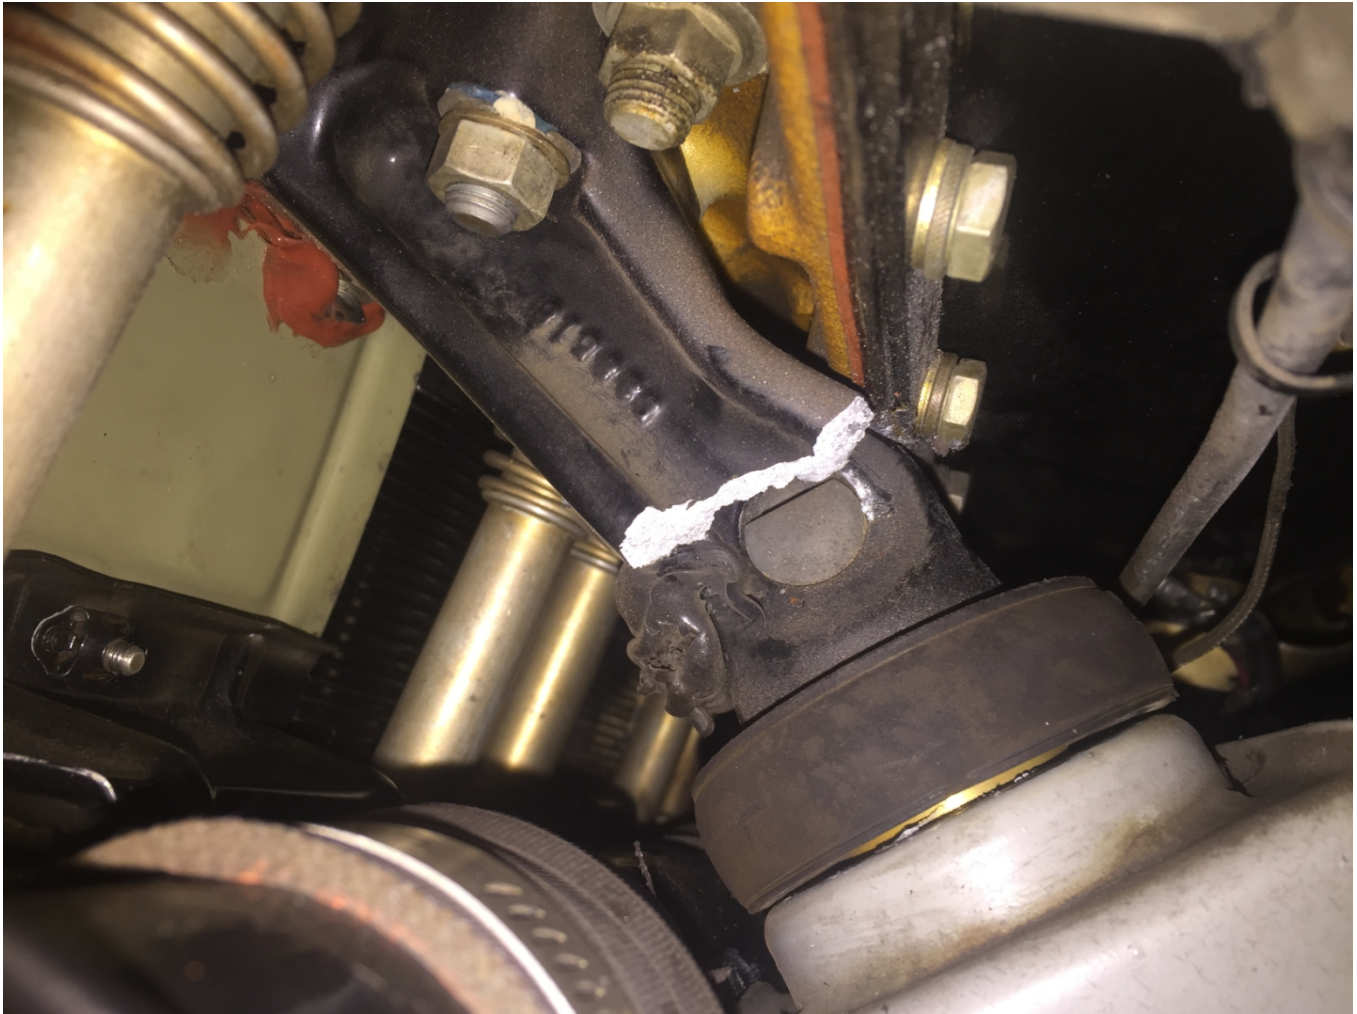
The pilot/operator was taxiing the airplane for takeoff. While the airplane was moving about 15 mph and about 2,700 rpm, a blade from the metal two-blade propeller separated. After the separation, the pilot maintained control of the airplane and shut down the airplane. The engine mount sustained substantial damage from excessive vibrations caused by the propeller blade separation.

A postflight inspection by the pilot revealed the engine mount sustained substantial damage from excessive vibrations caused by the propeller blade separation as shown below in figure 2.

Figure 2 – View of the fractured engine mount (courtesy of the pilot).

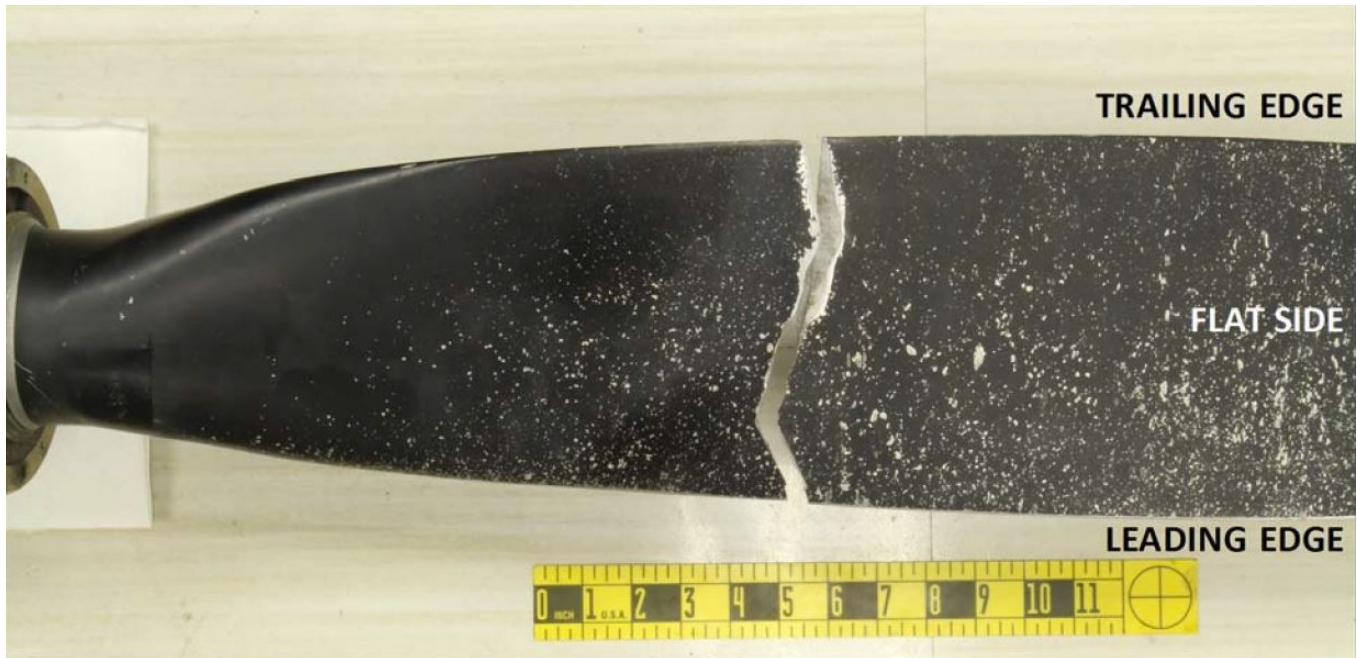
An examination of the fractured propeller blade revealed that it had failed due to fatigue cracking that had initiated from a nick in the leading edge. Measurement of the nick revealed it was within tolerance for a field repair although a field repair had not been performed.

The #2 blade of the submitted propeller separated into two pieces as shown below in figure 3. The separation was located approximately a third of the blade length from the root of the blade. The crack extended from the leading edge and was roughly v-shaped along the chord of the blade. The blades were disassembled from the hub.

Figure 3 – View of the separated blade (blade #2).

The fracture surface was sectioned from the root half of the blade. There was a distinct thumbnail-shaped pattern emanating from a small nick in the leading edge of the blade.

The size of the nick measured approximately 0.07 inches by 0.08 inches, with a maximum depth of roughly 0.02 inches. A long grain was observed on the fracture surface adjacent to the forward side of the blade. The orientation of the long grain likely contributed to the v-shape of the crack path along the chord length of the blade.

The nick exhibited no signs of a prior field repair. It could not be determined when the fatigue crack was initiated.

The fracture surface was examined using a Zeiss Auriga 40 field emission scanning electron microscope. The fracture surface had transgranular features consistent with fatigue. Crack arrest lines on the fracture surface indicated the fatigue emanated from a corner of deformed material that resulted from the nick in the leading edge.

Small nicks on the propeller, particularly near the tips and on the leading edges, should be dressed out as soon as possible since these nicks produce stress concentrations, and if ignored, may result in cracks.

Stress riser damage found during a routine inspection must be field repaired if it is not beyond the field repair limits. If damage is beyond the field repair limits, the blade must be evaluated and/or replaced by an FAA approved Part 145 Propeller Repair Station or international equivalent.
