# Aviation Investigation Final Report

<b>Location:</b>	Aniak, Alaska	<b>Accident Number:</b>	ANC17LA052
<b>Date &amp; Time:</b>	August 18, 2017, 14:00 Local	<b>Registration:</b>	N92DC
<b>Aircraft:</b>	Cessna A185	<b>Aircraft Damage:</b>	Substantial
<b>Defining Event:</b>	Part(s) separation from AC	<b>Injuries:</b>	4 None
<b>Flight Conducted Under:</b>	Part 91: General aviation

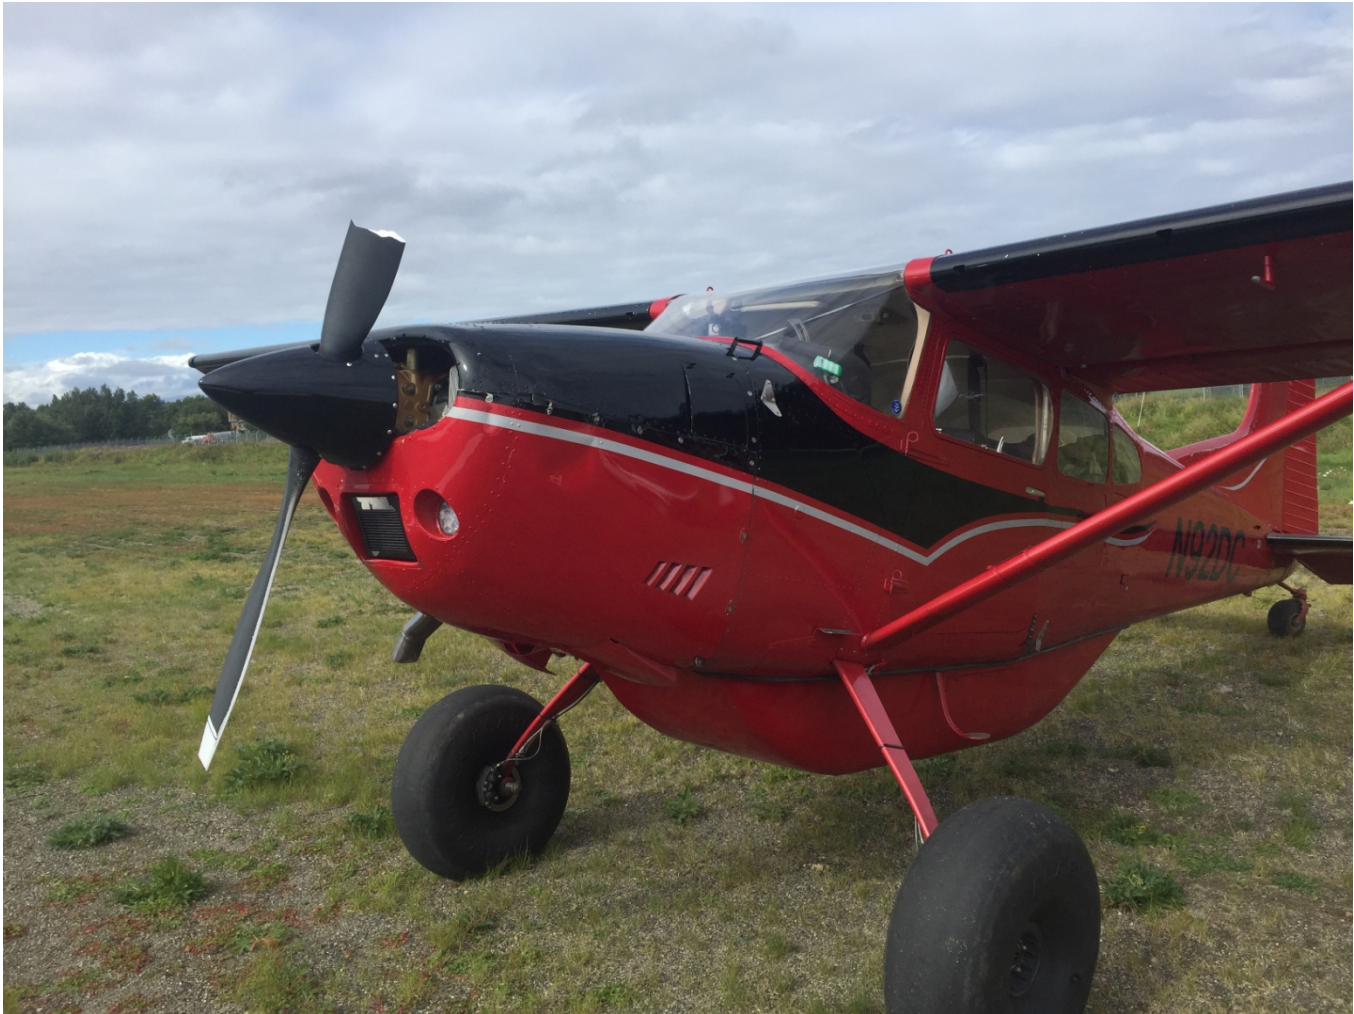
The pilot reported the purpose of the flight was to depart from ANI and take the three passengers on a remote guided hunting operation south of Aniak, Alaska. While the airplane was taxiing for takeoff at about 15 mph and about 2,700 rpm, a blade from the metal two blade propeller separated. After the separation, the pilot was able to maintain control of the airplane and shutdown the airplane without further incident as shown below in figure 1. No injuries to personnel on the ground occurred after the propeller blade separation.

Figure 1 – View of the airplane after it was shutdown (courtesy of the pilot).

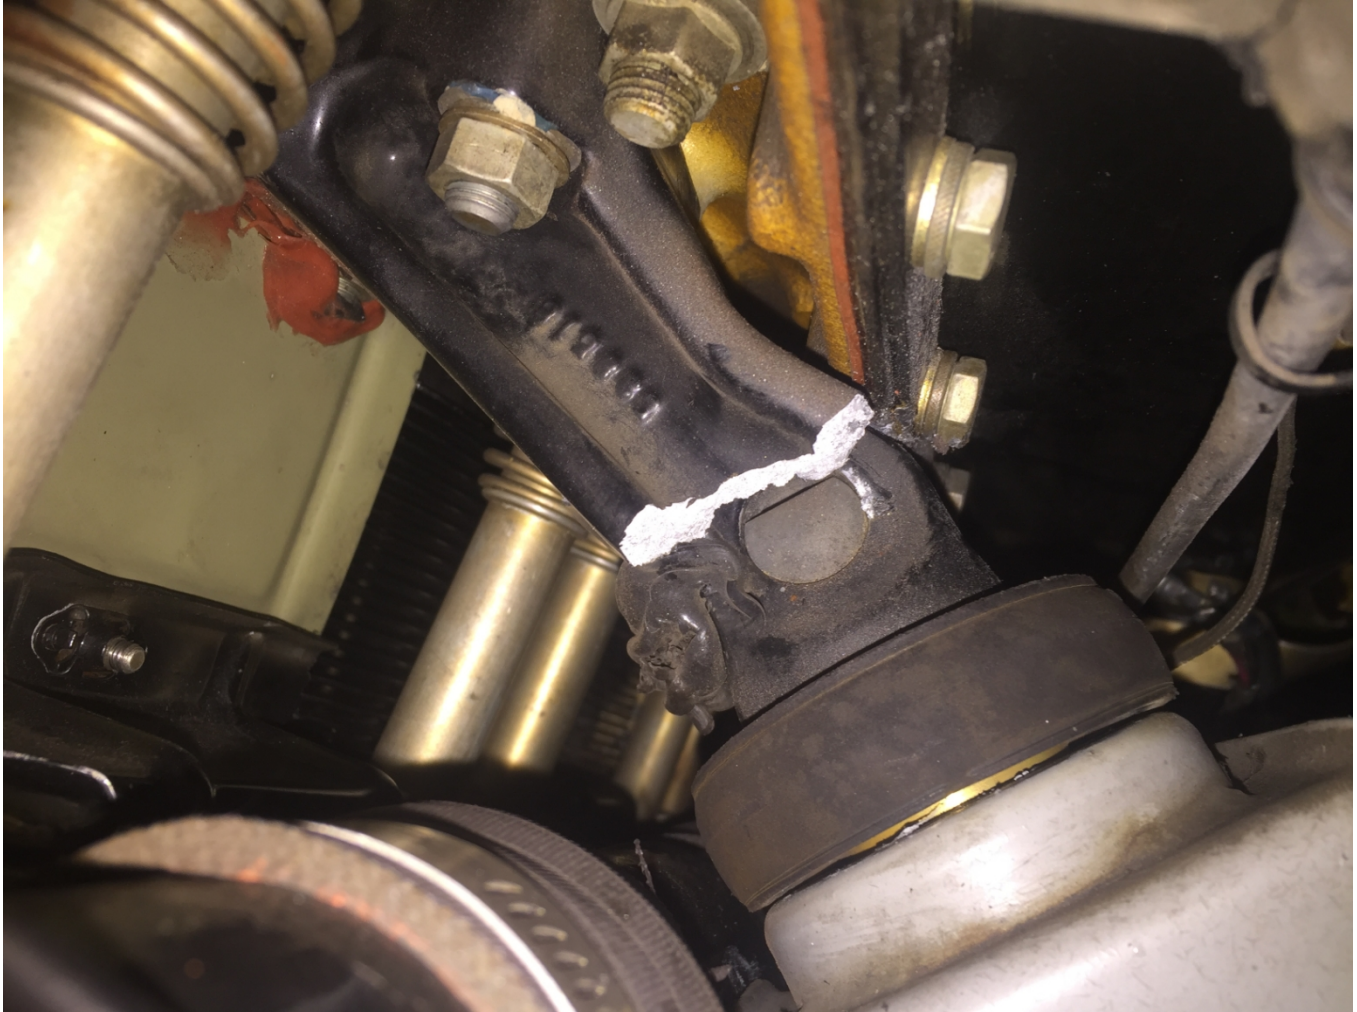
A postflight inspection by the pilot revealed the engine mount sustained substantial damage from excessive vibrations caused by the propeller blade separation as shown below in figure 2.

Figure 2 – View of the fractured engine mount (courtesy of the pilot).

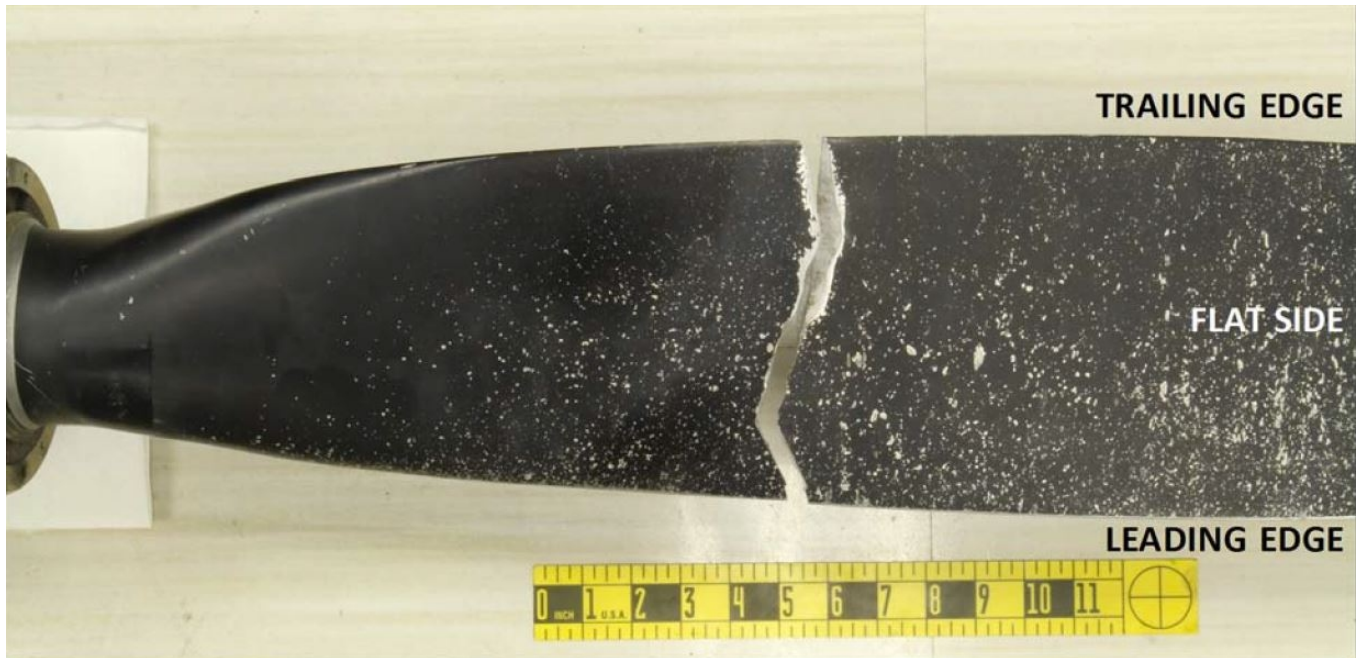
The #2 blade of the submitted propeller separated into two pieces as shown below in figure 3. The separation was located approximately a third of the blade length from the root of the blade. The crack extended from the leading edge and was roughly v-shaped along the chord of the blade. The blades were disassembled from the hub.

Figure 3 – View of the separated blade (blade #2).

The fracture surface was sectioned from the root half of the blade. There was a distinct thumbnail-shaped pattern emanating from a small nick in the leading edge of the blade.

The size of the nick measured approximately 0.07 inches by 0.08 inches, with a maximum depth of roughly 0.02 inches. A long grain was observed on the fracture surface adjacent to the forward side of the blade. The orientation of the long grain likely contributed to the v-shape of the crack path along the chord length of the blade.

The nick exhibited no signs of a prior field repair. It could not be determined when the fatigue crack was initiated.

The fracture surface was examined using a Zeiss Auriga 40 field emission scanning electron microscope. The fracture surface had transgranular features consistent with fatigue. Crack arrest lines on the fracture surface indicated the fatigue emanated from a corner of deformed material that resulted from the nick in the leading edge.

The airplane manufacturer owner's manual indicates that the propeller should be checked for nicks during the preflight inspection. It is likely the pilot/operator did not adequately inspect the propeller during the preflight inspection. Had an adequate inspection been completed, the nick likely would have been identified and could have been field repaired.
