Aviation Investigation Final Report

Location:	Aniak, Alaska	Accident Number:	ANC17LA052
Date & Time:	August 18, 2017, 14:00 Local	Registration:	N92DC
Aircraft:	Cessna A185	Aircraft Damage:	Substantial
Defining Event:	Part(s) separation from AC	Injuries:	4 None
Flight Conducted Under:	Part 91: General aviation

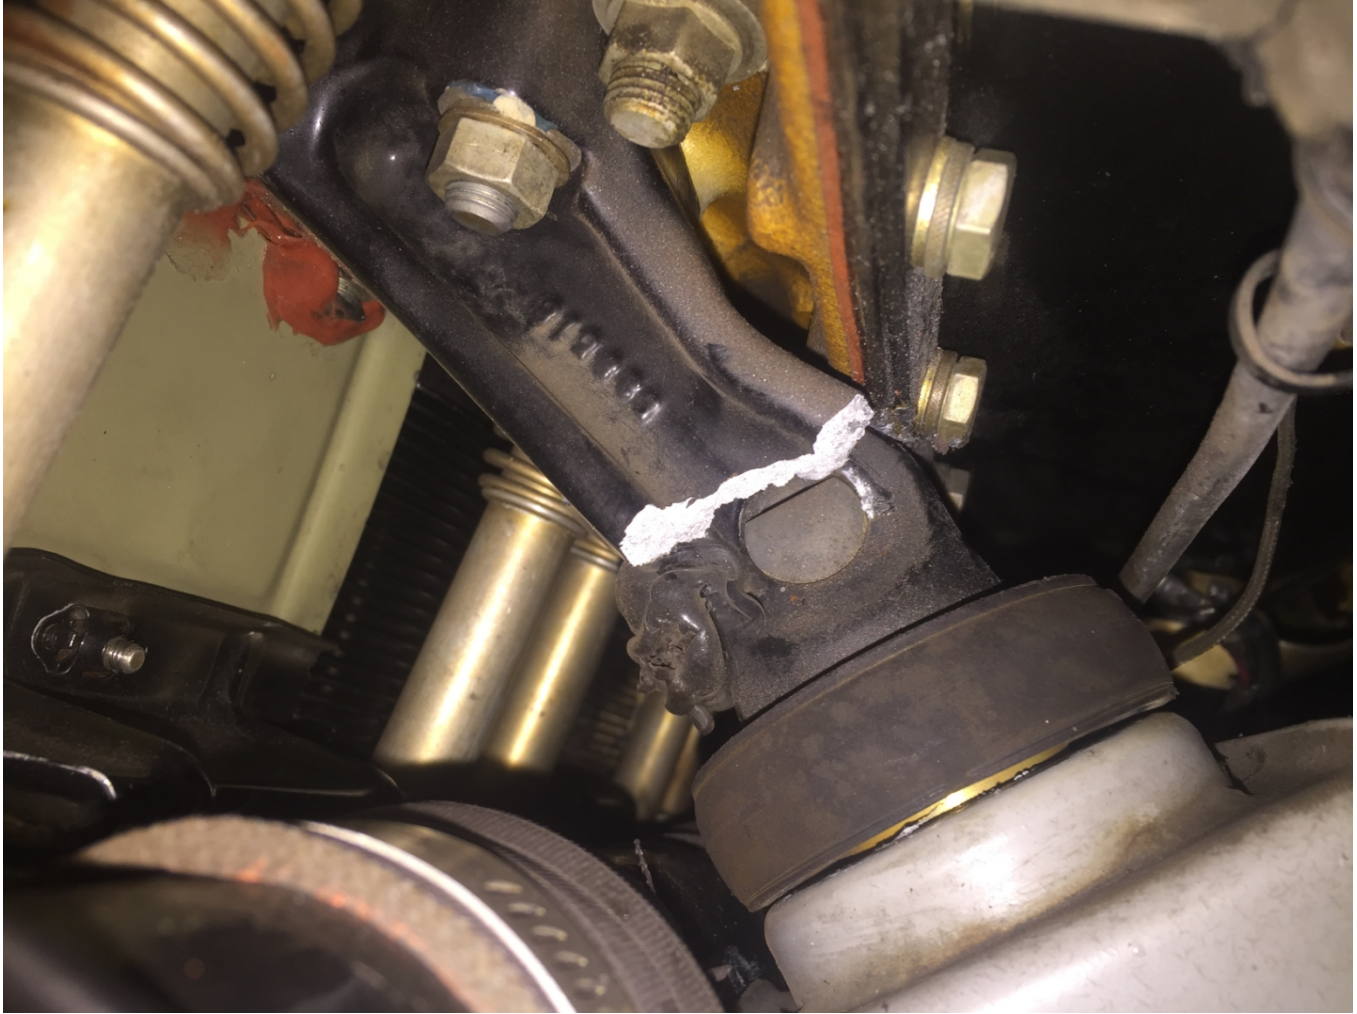
The pilot/operator was taxiing the airplane for takeoff. While the airplane was moving about 15 mph and about 2,700 rpm, a blade from the metal two-blade propeller separated. After the separation, the pilot maintained control of the airplane and shut down the airplane. The engine mount sustained substantial damage from excessive vibrations caused by the propeller blade separation.

A postflight inspection by the pilot revealed the engine mount sustained substantial damage from excessive vibrations caused by the propeller blade separation as shown below in figure 2.

Figure 2 – View of the fractured engine mount (courtesy of the pilot).
