Aviation Investigation Final Report

Location:	North Branford, Connecticut	Accident Number:	ERA17FA327
Date & Time:	September 16, 2017, 13:00 Local	Registration:	N53CP
Aircraft:	Mooney M20C	Aircraft Damage:	Substantial
Defining Event:	Loss of engine power (total)	Injuries:	2 Fatal
Flight Conducted Under:	Part 91: General aviation - Personal

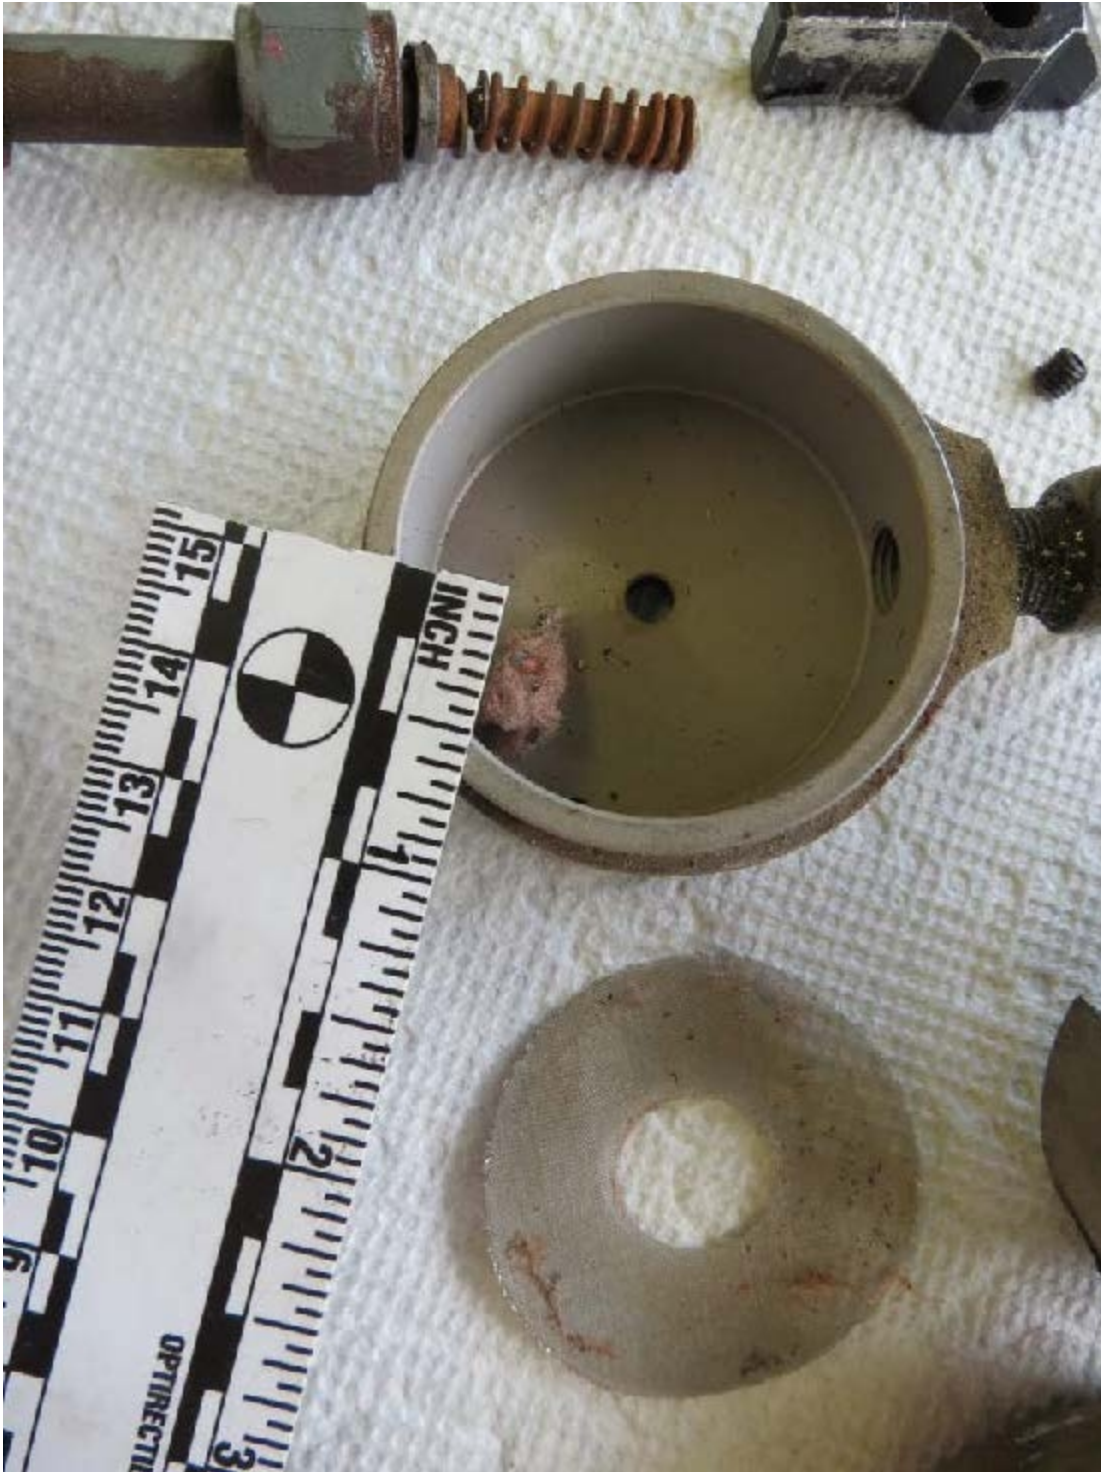
A total loss of engine power due to fuel starvation as the result of foreign object debris in the fuel selector valve. Contributing to the accident was the pilot's selection of a low cruising altitude, which reduced the available time to troubleshoot the loss of engine power and afforded fewer forced landing site options, and improper maintenance of the airplane, which allowed a portion of a shop towel into the fuel system.

Liquid with an odor consistent with aviation fuel was observed in the engine-driven fuel pump, the hose from the pump to the servo, in the servo, and in the fuel selector. The fuel selector valve was removed from the airframe and air pressure applied to the valve fuel outlet port. Air did not pass through the selector valve when the handle was in the position marked "LEFT." The handle was moved to the "OFF" position, then back to the "LEFT" position, and it remained blocked. Air did not pass through the valve when the actuator handle was placed in the position marked "OFF" or in the rearward, unmarked position. Air passed freely when the handle was placed in the position marked "RIGHT." When the handle was returned to the position marked "LEFT," no air passed through the selector valve. The selector handle moved normally with no unusual resistance between the settings.

The valve was disassembled and a spongy mass of reddish fibers consistent in appearance with red cotton shop towel fibers were observed in the selector cavity (see figure 1). The rounded mass was about 5/8 inches in length and about 3/8 inches in width. Fibers also covered about 5% of the fuel drain screen.

Figure 1-Debris discovered in the fuel selector.
