# Aviation Investigation Final Report

<b>Location:</b>	North Branford, Connecticut	<b>Accident Number:</b>	ERA17FA327
<b>Date &amp; Time:</b>	September 16, 2017, 13:00 Local	<b>Registration:</b>	N53CP
<b>Aircraft:</b>	Mooney M20C	<b>Aircraft Damage:</b>	Substantial
<b>Defining Event:</b>	Loss of engine power (total)	<b>Injuries:</b>	2 Fatal
<b>Flight Conducted Under:</b>	Part 91: General aviation - Personal

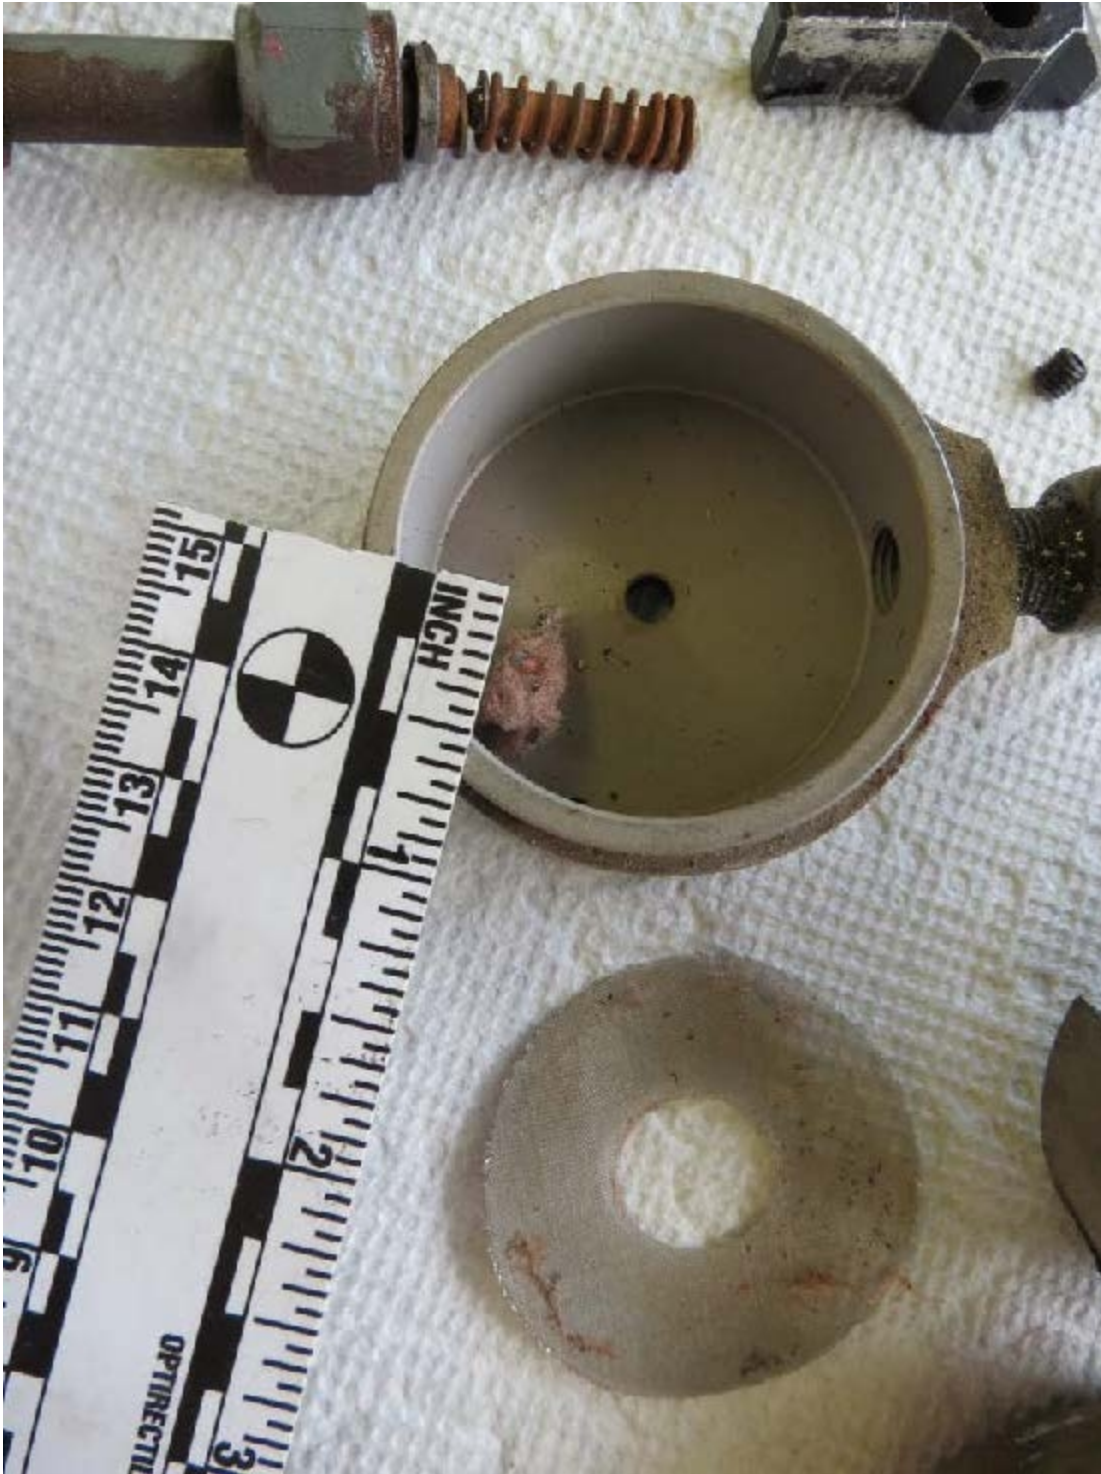
A total loss of engine power due to fuel starvation as the result of foreign object debris in the fuel selector valve. Contributing to the accident was the pilot's selection of a low cruising altitude, which reduced the available time to troubleshoot the loss of engine power and afforded fewer forced landing site options, and improper maintenance of the airplane, which allowed a portion of a shop towel into the fuel system.

Liquid with an odor consistent with aviation fuel was observed in the engine-driven fuel pump, the hose from the pump to the servo, in the servo, and in the fuel selector. The fuel selector valve was removed from the airframe and air pressure applied to the valve fuel outlet port. Air did not pass through the selector valve when the handle was in the position marked "LEFT." The handle was moved to the "OFF" position, then back to the "LEFT" position, and it remained blocked. Air did not pass through the valve when the actuator handle was placed in the position marked "OFF" or in the rearward, unmarked position. Air passed freely when the handle was placed in the position marked "RIGHT." When the handle was returned to the position marked "LEFT," no air passed through the selector valve. The selector handle moved normally with no unusual resistance between the settings.

The valve was disassembled and a spongy mass of reddish fibers consistent in appearance with red cotton shop towel fibers were observed in the selector cavity (see figure 1). The rounded mass was about 5/8 inches in length and about 3/8 inches in width. Fibers also covered about 5% of the fuel drain screen.

Figure 1-Debris discovered in the fuel selector.
