Aviation Investigation Final Report

Location:	North Branford, Connecticut	Accident Number:	ERA17FA327
Date & Time:	September 16, 2017, 13:00 Local	Registration:	N53CP
Aircraft:	Mooney M20C	Aircraft Damage:	Substantial
Defining Event:	Loss of engine power (total)	Injuries:	2 Fatal
Flight Conducted Under:	Part 91: General aviation - Personal

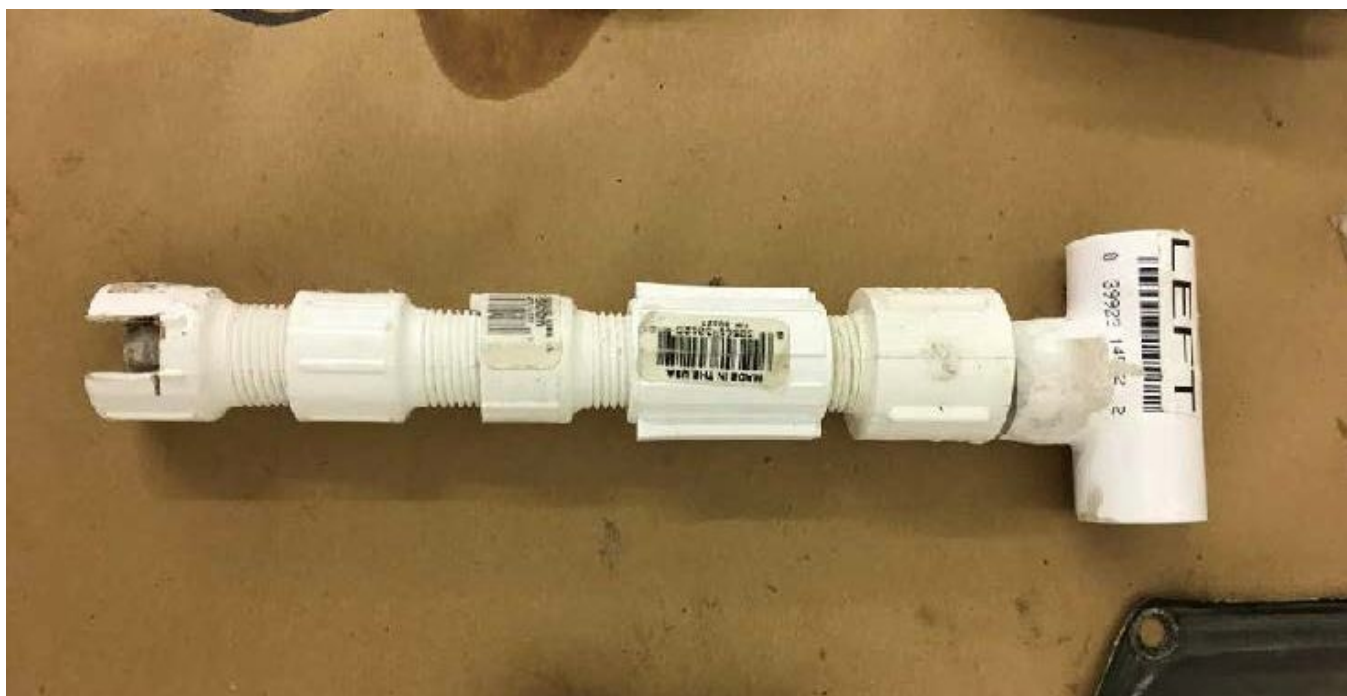
Figure 2-Homemade fuel selector tool after partial reassembly.

Following the loss of engine power, the pilot may have attempted to switch the fuel selector from the left tank to the right tank and was unable to do so, either due to a failure of his homemade tool or to the inadequate time afforded to troubleshoot the loss of engine power due to his selection of a low cruising altitude, or a combination of the two factors. The airplane's low cruising altitude also reduced the pilot's available forced landing site options after the engine lost power. It is likely that the pilot was attempting to reach an open field that was about 1,500 ft beyond the accident site and had lowered the landing gear

A section of PVC similar to plumbing or electrical conduit was discovered in the wreckage (see figure

2). It was made up of five individually-threaded, male-to-female connections which, when threaded together, measured about 9 inches long. On the top of the device was a PVC pipe in the shape of a handle. The entire device was in three separate pieces when discovered; the top of the t-handle was broken from the device and the bottom section was unscrewed. On each side of the handle was a label indicating "LEFT" and "RIGHT." The top of the handle was labeled "FUEL." On the bottom of the T-handle connection, the vertical pipe appeared to be hand carved/shaved so that it would fit into the top section of the device. There was a 3/4-inch notch cut out on the bottom of the device. When the device was reassembled during the examination, it fit into the airplane fuel selector handle, and appeared to be designed to switch the fuel tanks; however, the reason for its fabrication and use was unknown.
