Aviation Investigation Final Report

Location:	Glenwood Springs, Colorado	Accident Number:	CEN17FA354
Date & Time:	September 15, 2017, 20:10 Local	Registration:	N462SR
Aircraft:	CIRRUS DESIGN CORP SR22	Aircraft Damage:	Destroyed
Defining Event:	Loss of control in flight	Injuries:	4 Fatal
Flight Conducted Under:	Part 91: General aviation - Personal

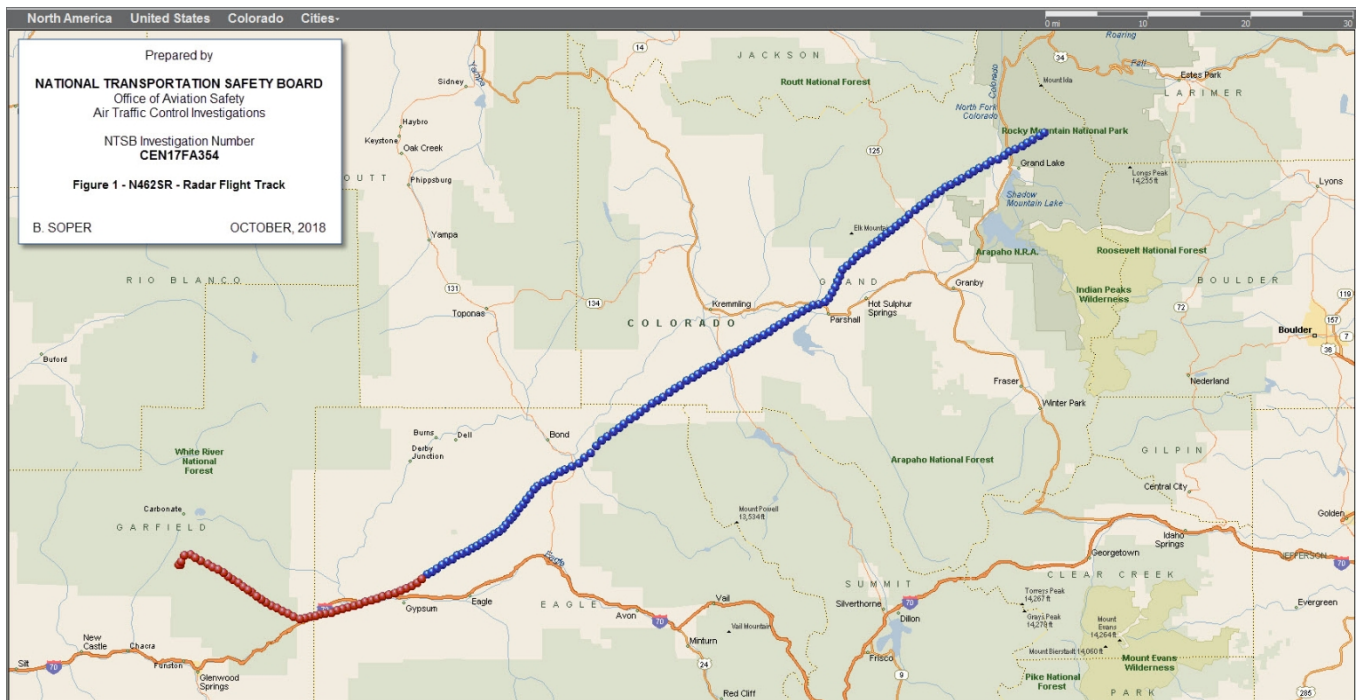
Figure 1 Entire Flight Radar Track

According to air traffic control information from the Federal Aviation Administration (FAA), the pilot was receiving VFR flight-following services during the flight. Radar track data indicated that the airplane departed and traveled on a southwesterly heading toward the destination. At 1925, the pilot stated to the controller that he was going to climb the airplane to 15,000 ft mean sea level (msl) to "get over the mountains and then back down." At 1928, the airplane turned to a southwesterly direct heading to CNY at an indicated altitude about 10,700 ft msl. By 1932, the airplane had climbed to 13,200 ft and stopped climbing. From 1940 to 2000, radar data showed the airplane on a southwest heading with a series of altitude changes between 13,200 ft and 10,500 ft. At 2004, about 10 miles northeast of Glenwood Springs, Colorado, the airplane turned to the northwest, at an altitude of 11,500 ft msl, and continued northwest for about 12 miles (See Figure 1).

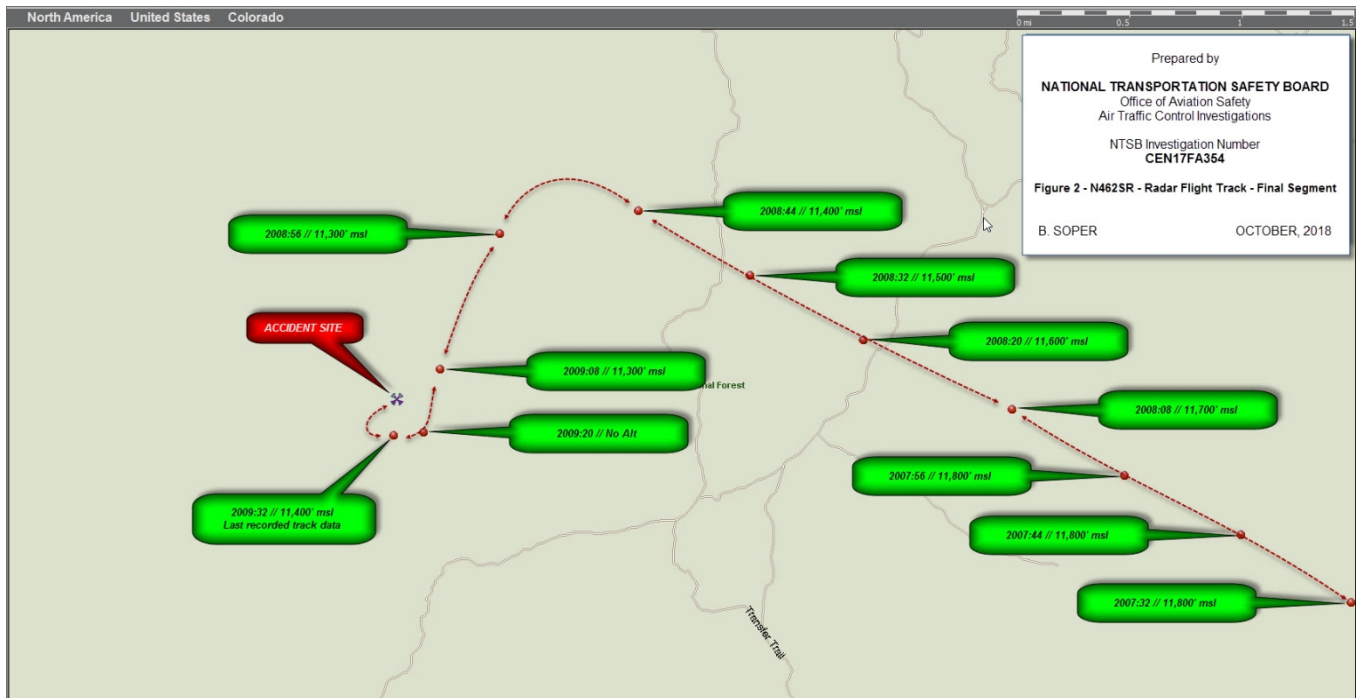
Figure 2 Radar Flight Track - Final Segment

At 2008, a passenger sent a text message to her mother, "Taking the long way around, lots of weather, keep you posted." From 2008:32 to 2009:08, the airplane was in a gradual left turn to the southwest, descending from 11,500 ft to 11,300 ft, then climbing to 11,400 ft. The last recorded radar return was at 2009:32 at an altitude of 11,400 ft msl and about 1/4 mile south of the accident site (See Figure 2).

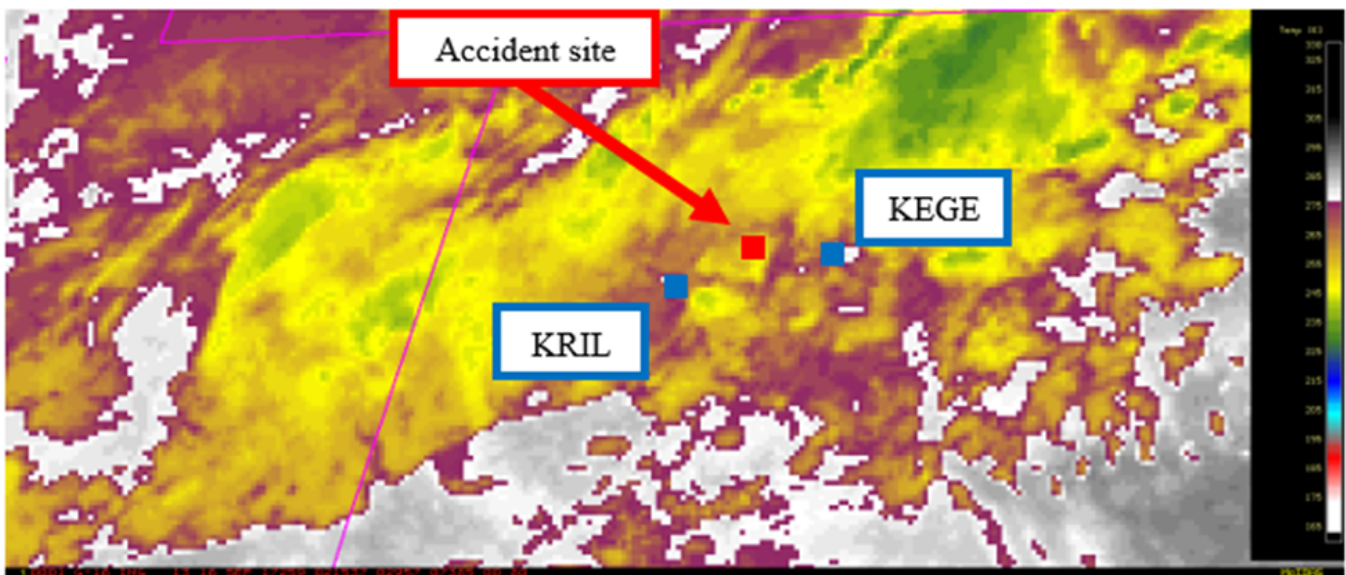
Figure 3 GOES-16 Infrared Image at 2015 MDT

Infrared data from the Geostationary Operational Environmental Satellite number 16 (GOES-16) was obtained. Satellite imagery surrounding the time of the accident was reviewed and indicated cloud cover over the accident site with the cloud cover moving from southwest to northeast. At 2015, the approximate cloud-top heights were 22,000 ft over the accident site (See Figure 3).

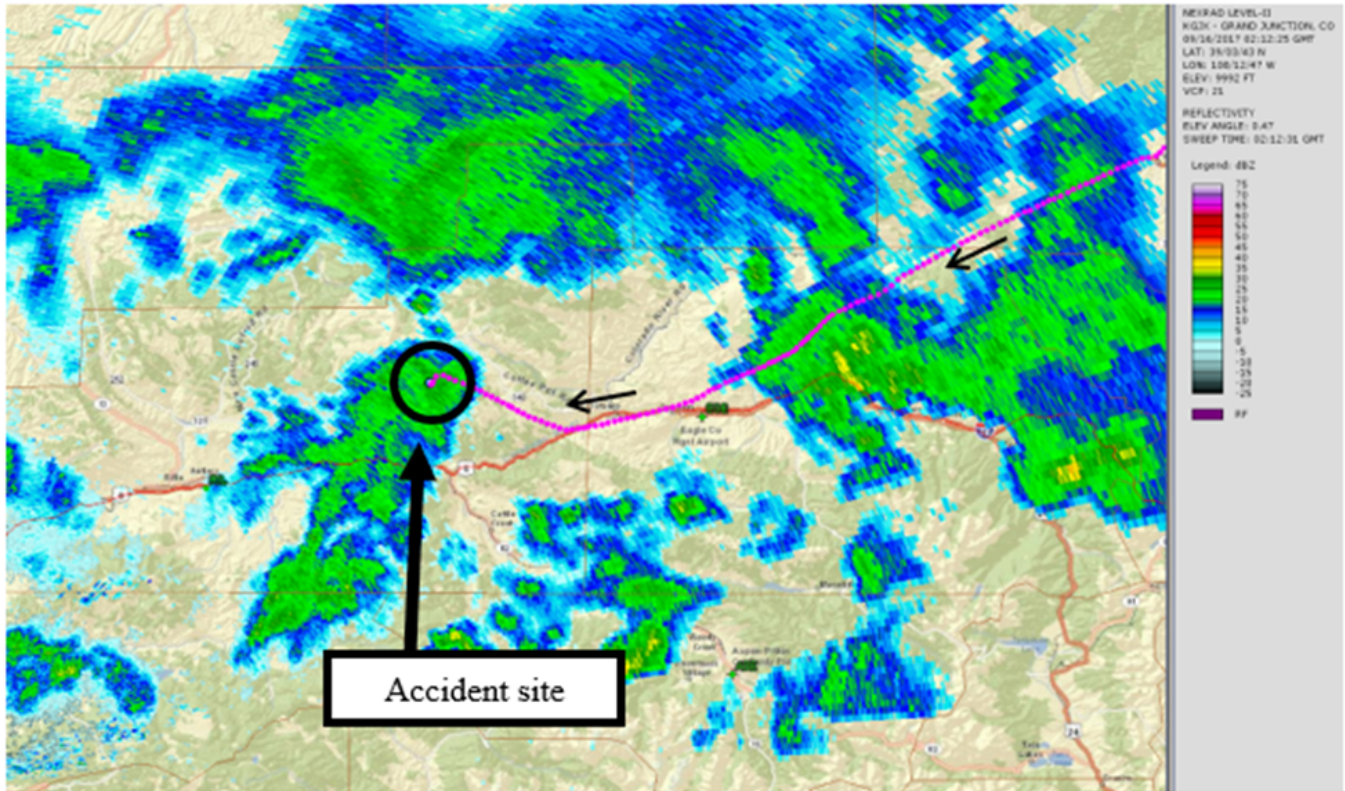
Figure 4 WSR-88D Reflectivity Scan at 2012 MDT

The closest NWS Weather Surveillance Radar-1988, Doppler (WSR-88D), was the Grand Junction, Colorado, radar, located 55 miles southwest of the accident site at an elevation of 9,992 ft. Base reflectivity values between 2007 and 2012 above the accident site corresponded to light precipitation (See Figure 4). No lightning strikes were noted near the accident site at the accident time.

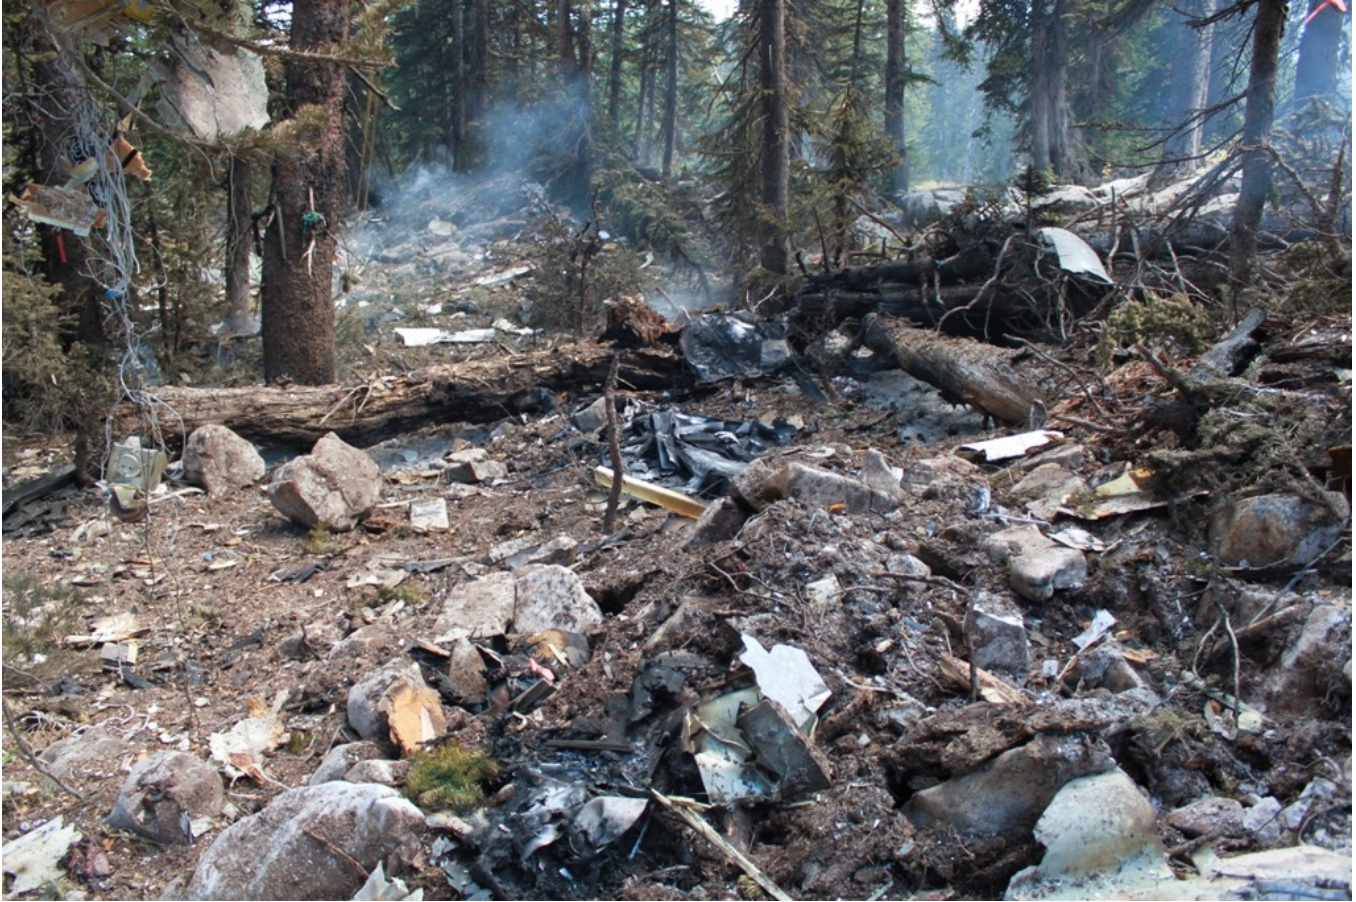
Figure 5 Accident Site

The accident site was located on rocky, tree-covered mountainous terrain about 10,800 ft msl (See Figure 5). The airplane impacted trees and terrain on a measured magnetic heading about 075°. A postimpact fire consumed a portion of the airplane. The initial impact point contained a portion of a propeller blade, fragments of the engine and engine mount, and forward fuselage structure. Several trees were severed at different heights before the initial impact with terrain. Based on the tree impacts, the calculated bank angle at the initial impact was about 34° right wing low.

The airframe and engine were fragmented and distributed in the debris field. The CAPS components were separated from the airframe and distributed in the debris field. The parachute was fully extended in a folded state with the slider at the base of the parachute canopy and entangled in tree branches. The CAPS rocket was located about 200 ft from the initial impact and was not expended.
