# Aviation Investigation Final Report

<b>Location:</b>	Salinas, California	<b>Accident Number:</b>	WPR17LA206
<b>Date &amp; Time:</b>	September 17, 2017, 07:00 Local	<b>Registration:</b>	N3285T
<b>Aircraft:</b>	Bell 47G 5	<b>Aircraft Damage:</b>	Substantial
<b>Defining Event:</b>	Controlled flight into terr/obj (CFIT)	<b>Injuries:</b>	1 Minor
<b>Flight Conducted Under:</b>	Part 137: Agricultural

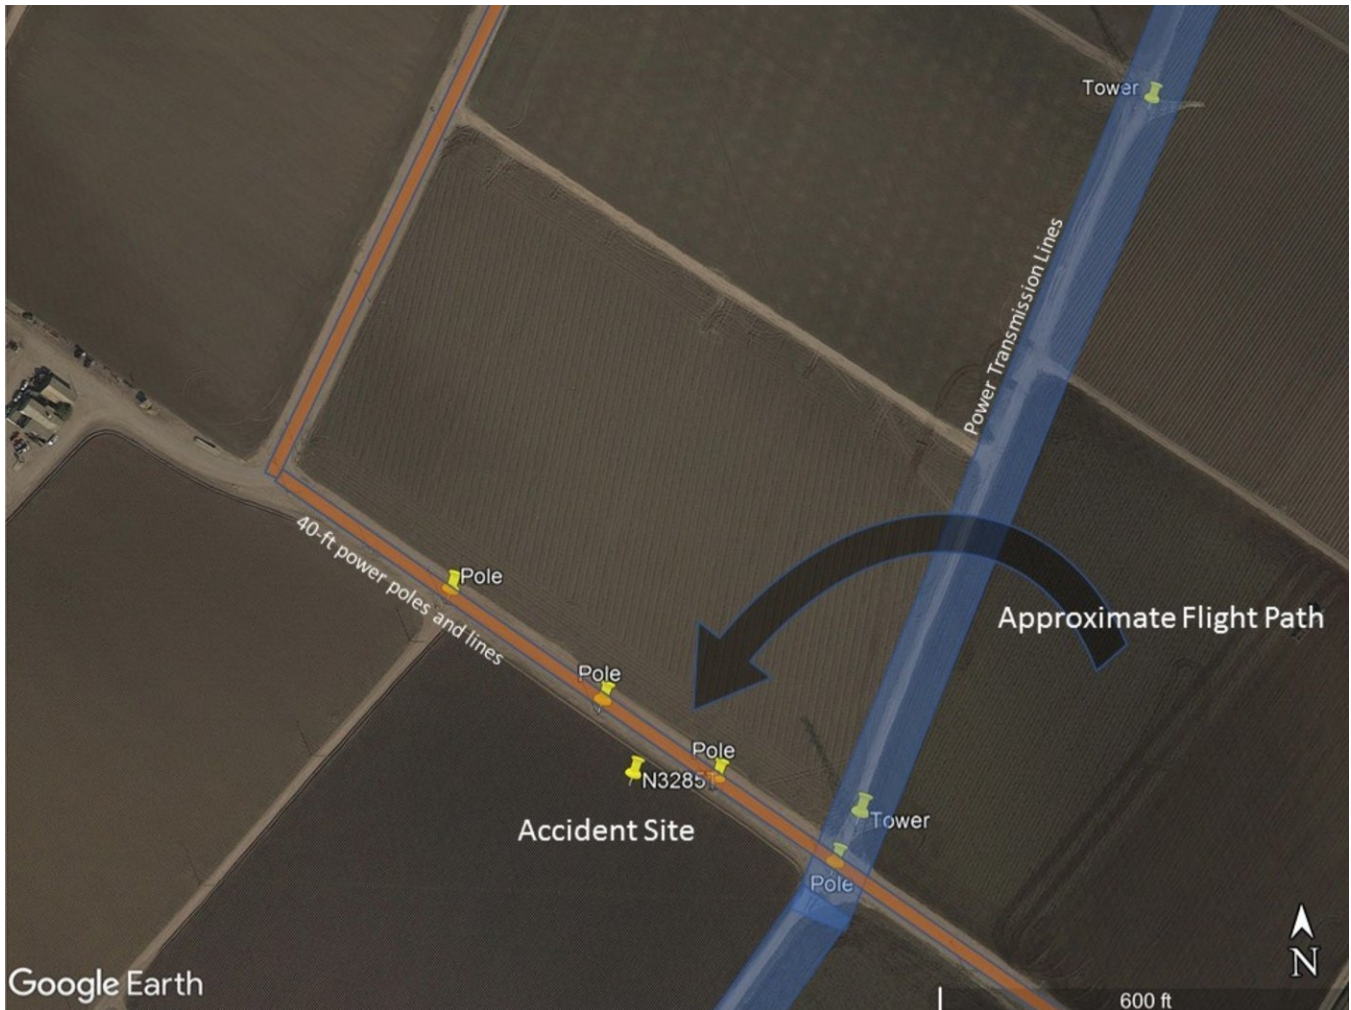
According to the pilot, the accident occurred during his first application pass on the second field of the day. After loading the helicopter with chemicals near the field, he departed and flew around a large power transmission line tower to the east of the field. He planned to fly the first pass from the northeast side and spray the middle of the field to the southwest. He remembered looking for vehicle traffic along the edge of the field before crossing under the smaller power lines supported by 40-ft power poles that ran parallel to the road when the helicopter impacted a wire and, subsequently, terrain. (see Figure 1). The pilot did not recall seeing the wire on the 40-ft power poles before the accident. He further reported that he had been spraying this field for the previous 20 years, and that the weather was not an issue on the morning of the accident.

**Figure 1-Accident site and approximate flight path.**

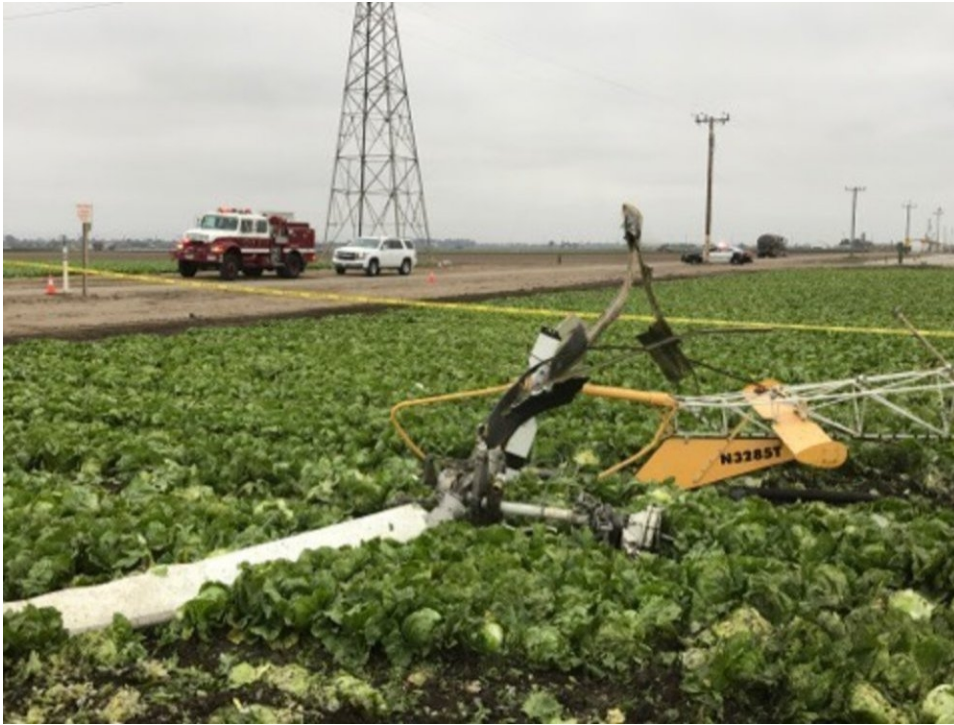
Examination of the helicopter by a Federal Aviation Administration inspector revealed that the main rotor assembly was separated from the helicopter and the main rotor blades exhibited impact damage. Remnants of wire were found wrapped around the main rotor drive shaft. (see Figure 2). The examination of the wreckage revealed no evidence of mechanical malfunctions or failures that would have precluded normal operation.

**Figure 2-Accident site.**
