# Aviation Investigation Final Report

<b>Location:</b>	Hoffman Island, New York	<b>Incident Number:</b>	DCA17IA202
<b>Date &amp; Time:</b>	September 21, 2017, 19:20 Local	<b>Registration:</b>	UNREG
<b>Aircraft:</b>	DJI Phantom	<b>Aircraft Damage:</b>	Destroyed
<b>Defining Event:</b>	Midair collision	<b>Injuries:</b>	1 None
<b>Flight Conducted Under:</b>	Part 107: Small UAS

On September 21, 2017, at 1920 eastern daylight time, a Sikorsky UH-60M Black Hawk helicopter, R20087, operated by the U.S. Army as CAVM087 ("Caveman 87"), collided with a privately owned and operated Dà-Jiang Innovations (DJI) Phantom 4 small unmanned aircraft system (sUAS). The collision occurred about 300 ft above mean sea level (msl) and 1 mile east of Midland Beach, Staten Island, New York, in the vicinity of Hoffman Island. The helicopter received minor damage, and the sUAS was destroyed. There were no injuries or ground damage.

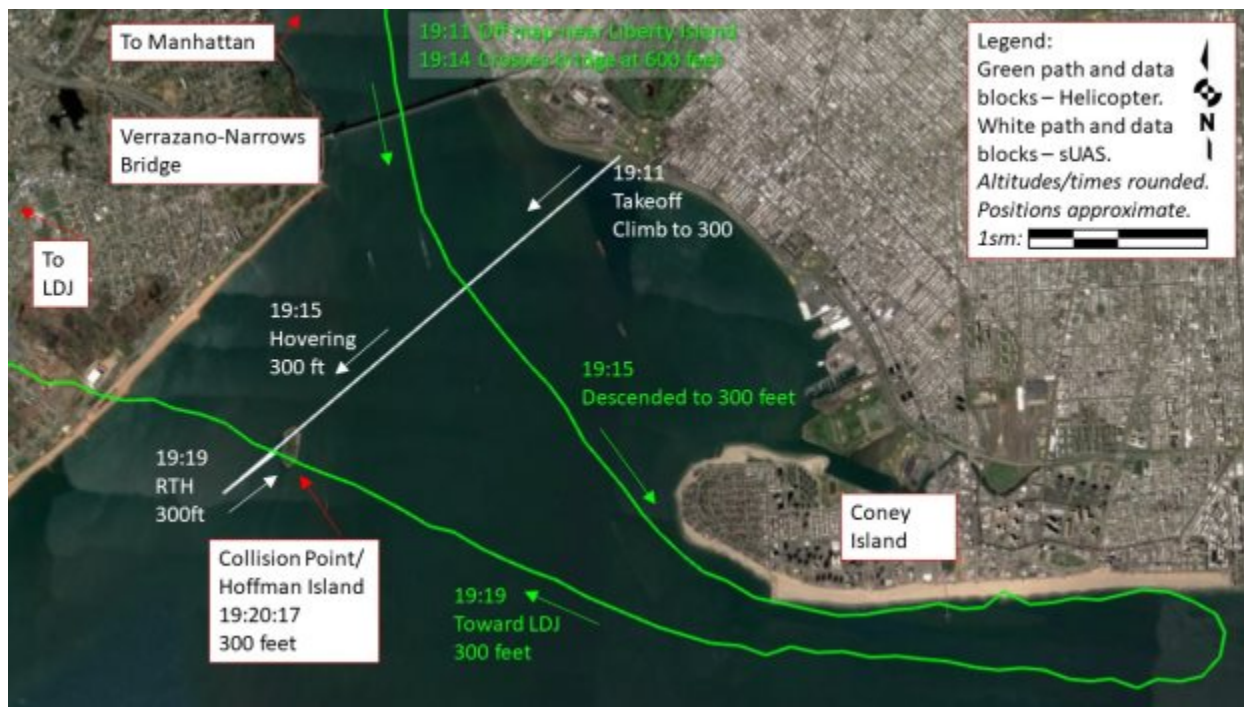
Figure 1: Approximate route of flight of the UH-60 and sUAS

At 1914:30, ATC radar indicated the flight of helicopters was travelling south-southeasterly from the Verrazano-Narrows Bridge toward Coney Island at 400 ft (Figure 1). The helicopters passed the sUAS pilot's position from his right to left about 1 mile from his location. The sUAS was about 1 1/2 miles from the sUAS pilot at that time and along a common line of sight. Shortly afterward, at 1915:30, data logs indicated the sUAS paused and hovered northeast of Hoffman Island for about 2 minutes before resuming a southwesterly track toward the island. During this time, the helicopters were flying east along the Coney Island shoreline about 300 ft msl.

At 1919:15, the sUAS pilot pressed the return-to-home (RTH) button on the control tablet, and the aircraft turned around and began tracking northeast toward the home point. The helicopters had completed a turn toward LDJ, and were just west of Coney Island at 300 ft. At 1919:51, the sUAS battery endurance warning activated, indicating that only enough charge remained to return directly to the home point. The pilot did not have visual contact with the sUAS or the helicopters at that time. As the sUAS was tracking northeast, telemetry data dropped out for about 9 seconds but returned just before the collision. The position of the aircraft was near the maximum range of the remote controller. At 1920:17.6, the data logs ended. The last position and altitude logged correlated with the position and altitude of the incident helicopter's recorded data and ATC radar information; about 300 ft west of Hoffman Island. The sUAS pilot reported that he lost signal with the aircraft and assumed it would return home as programmed. After waiting about 30 minutes, he assumed it had experienced a malfunction and crashed in the water.

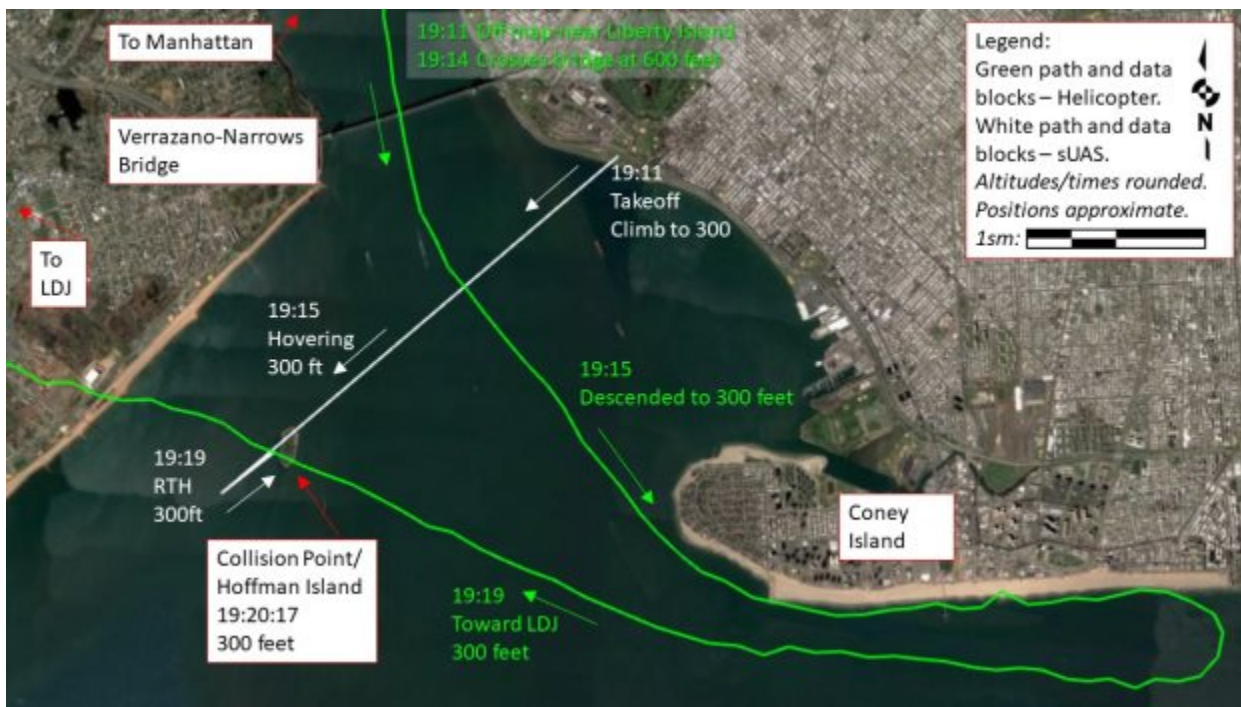
Figure 1: Approximate route of flight of the UH-60 and sUAS

At 1914:30, ATC radar indicated the flight of helicopters was travelling south-southeasterly from the Verrazano-Narrows Bridge toward Coney Island at 400 ft (Figure 1). The helicopters passed the sUAS pilot's position from his right to left about 1 mile from his location. The sUAS was about 1 1/2 miles from the sUAS pilot at that time and along a common line of sight. Shortly afterward, at 1915:30, data logs indicated the sUAS paused and hovered northeast of Hoffman Island for about 2 minutes before resuming a southwesterly track toward the island. During this time, the helicopters were flying east along the Coney Island shoreline about 300 ft msl.

At 1919:15, the sUAS pilot pressed the return-to-home (RTH) button on the control tablet, and the aircraft turned around and began tracking northeast toward the home point. The helicopters had completed a turn toward LDJ, and were just west of Coney Island at 300 ft. At 1919:51, the sUAS battery endurance warning activated, indicating that only enough charge remained to return directly to the home point. The pilot did not have visual contact with the sUAS or the helicopters at that time. As the sUAS was tracking northeast, telemetry data dropped out for about 9 seconds but returned just before the collision. The position of the aircraft was near the maximum range of the remote controller. At 1920:17.6, the data logs ended. The last position and altitude logged correlated with the position and altitude of the incident helicopter's recorded data and ATC radar information; about 300 ft west of Hoffman Island. The sUAS pilot reported that he lost signal with the aircraft and assumed it would return home as programmed. After waiting about 30 minutes, he assumed it had experienced a malfunction and crashed in the water.
