Aviation Investigation Final Report

Location:	Four Corners, California	Accident Number:	WPR18FA013
Date & Time:	October 21, 2017, 16:12 Local	Registration:	N414MT
Aircraft:	Flugzeugproduktions-und Vertri EA 300/L	Aircraft Damage:	Destroyed
Defining Event:	Unknown or undetermined	Injuries:	2 Fatal
Flight Conducted Under:	Part 91: General aviation - Instructional

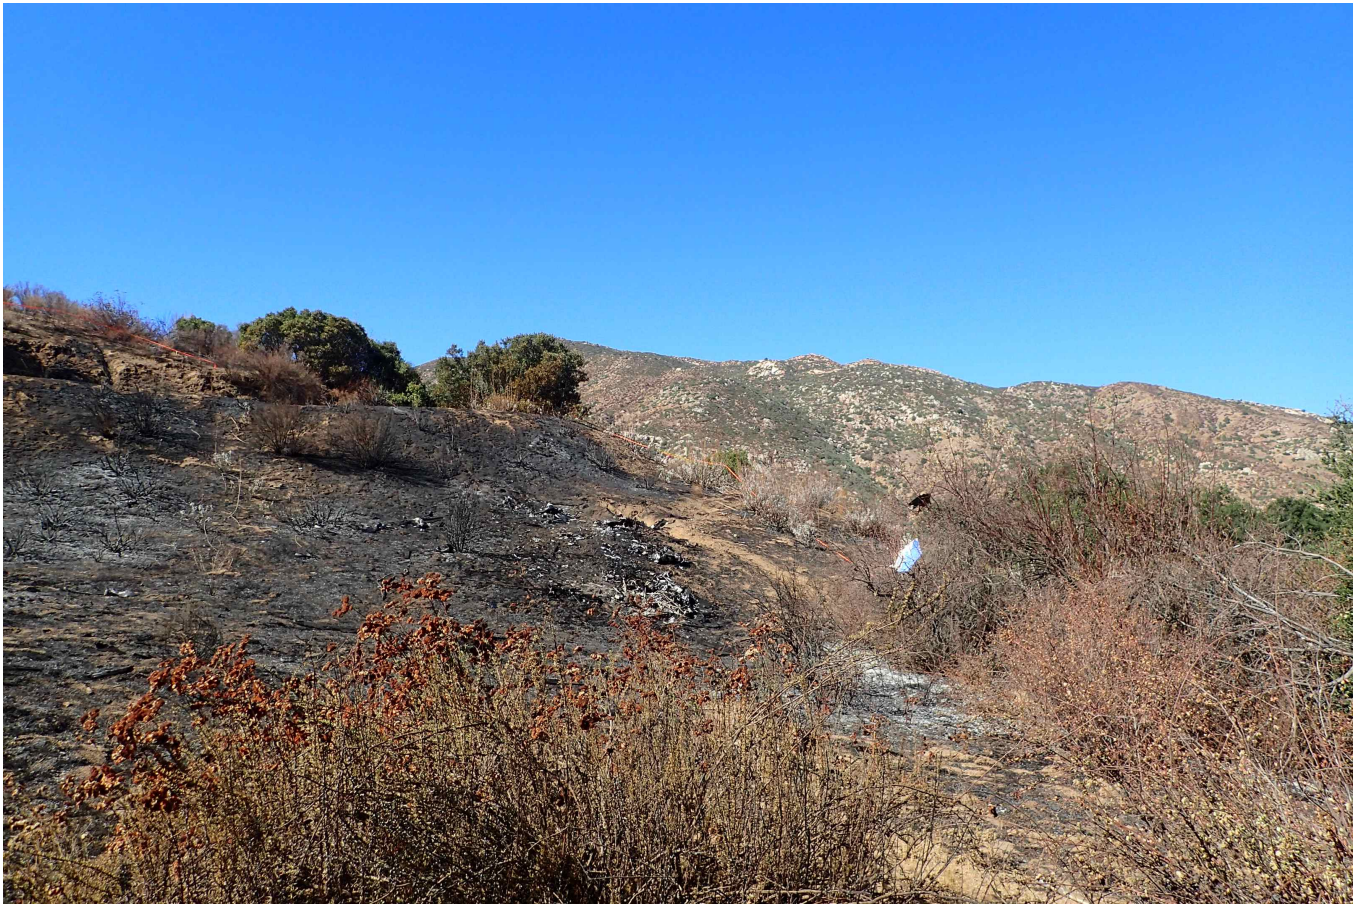
Figure 1. Accident Site Viewed to the South

Most of the airplane's composite structure was consumed by fire, except for about a dozen composite skin fragments, which were scattered in the surrounding trees and in the immediate vicinity of the impact site. The impact ignited a brush fire, which burned about 45 acres of land northeast of the accident site along the flank of the adjacent hillside.

A secondary debris field was located in a dry riverbed about 400 ft north of the crater. The debris was oriented east-west, about 800 ft long, and contained the left (lock side) and rear arch sections of the canopy frame, multiple pieces of canopy plexiglass material, and parts from the passenger's headset. No items in the secondary debris field, including the canopy components, displayed any indications of fire or bird strike.

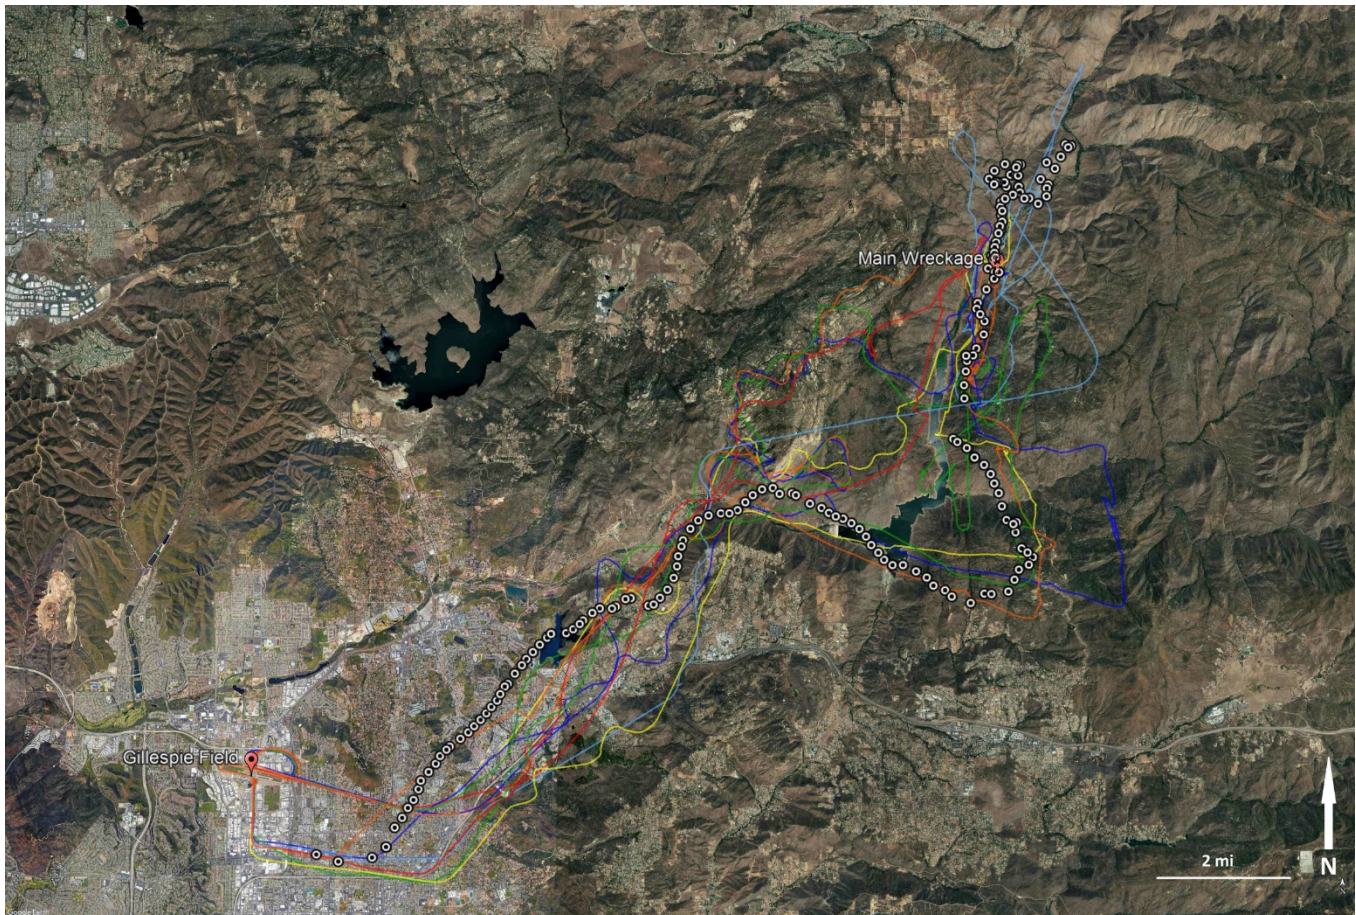
Figure 2. Radar Track from the Accident Flight (white dots) Compared to the GPS Tracks of the Previous Flights with the Accident Pilot

The GPS data from the flights performed by the accident pilot over the El Capitan area during the period from October 8 through October 13, 2017, was compared to the radar data for the accident flight. The accident flight followed the same general path as the other flights. (See figure 2.)
