# Aviation Investigation Final Report

<b>Location:</b>	Four Corners, California	<b>Accident Number:</b>	WPR18FA013
<b>Date &amp; Time:</b>	October 21, 2017, 16:12 Local	<b>Registration:</b>	N414MT
<b>Aircraft:</b>	Flugzeugproduktions-und Vertri EA 300/L	<b>Aircraft Damage:</b>	Destroyed
<b>Defining Event:</b>	Unknown or undetermined	<b>Injuries:</b>	2 Fatal
<b>Flight Conducted Under:</b>	Part 91: General aviation - Instructional

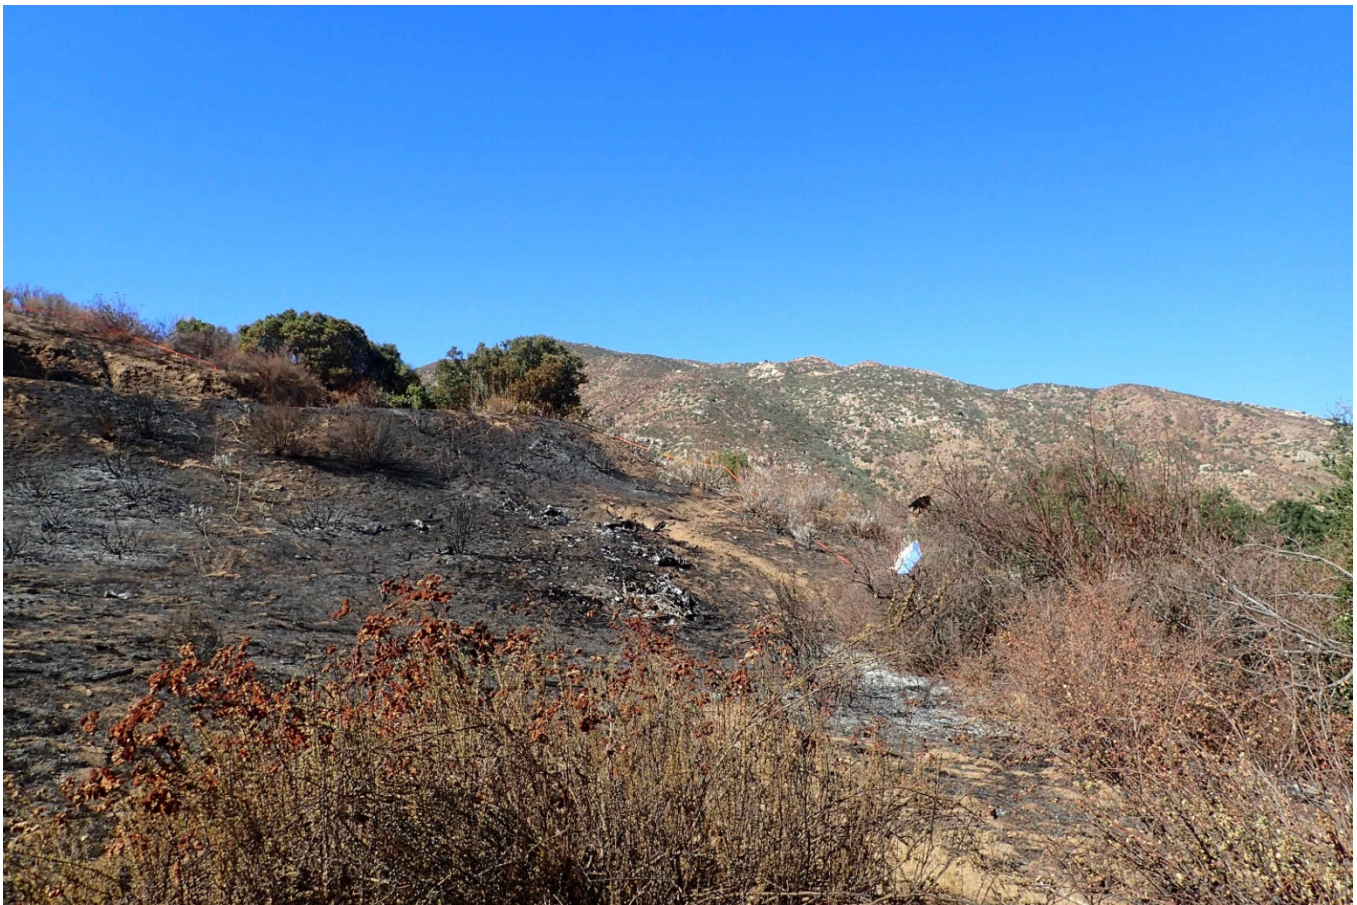
The debris field and wreckage distribution indicated that the airplane impacted the ground in a near-vertical attitude at high speed. The airplane was heavily fragmented during the impact, but remnants of all flight control surfaces were found within the immediate vicinity of the accident site.

skin fragments, which were scattered in the surrounding trees and in the immediate vicinity of the impact site. The impact ignited a brush fire, which burned about 45 acres of land northeast of the accident site along the flank of the adjacent hillside.

A secondary debris field was located in a dry riverbed about 400 ft north of the crater. The debris was oriented east-west, about 800 ft long, and contained the left (lock side) and rear arch sections of the canopy frame, multiple pieces of canopy plexiglass material, and parts from the passenger's headset. No items in the secondary debris field, including the canopy components, displayed any indications of fire or bird strike.

Figure 1. Accident Site Viewed to the South

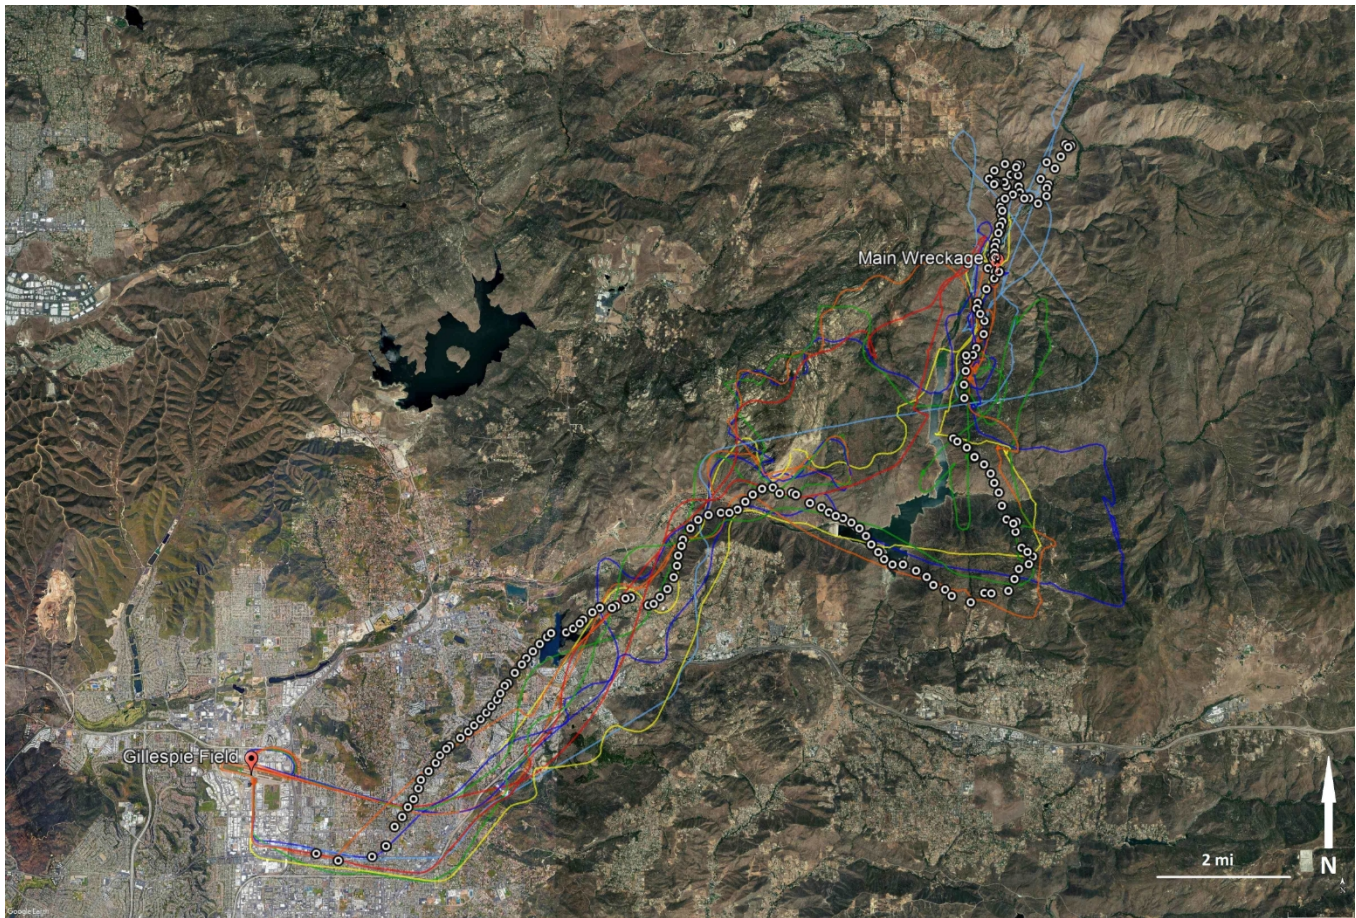
The GPS data from the flights performed by the accident pilot over the El Capitan area during the period from October 8 through October 13, 2017, was compared to the radar data for the accident flight. The accident flight followed the same general path as the other flights. (See figure 2.)

Figure 2. Radar Track from the Accident Flight (white dots) Compared to the GPS Tracks of the Previous Flights with the Accident Pilot
