# Aviation Investigation Final Report

<b>Location:</b>	Anchorage, Alaska	<b>Accident Number:</b>	ANC18LA005
<b>Date &amp; Time:</b>	October 21, 2017, 05:30 Local	<b>Registration:</b>	N363JH
<b>Aircraft:</b>	RAYTHEON AIRCRAFT COMPANY B200	<b>Aircraft Damage:</b>	Substantial
<b>Defining Event:</b>	Landing gear not configured	<b>Injuries:</b>	4 None
<b>Flight Conducted Under:</b>	Part 135: Air taxi & commuter - Non-scheduled - Air Medical (Medical emergency)

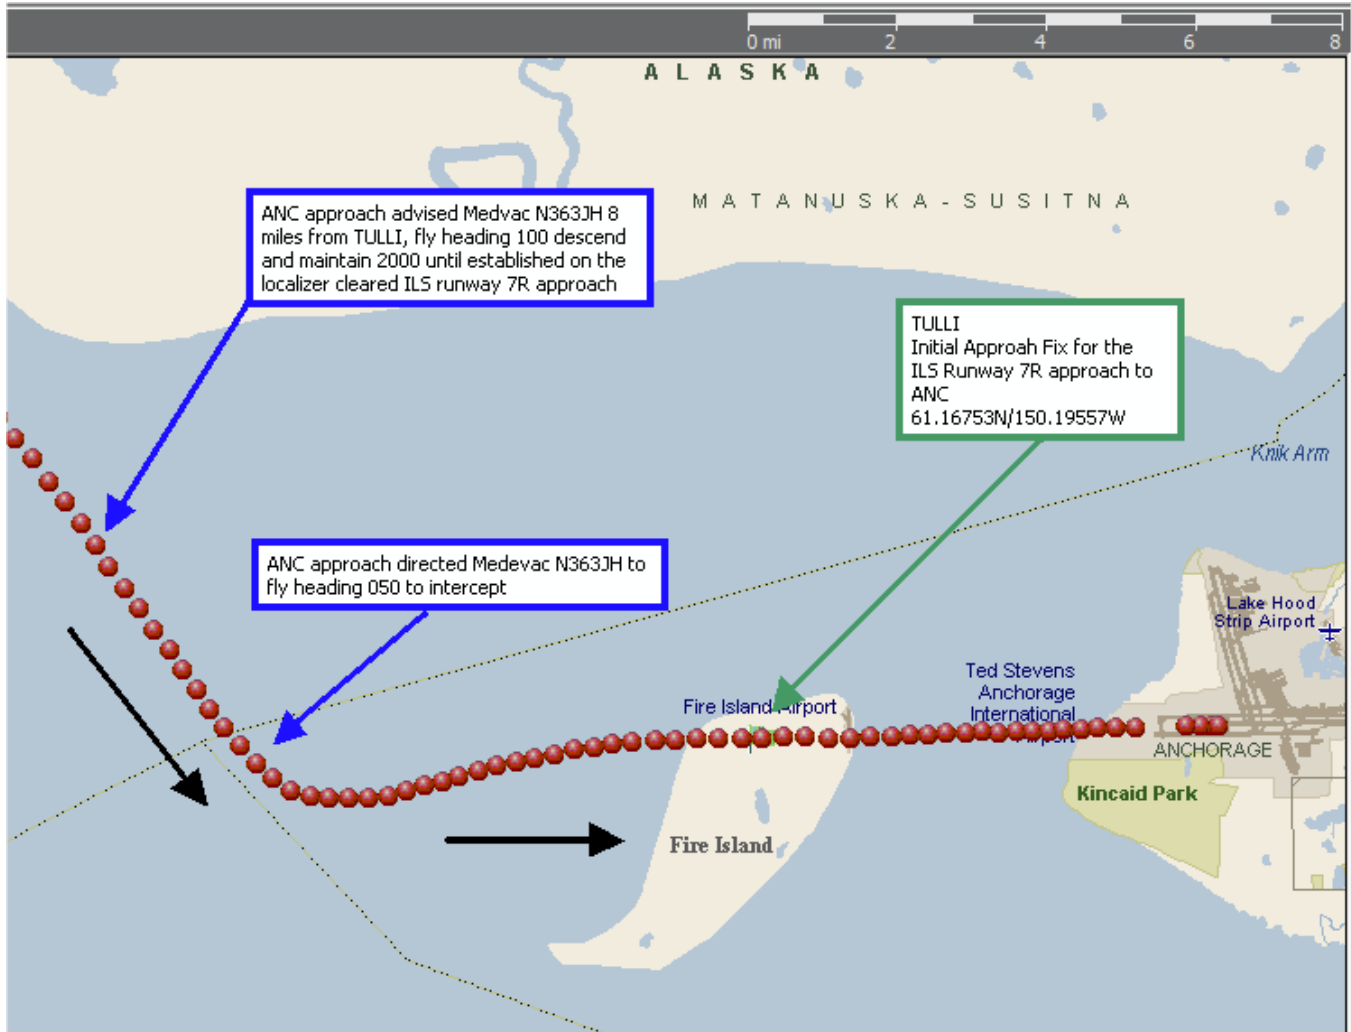
The controller responded back with a vector for the instrument landing system (ILS) runway 7 right approach. The pilot reported his groundspeed was about 210 kts indicated airspeed, he joined the final approach course, and was cleared to land. He reported he believes he was given a vector heading that was too close to the final approach fix and the airplane went through the final approach fix. The pilot then received another heading and he re-established himself on the final approach course. The radar flight track data is shown below in figure 1.

Figure 1 – Radar flight track data of the airplane, showing the initial approach fix and the destination airport.

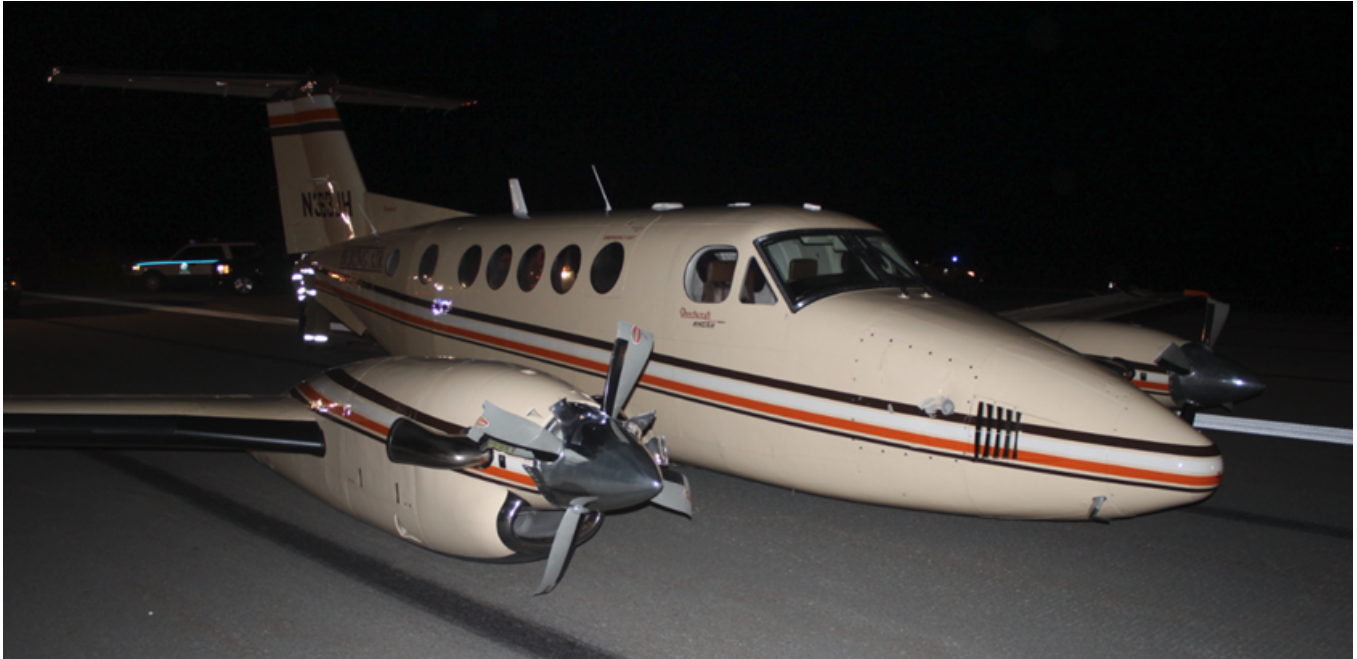
For the landing, the pilot selected the approach flaps setting. He reported he failed to visually check and confirm for the three-landing gear down and locked indication lights in the cockpit. Upon touchdown on the runway with the landing gear not extended, the airplane skid on the pod installed on the underside of the fuselage along with the two engine nacelle assemblies on each wing. During the landing sequence, the metal 4-blade Hartzell HC-E4N-3G propellers for each engine separated about midspan due to runway impact damage as shown below in figure 2. The right side forward fuselage sustained minor damage from various separated propeller blade debris impacts. The airplane came to rest on the runway, and the occupants egressed without further incident.

Figure 2 – View of the right side of the airplane on the runway.

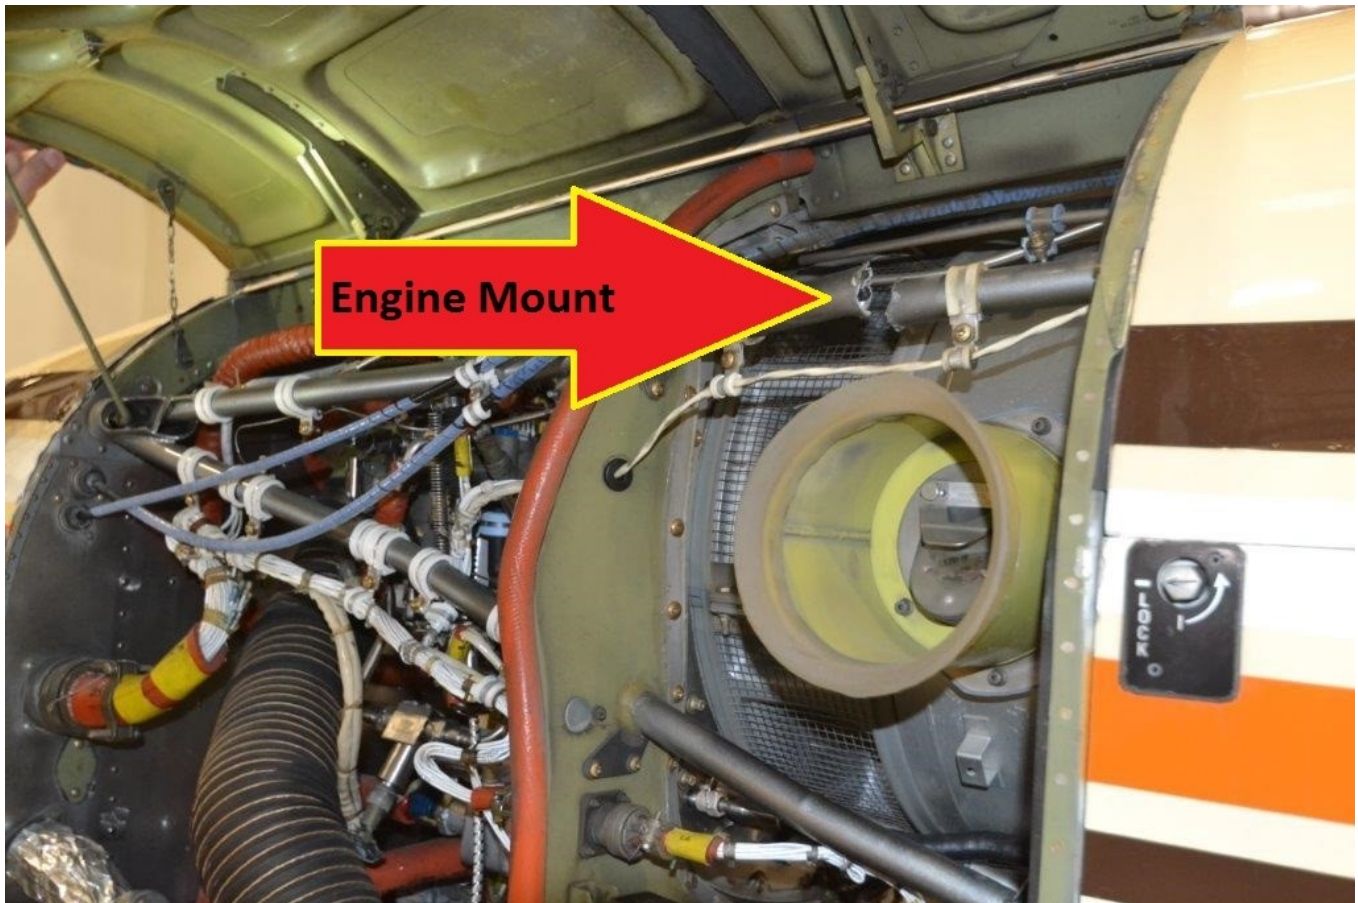
The airplane sustained substantial damage to the right engine mount. Although the landing gear switch was found in the down position, it could not be determined when it was placed in that position.

The airplane was recovered and transported to secure location for a comprehensive damage assessment. The airplane sustained substantial damage to the right engine mount as shown below in figure 3.

Figure 3 – View of the fractured right engine mount (courtesy of Bering Air).

The Bering Air director of maintenance reported that after an internal inspection of both Pratt & Whitney Canada PT6A-61 turbo prop engines, it was determined that it was not economically feasible to repair both engines as two new engines were purchased instead.
