Aviation Investigation Final Report

Location:	Clearwater, Florida	Accident Number:	ANC18FA007
Date & Time:	November 7, 2017, 12:04 Local	Registration:	N922BA
Aircraft:	ICON AIRCRAFT INC A5	Aircraft Damage:	Substantial
Defining Event:	Loss of control in flight	Injuries:	1 Fatal
Flight Conducted Under:	Part 91: General aviation - Personal

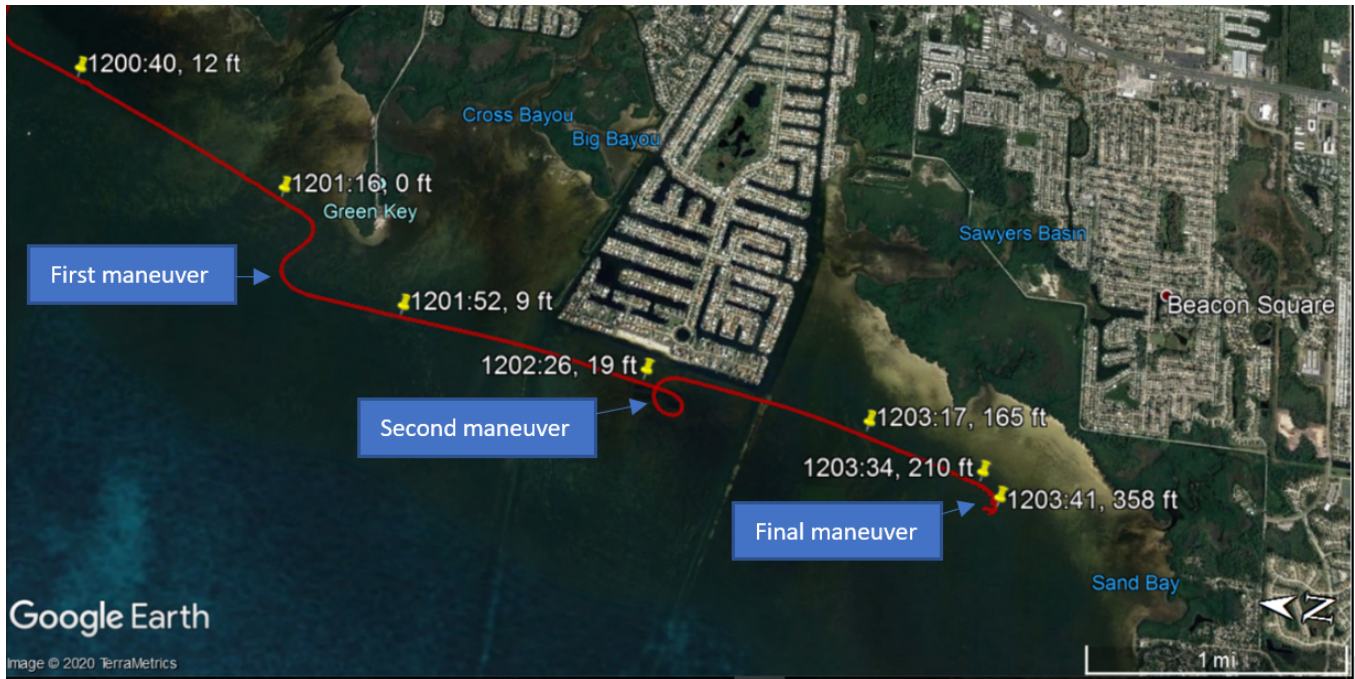
Figure 1. Last 3 minutes of GPS flight track.

The airplane departed from Island Ford Lake in Odessa, Florida, about 1147. According to data from the Icon digital to analog (DAC) data memory unit that was installed on the airplane, the airplane climbed to a GPS altitude of 1,909 ft and proceeded north for 4 nautical miles (nm) before turning west toward the Gulf of Mexico. The airplane then flew for 10 nm at a GPS altitude of about 600 ft and descended over the gulf before turning south. During the final 3 minutes of the flight, the airplane was traveling in a southerly direction along the shoreline; figure 1 shows the flight track. During the last 2.5 minutes of the flight, the pilot conducted three maneuvers with high angles of attack (AOA) and load factors of almost 2 Gs; at that time, the airplane was over the water at GPS altitudes between 0 and 358 ft. During the final maneuver of the flight, the airplane entered a right turn, the engine power decreased, and the AOA reached 16°. The last recorded data point, at 1203:41, showed that the airplane's airspeed was 75 knots and heading was 354°.

At 1203:34, the pilot initiated a final maneuver: a climbing right turn from a GPS altitude of 210 ft and an indicated airspeed of 81 knots. The airplane's load factor increased rapidly to 1.91 Gs and then varied between 1 and about 2 Gs as the AOA increased steadily to 15°, which is at the top of yellow band on the AOA indicator. About 3 seconds after initiating the climb, the engine throttle lever was retarded from 99% to 27%, resulting in a corresponding decrease in engine speed from about 5,393 to 2,261 rpm. The lowest recorded indicated airspeed during the maneuver, 54 knots, occurred as the airplane reached a GPS altitude of 358 ft, the apex of the maneuver, with a low energy state. The computed bank angle exceeded 50° and the computed pitch angle exceeded 30° before the airplane descended toward the water.

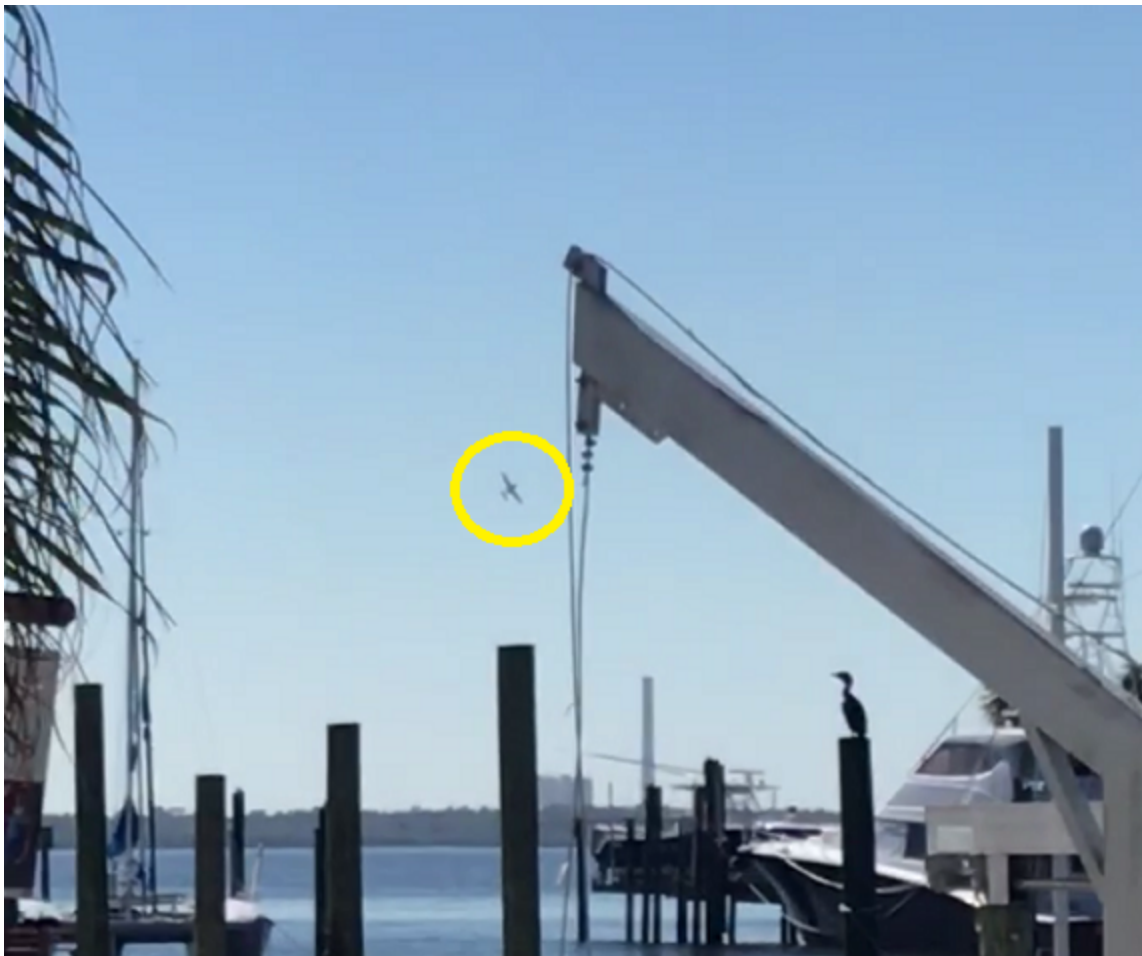
Figure 2. Still image of the accident airplane just before the crash (Courtesy of Mr. Fred Grunden.)

Multiple witnesses in the area stated that they saw the airplane flying very low, between 5 and 300 ft, over the water as the airplane maneuvered south close to the shoreline. Some witnesses reported that the airplane was making steep turns and high-pitch climbs up to about 500 ft and that the engine sounded normal. A witness provided an image of the airplane over the water, as shown in figure 2. A commercial fisherman stated that the airplane flew over his vessel at an altitude that was less than 300 ft. Another commercial fisherman, who was located about 900 ft north of the accident site, stated that he observed the airplane flying from the north "really close" to houses. The airplane then flew south past his position, descended briefly, and climbed. After entering a steep climb, the airplane descended on an easterly heading in a steep nose-down attitude; the airplane's pitch attitude decreased as the airplane continued to descend. The witness reported that the airplane impacted the water in a 45° nose-down, wings-level attitude.
