Aviation Investigation Final Report

Location:	Clearwater, Florida	Accident Number:	ANC18FA007
Date & Time:	November 7, 2017, 12:04 Local	Registration:	N922BA
Aircraft:	ICON AIRCRAFT INC A5	Aircraft Damage:	Substantial
Defining Event:	Loss of control in flight	Injuries:	1 Fatal
Flight Conducted Under:	Part 91: General aviation - Personal

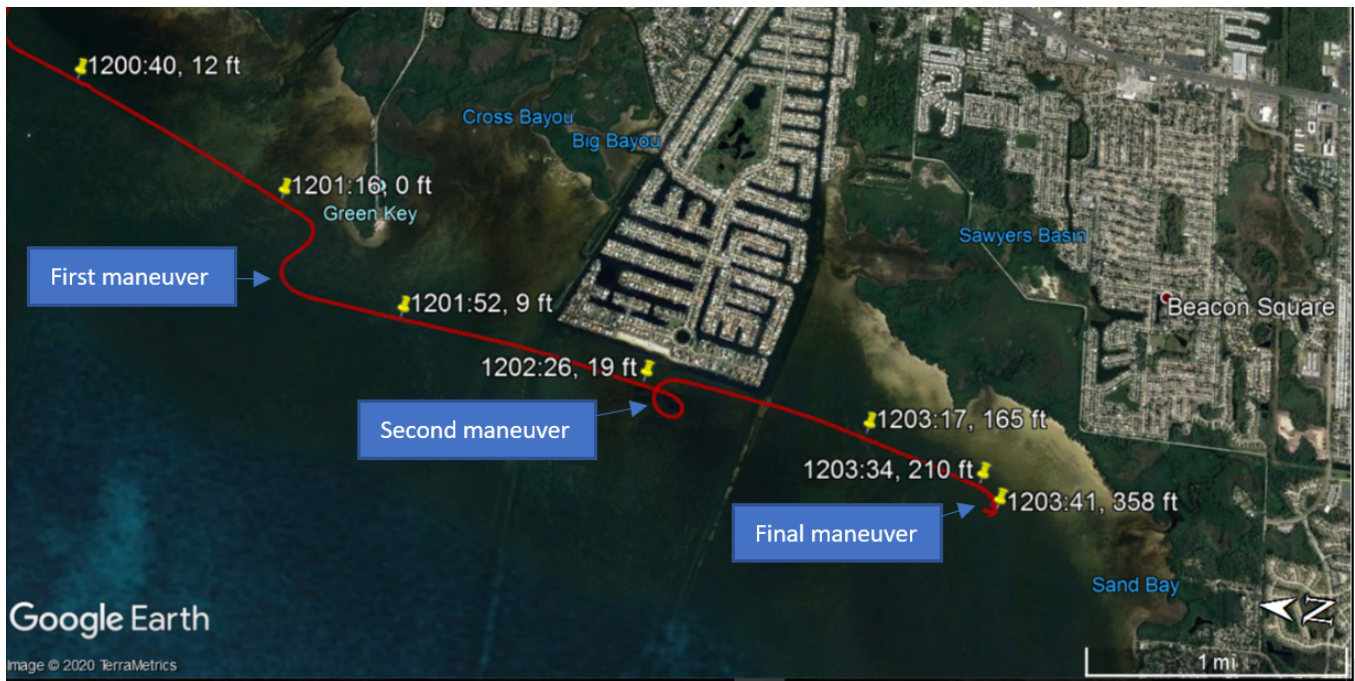
The airplane departed from Island Ford Lake in Odessa, Florida, about 1147. According to data from the Icon digital to analog (DAC) data memory unit that was installed on the airplane, the airplane climbed to a GPS altitude of 1,909 ft and proceeded north for 4 nautical miles (nm) before turning west toward the Gulf of Mexico. The airplane then flew for 10 nm at a GPS altitude of about 600 ft and descended over the gulf before turning south. During the final 3 minutes of the flight, the airplane was traveling in a southerly direction along the shoreline; figure 1 shows the flight track. During the last 2.5 minutes of the flight, the pilot conducted three maneuvers with high angles of attack (AOA) and load factors of almost 2 Gs; at that time, the airplane was over the water at GPS altitudes between 0 and 358 ft. During the final maneuver of the flight, the airplane entered a right turn, the engine power decreased, and the AOA reached 16°. The last recorded data point, at 1203:41, showed that the airplane's airspeed was 75 knots and heading was 354°.

Figure 1. Last 3 minutes of GPS flight track.

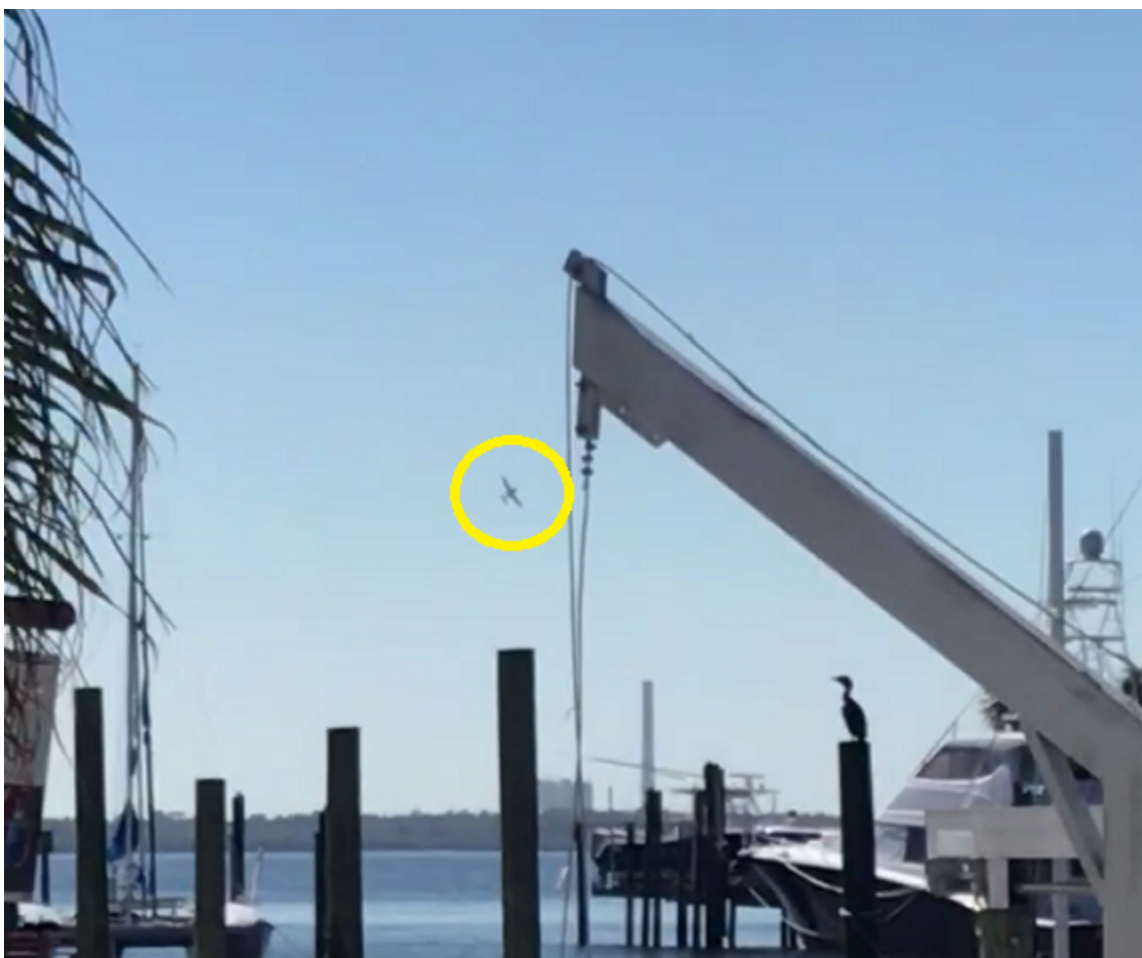
Multiple witnesses in the area stated that they saw the airplane flying very low, between 5 and 300 ft, over the water as the airplane maneuvered south close to the shoreline. Some witnesses reported that the airplane was making steep turns and high-pitch climbs up to about 500 ft and that the engine sounded normal. A witness provided an image of the airplane over the water, as shown in figure 2. A commercial fisherman stated that the airplane flew over his vessel at an altitude that was less than 300 ft. Another commercial fisherman, who was located about 900 ft north of the accident site, stated that he observed the airplane flying from the north "really close" to houses. The airplane then flew south past his position, descended briefly, and climbed. After entering a steep climb, the airplane descended on an easterly heading in a steep nose-down attitude; the airplane's pitch attitude decreased as the airplane continued to descend. The witness reported that the airplane impacted the water in a 45° nose-down, wings-level attitude.

Figure 2. Still image of the accident airplane just before the crash (Courtesy of Mr. Fred Grunden.)

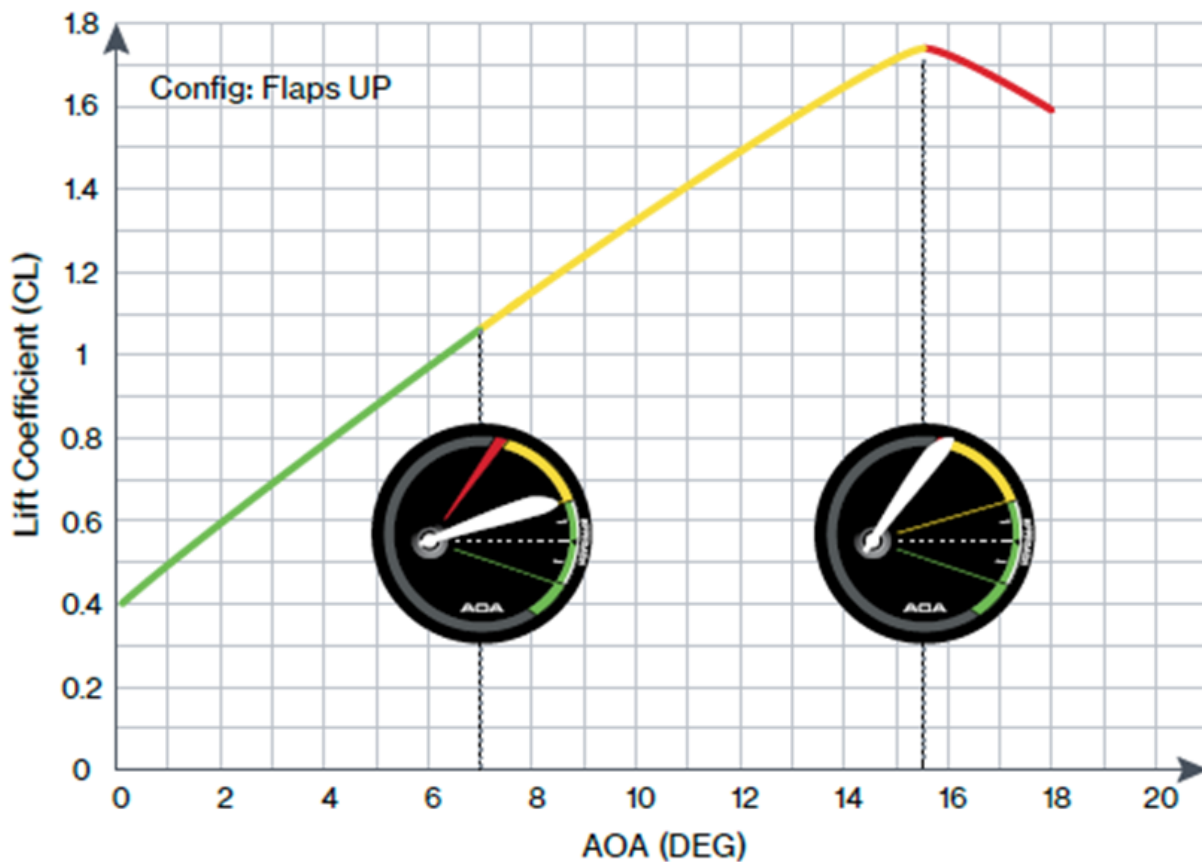
Figure 3. AOA information from the Icon Sport Flying Academics information.

The recorded data indicated that, at 1201:19, the pilot began a rapid climbing "S" turn from a GPS altitude of 0 to 134 ft and then descended to 36 ft; the airplane reached a maximum load factor of 1.94 Gs and a maximum AOA of 7.53°. At 1202:29, the pilot performed a second maneuver, a climbing right 360° turn from a GPS altitude of 19 to 136 ft; the airplane reached a maximum load factor of 1.93 Gs and a maximum AOA of 15.73°, which is within the red band on the AOA indicator (shown as an inset in figure 3).

At 1203:34, the pilot initiated a final maneuver: a climbing right turn from a GPS altitude of 210 ft and an indicated airspeed of 81 knots. The airplane's load factor increased rapidly to 1.91 Gs and then varied between 1 and about 2 Gs as the AOA increased steadily to 15°, which is at the top of yellow band on the AOA indicator. About 3 seconds after initiating the climb, the engine throttle lever was retarded from 99% to 27%, resulting in a corresponding decrease in engine speed from about 5,393 to 2,261 rpm. The lowest recorded indicated airspeed during the maneuver, 54 knots, occurred as the airplane reached a GPS altitude of 358 ft, the apex of the maneuver, with a low energy state. The computed bank angle exceeded 50° and the computed pitch angle exceeded 30° before the airplane descended toward the water.

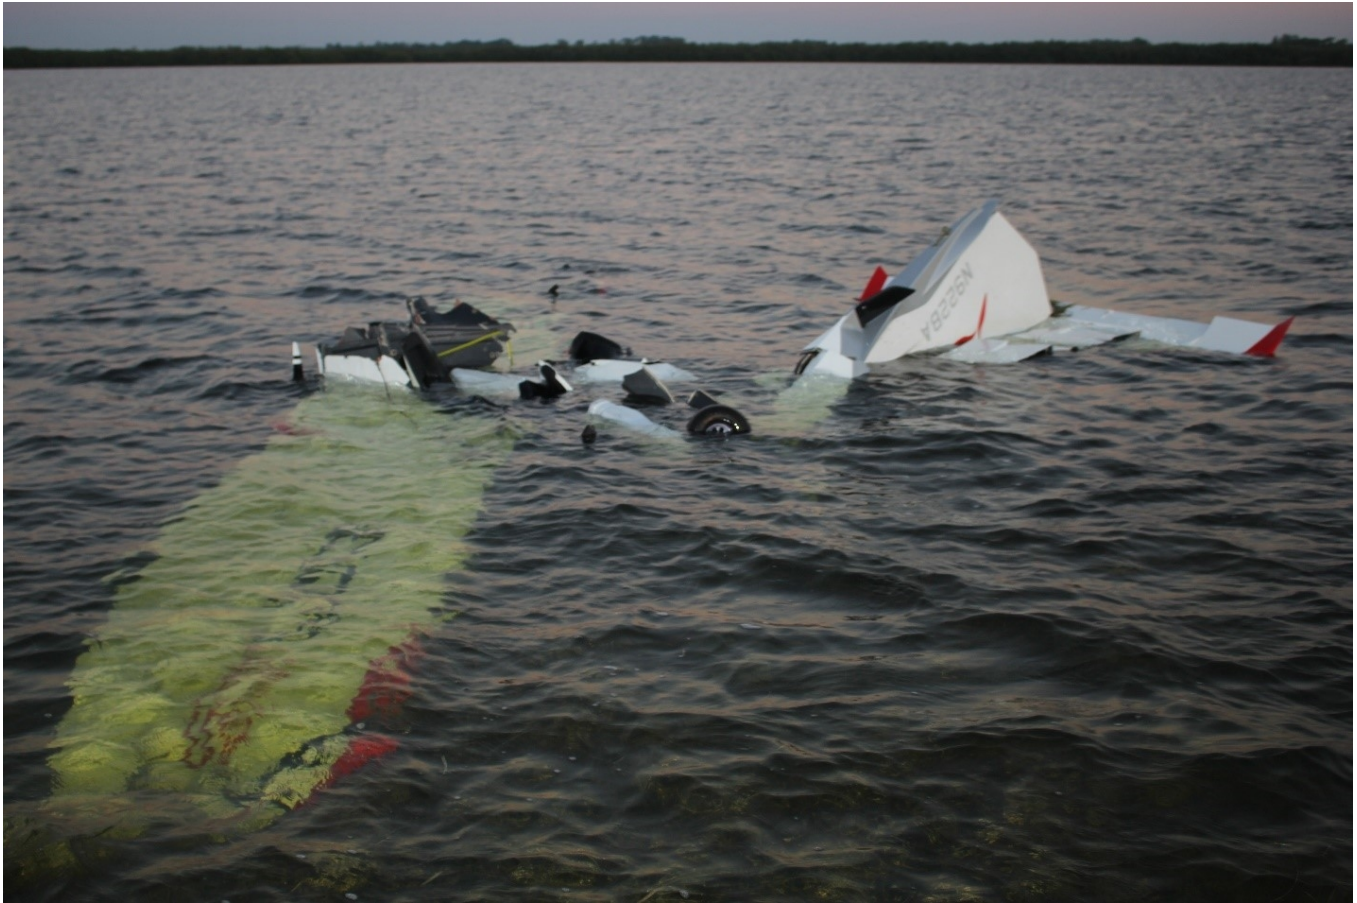
The airplane came to rest inverted in about 4 ft of water and was oriented on a 192° heading, as shown in figure 4. The empennage was separated and displaced forward of the wings. All major airplane components were located at the accident scene. The front fuselage and cockpit were highly fragmented, with pieces scattered within a 300-ft radius of the main wreckage.

Figure 4. Airplane wreckage at the accident scene.
