Aviation Investigation Final Report

Location:	Seattle, Washington	Incident Number:	ENG181A003
Date & Time:	November 7, 2017, 22:45 UTC	Registration:	N375HA
Aircraft:	Airbus A330-243	Aircraft Damage:	Minor
Defining Event:	Flight control sys malf/fail	Injuries:	2 None
Flight Conducted Under:	Part 121: Air carrier - Non-scheduled

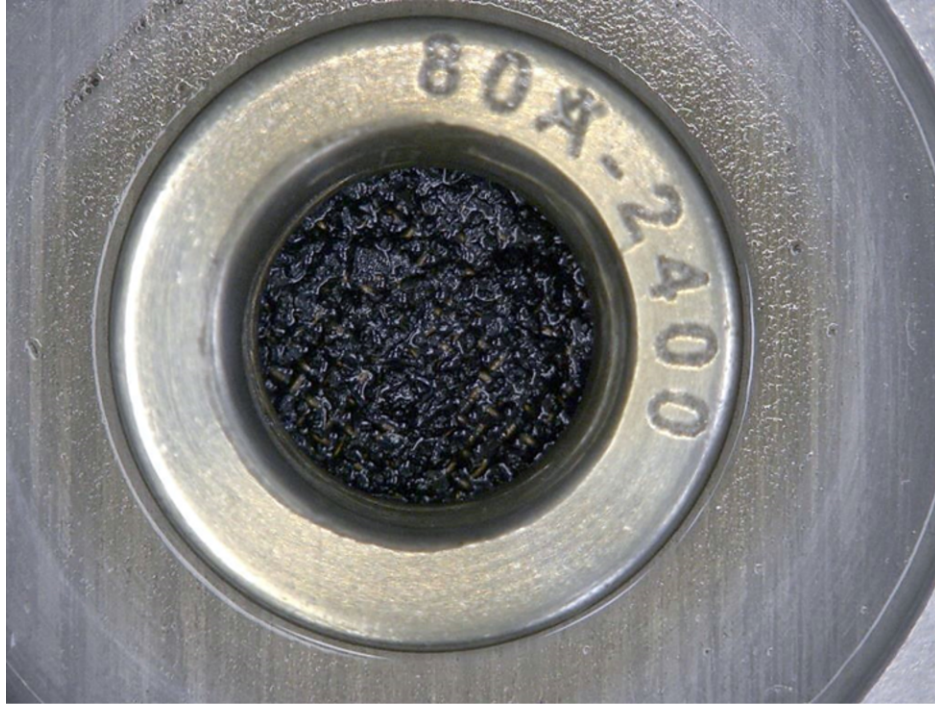
The TM has four filters - Supply Port (SP), Return Port, C1 Control and C2 Control. Examination of the TM revealed significant contamination of only the supply port filter (70 - 80µ) outer element. A backlight assessment of the filters visually confirmed both the supply and return port filters were 95% blocked with contamination. It was noted that the debris accumulation was adhered to the supporting mesh and element rather than being settled on the upstream side. A scanning electron microscope (SEM) energy dispersive x-ray (EDX) material analysis found its composition to include metallic elements (Cu, Fe, Ni and Cr) combined with fuel breakdown products (C, O, S and N).

The other three filters in the TM were blocked between 0% and 5%.

Image of the contaminated TM filter

It was noted that despite the finer LP filter (40 μ) and a HP fuel filter (45 μ) being upstream, the comparatively coarse (70 - 80 μ) TM SP filter contained particles of debris that were larger than 45 μ that were adhered on the filter element.

A review of the upstream components that had wear type operation with similar elemental composition, identified the HP pump gear (Fe - 82%, V - 10%, Cr - 6% and Mo - 1.3%), HP pump bearing (Cu - 90%, Sn - 5%, Zn - 3% and Pb - 2%) and the FOHE by-pass valve (Fe - 71%, Cr - 18%, Ni - 9%, Mn - 2%) as possible sources of the particles. The particle sizes were smaller than the 10 μ m, which is below the upstream filter capability of 45 μ m for the HP fuel filter and the 70 μ m HP wash flow filter and therefore could enter the VSV TM filters and flapper area; however, if they remained as individual particles they would normally pass through the area. As agglomerations with adhesive qualities, they became attached to the VSV TM SP filter and likely were the reason for blockage.

The adhesive behavior of the particles as observed on the filter could not be positively determined; however, recent industry research of fuel quality have concluded that jet fuel available on the United States west coast contains up to seven times higher levels of sulfates than east coast fuel. It has been noted that sulfate loading on fuel screens is routinely observed both on fuel component screens and on engine fuel filters of other engine installations.
