Aviation Investigation Final Report

Location:	Clearwater, Florida	Accident Number:	ANC18LA010
Date & Time:	November 19, 2017, 10:30 Local	Registration:	N1401J
Aircraft:	ROCKWELL INTERNATIONAL 112A	Aircraft Damage:	Substantial
Defining Event:	Fuel related	Injuries:	2 None
Flight Conducted Under:	Part 91: General aviation - Personal

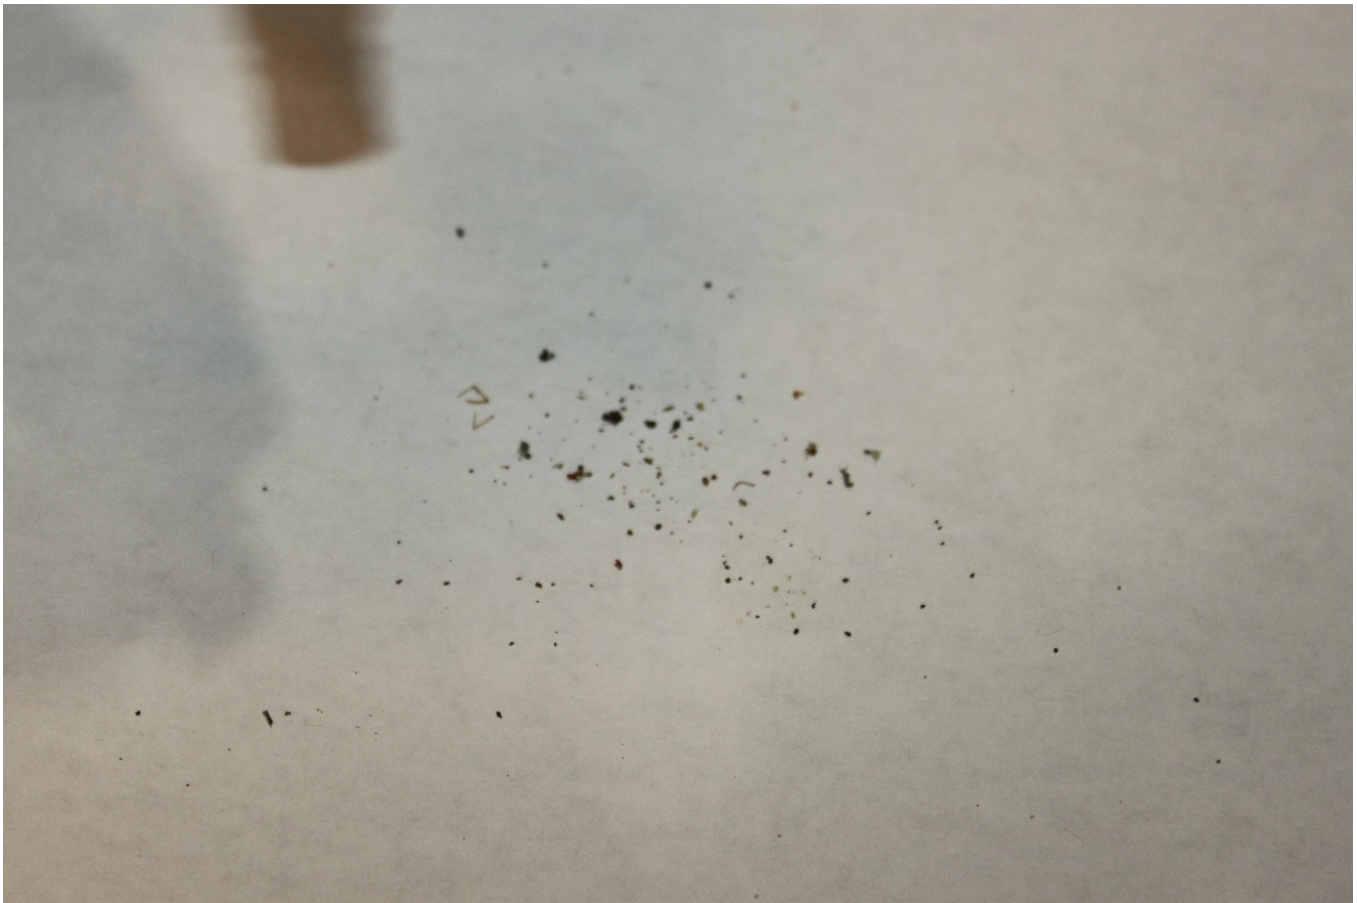
Postaccident testing of the engine and fuel injection servo revealed no preimpact mechanical malfunctions or failures that would have precluded normal operation. Although some debris was noted during the examination of the fuel injection servo, it was likely not enough to cause the engine to lose total power. Thus, the reason for the total loss of engine power could not be determined.

The fuel inlet strainer was removed and when tapped on white paper some debris was noted (figure 1). Some debris was also noted inside the strainer. Oil/dirt was noted on the exterior of the fuel servo. The mixture screw assembly was centered.

Fuel Servo Debris
