# Aviation Investigation Final Report

<b>Location:</b>	Starke, Florida	<b>Accident Number:</b>	ERA18FA030
<b>Date &amp; Time:</b>	November 23, 2017, 15:15 Local	<b>Registration:</b>	N6894N
<b>Aircraft:</b>	Mooney M20C	<b>Aircraft Damage:</b>	Destroyed
<b>Defining Event:</b>	Loss of control in flight	<b>Injuries:</b>	1 Fatal
<b>Flight Conducted Under:</b>	Part 91: General aviation - Personal

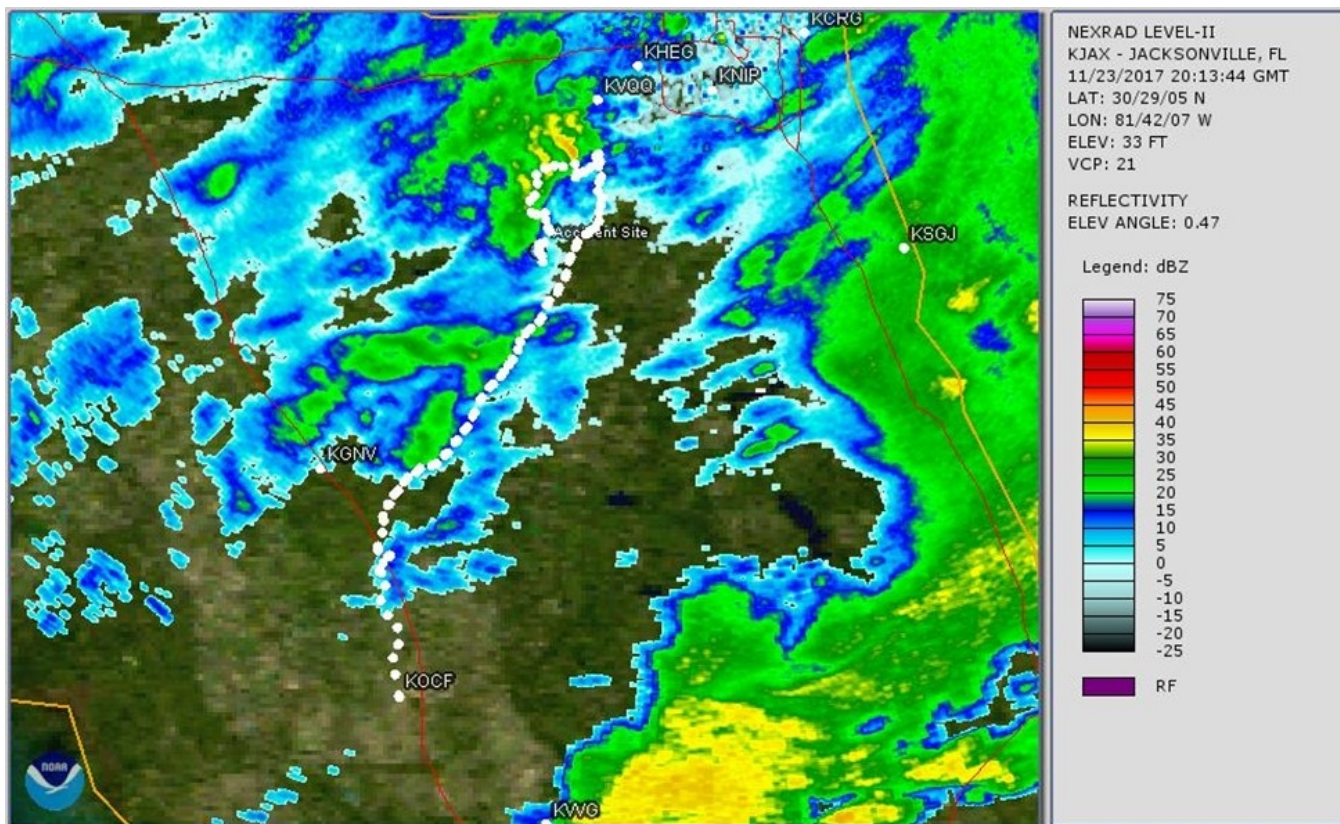
The National Weather Service KJAX WSR-88D detected a large area of light to moderate intensity echoes along the airplane's flight track and in the vicinity of the accident site, and indicated that the accident flight was in clouds and precipitation when the flight deviated west and then back to the south. The 1513 base reflectively image showed that the airplane's flight track operated through echoes of 30 to 40 dBZ, moderate intensity echoes and in an area of 15 to 20 dBZ echoes at the time of the accident (See figure 1).

Figure 1. KJAX WSR-88D 0.5° base reflectivity image for 1513 with airplane's flight track of overlaid
