Aviation Investigation Final Report

Location:	Starke, Florida	Accident Number:	ERA18FA030
Date & Time:	November 23, 2017, 15:15 Local	Registration:	N6894N
Aircraft:	Mooney M20C	Aircraft Damage:	Destroyed
Defining Event:	Loss of control in flight	Injuries:	1 Fatal
Flight Conducted Under:	Part 91: General aviation - Personal

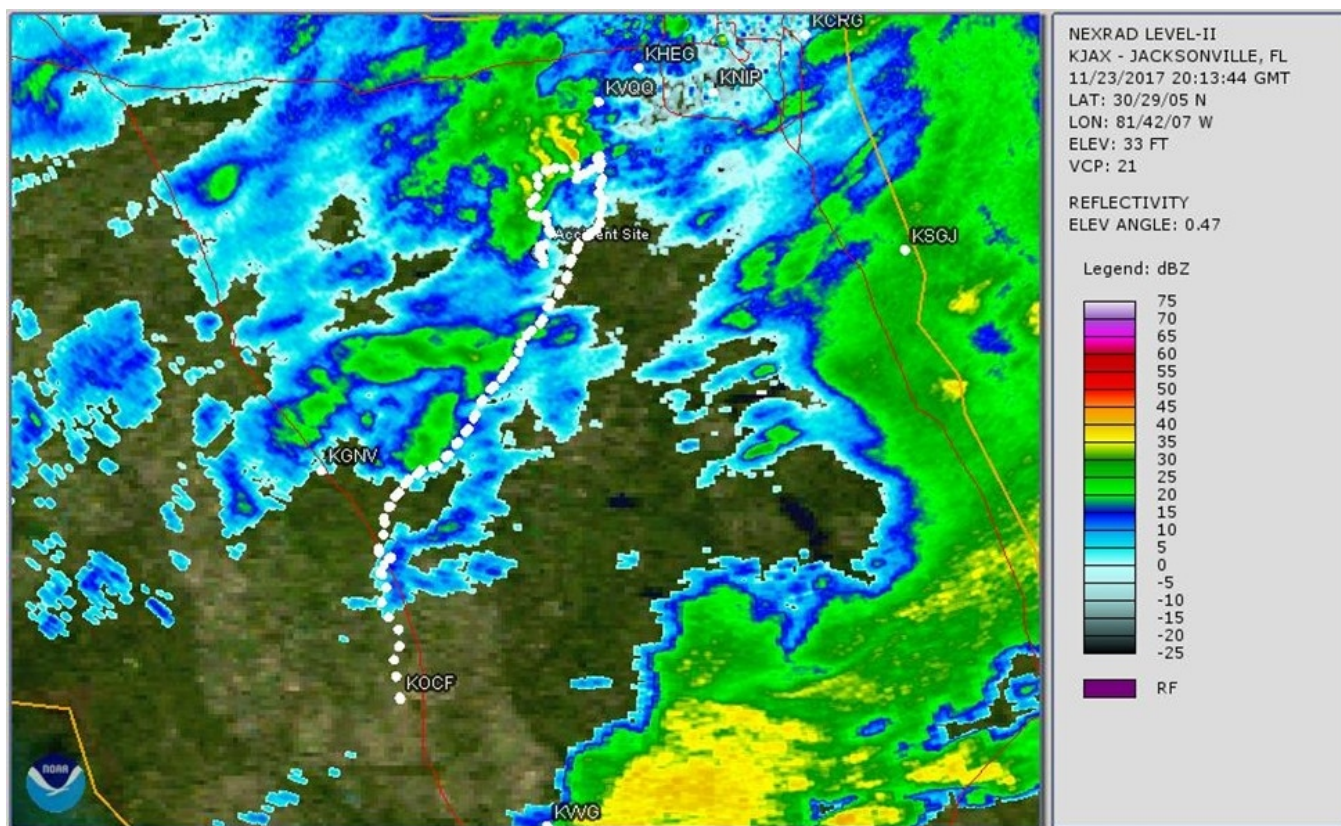
The National Weather Service KJAX WSR-88D detected a large area of light to moderate intensity echoes along the airplane's flight track and in the vicinity of the accident site, and indicated that the accident flight was in clouds and precipitation when the flight deviated west and then back to the south. The 1513 base reflectively image showed that the airplane's flight track operated through echoes of 30 to 40 dBZ, moderate intensity echoes and in an area of 15 to 20 dBZ echoes at the time of the accident (See figure 1).

Figure 1. KJAX WSR-88D 0.5° base reflectivity image for 1513 with airplane's flight track of overlaid
