Aviation Investigation Final Report

Location:	Caldwell, Idaho	Accident Number:	WPR18LA050
Date & Time:	December 17, 2017, 13:00 Local	Registration:	N716JB
Aircraft:	GRAY JIM ROBERT EXEC	Aircraft Damage:	Substantial
Defining Event:	Powerplant sys/comp malf/fail	Injuries:	1 None
Flight Conducted Under:	Part 91: General aviation - Personal

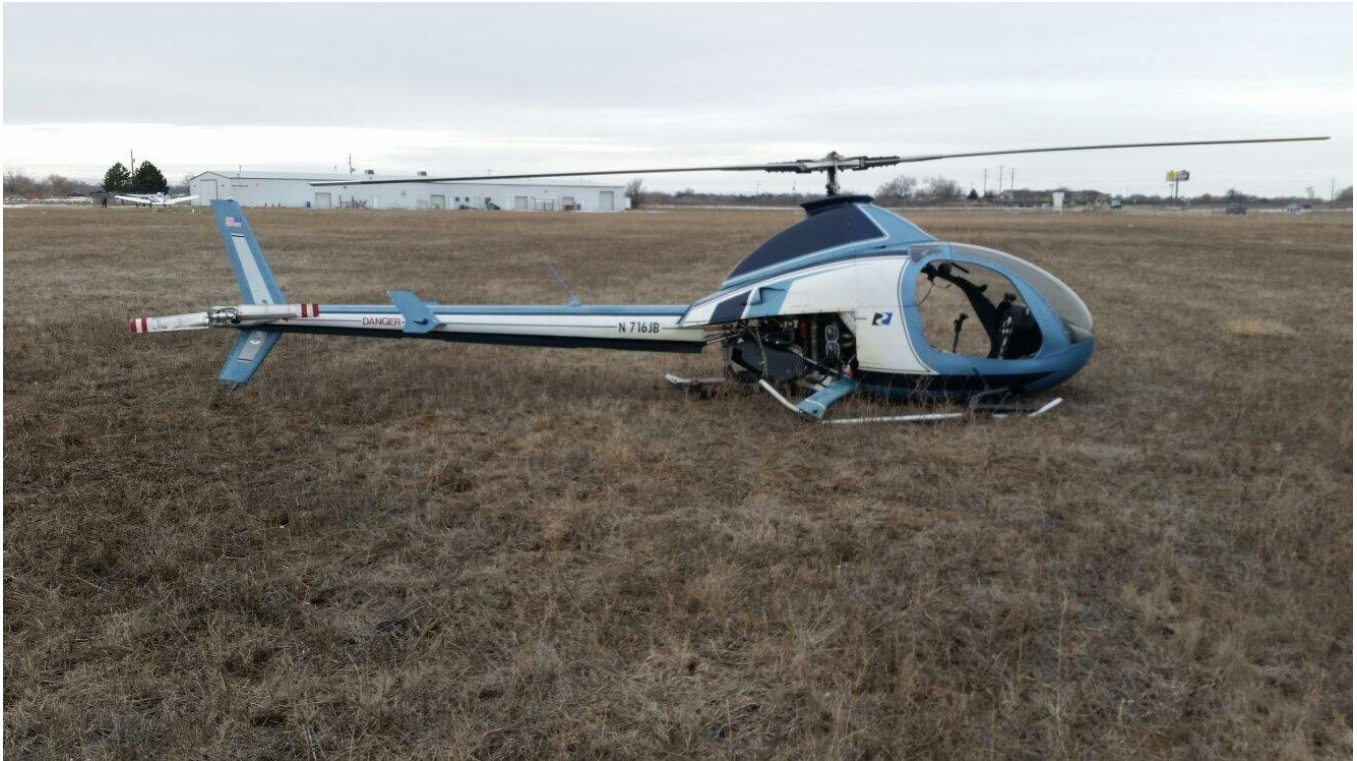
On December 17, 2017, about 1300 mountain standard time, an experimental amateur-built Rotorway Exec-90 series helicopter, N716JB, landed hard following a loss of engine power at Caldwell Industrial Airport, Caldwell, Idaho. The private pilot/builder was not injured, and the helicopter sustained substantial damage to the lower fuselage structure. The helicopter was registered to and operated by the pilot under the provisions of Title 14 *Code of Federal Regulations* Part 91 as a personal flight. Visual meteorological conditions prevailed, and no flight plan had been filed. The local flight departed Caldwell about 1230.

The pilot stated that he planned to perform a series of hover-taxi and air-taxi maneuvers on taxiway A as practice, after a two-week period of bad weather. After taxiing around the airport for about 30 minutes, he heard an unusual sound and the engine began to lose power. He was initiating a turn at the time, and as the helicopter descended to 10 ft, the engine lost all power. He performed a forced landing, and the helicopter landed hard.

Photo 1 – Helicopter at Accident Site

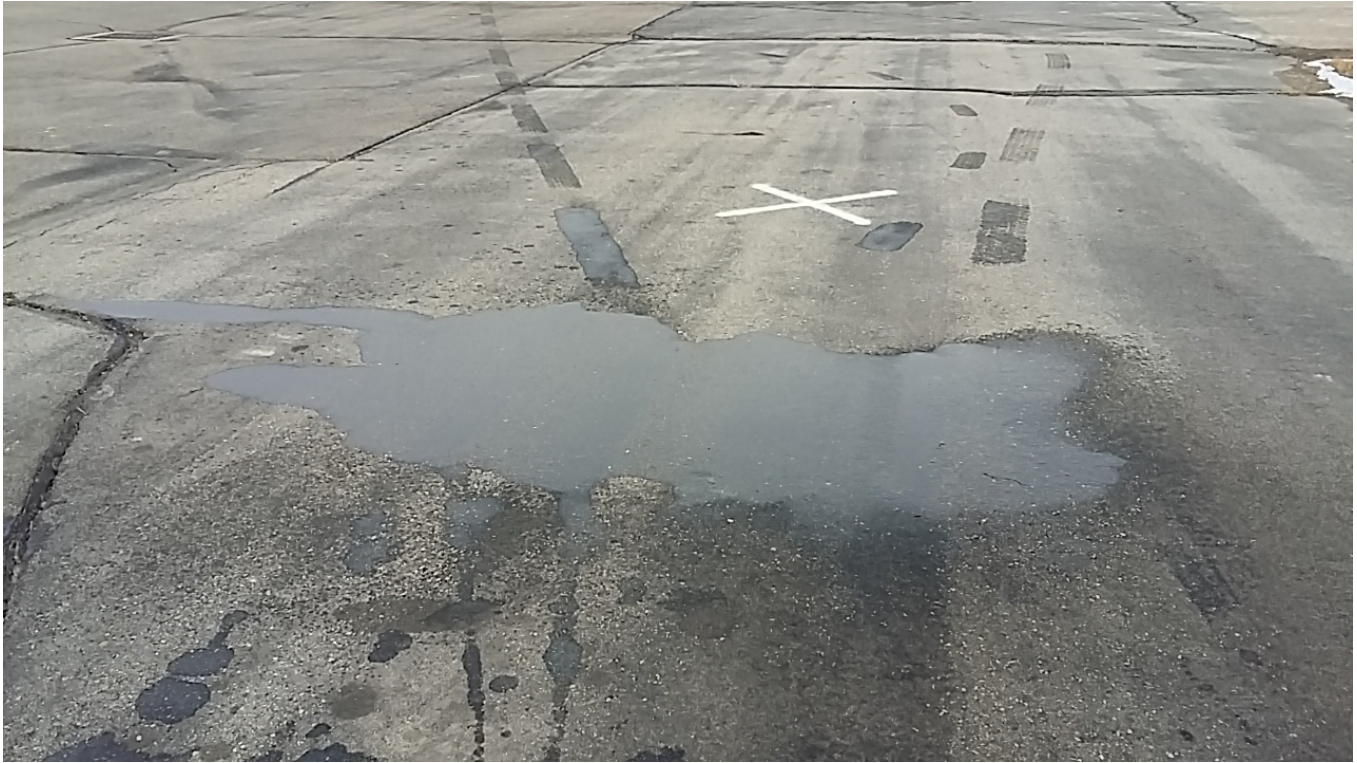
Examination of the helicopter revealed that oil was leaking from below the engine compartment, and a trail of oil was present on the ground in the areas that the helicopter had been taxiing.

Photo 2 – Oil on Ramp
