Aviation Investigation Final Report

Location:	Longmont, Colorado	Accident Number:	CEN18LA059
Date & Time:	December 20, 2017, 08:50 Local	Registration:	N519MA
Aircraft:	AMERICAN CHAMPION AIRCRAFT 7GCAA	Aircraft Damage:	Substantial
Defining Event:	Sys/Comp malf/fail (non-power)	Injuries:	2 None
Flight Conducted Under:	Part 91: General aviation - Instructional

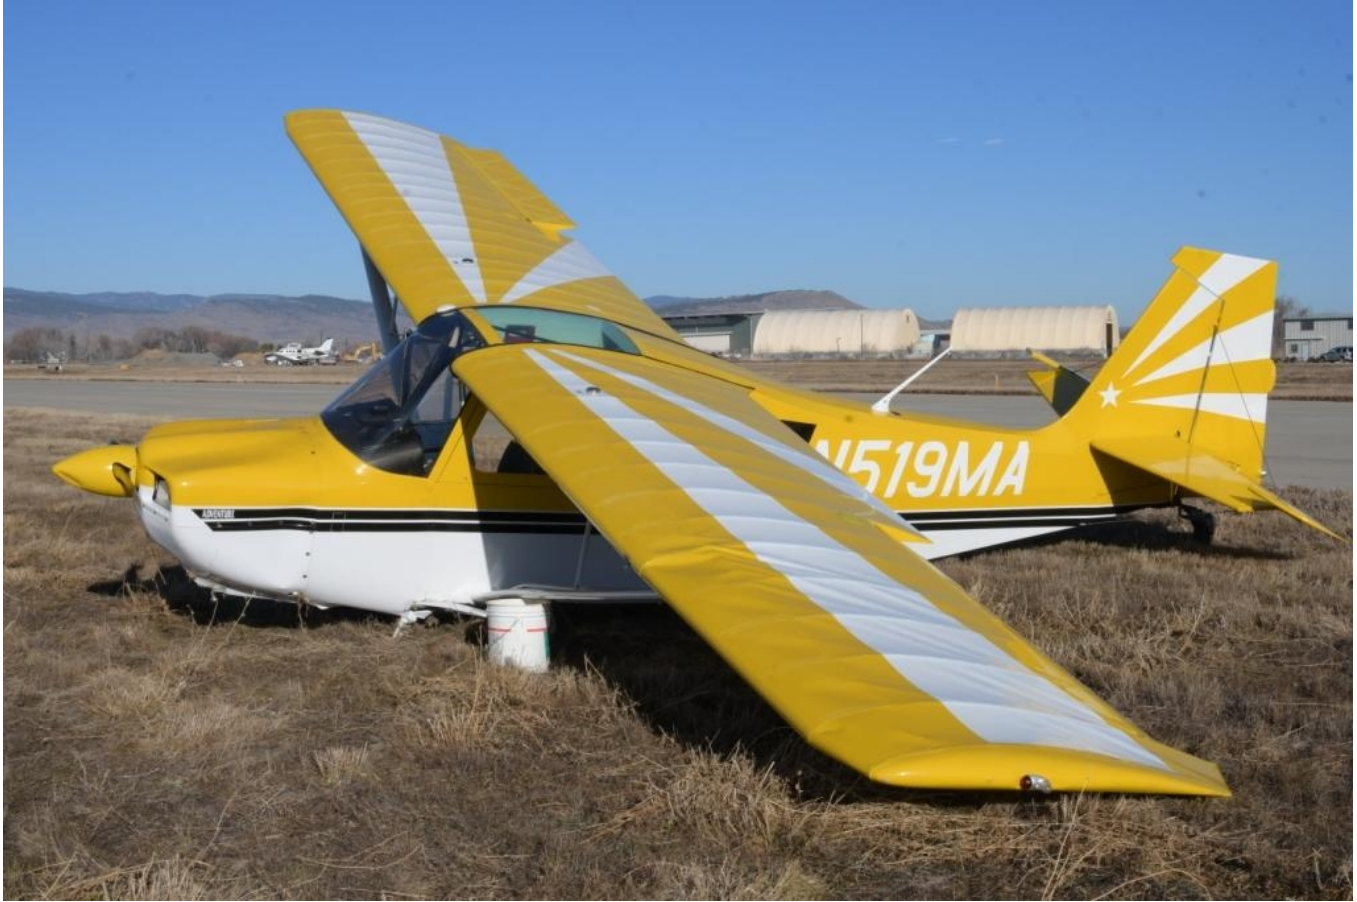
Figure 1 – Accident airplane

The flight instructor reported that private pilot made a hard landing during an instructional flight. The flight instructor heard a "snapping" sound during the landing so he took over the flight controls. He increased the throttle to compensate for the bounced landing and then landed the airplane on the runway. The left landing gear collapsed upward and aft damaging the left wing strut. The airplane continued forward on its nose and left wing as it departed the left side of the runway near taxiway A2 (figure 1).

The responding Federal Aviation Administration (FAA) inspector reported that the left landing gear thru-bolt was fractured. The left wing was bent upward, and the bottom and left side of the fuselage was damaged.

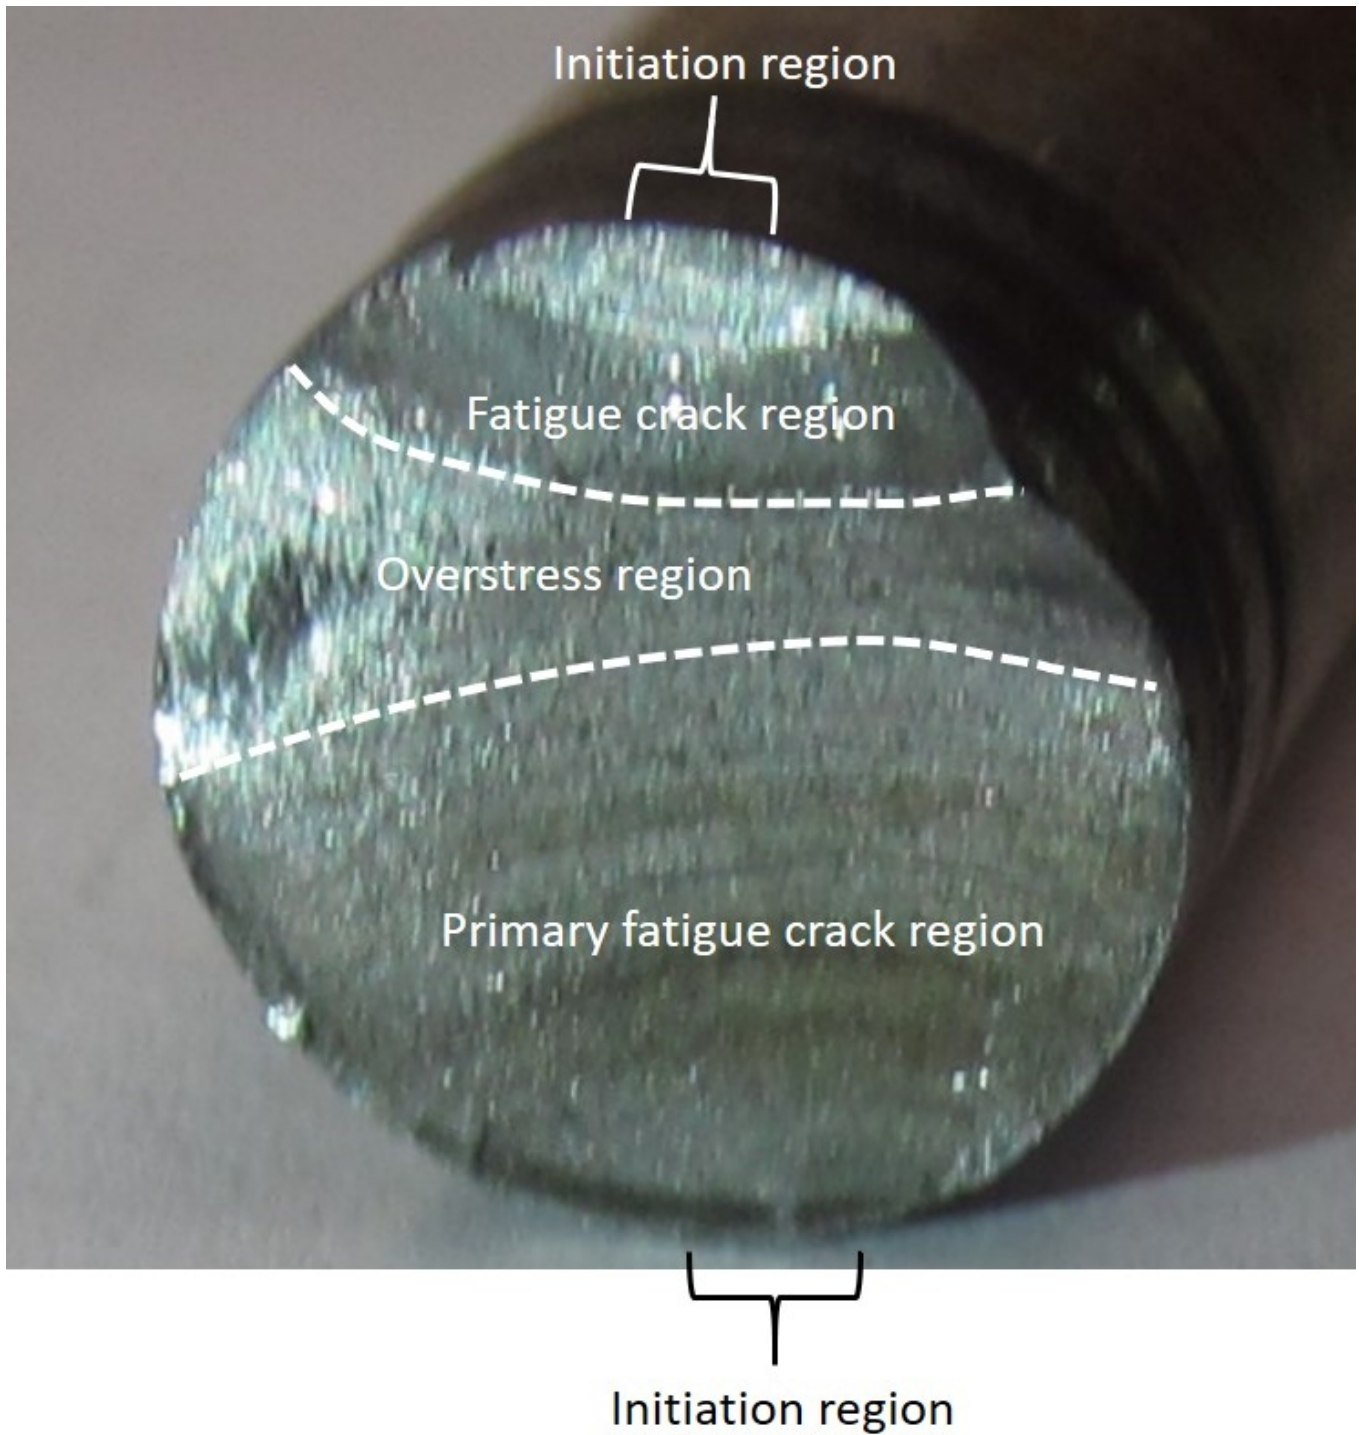
Figure 2 – Bolt fracture surface with notation

A metallurgical examination of the landing gear through bolt fracture revealed two opposing regions of fatigue comprising 80-90% of the cross-sectional area of the bolt. These were separated by a narrow region of overstress, consistent with reverse bending fatigue crack propagation, which likely grew under low stress as evidenced by the length of the fatigue cracks.

The National Transportation Safety Board determines the probable cause(s) of this accident to be: The failure of the landing gear through bolt primarily due to fatigue during a hard landing, which resulted in a landing gear collapse and runway excursion. Contributing to the accident was noncompliance with the manufacturer service letter.

A metallurgical examination of the landing gear thru-bolt fracture revealed a primary fatigue fracture that initiated at the shank surface and propagated through about 60% of the bolt diameter (figure 2). A second fatigue crack initiated on the shank surface about 180° from the primary crack and propagated through 20% to 30% of the bolt diameter. The fracture surface exhibited a narrow region of overstress fracture between the two fatigue crack regions.
