# Aviation Investigation Final Report

<b>Location:</b>	Bartow, Florida	<b>Accident Number:</b>	CEN18FA061
<b>Date &amp; Time:</b>	December 24, 2017, 07:17 Local	<b>Registration:</b>	N247AT
<b>Aircraft:</b>	Cessna 340	<b>Aircraft Damage:</b>	Destroyed
<b>Defining Event:</b>	Loss of control in flight	<b>Injuries:</b>	5 Fatal
<b>Flight Conducted Under:</b>	Part 91: General aviation - Personal

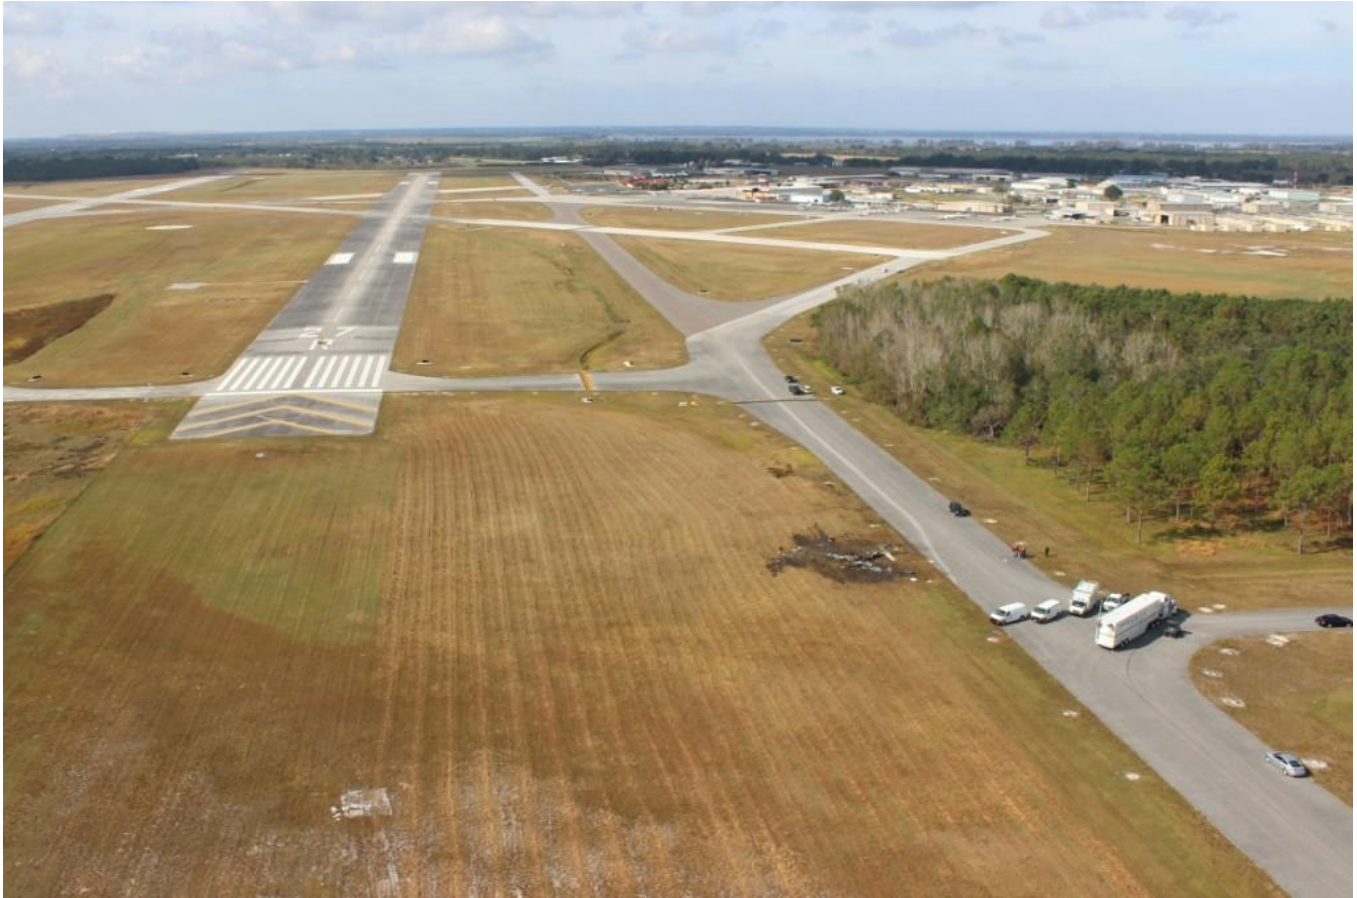
Figure 1 – Aerial View of Accident Site

The accident site was located on airport property about 190 yards east-northeast of the departure end of runway 9L and 10 ft south of taxiway delta (figure 1).

The debris path was about 230 ft long and oriented northeast. The beginning of the debris path was defined by several ground impact craters in a line perpendicular to the debris path and the main wreckage. The middle impact crater contained pieces of the airplane's nose cowling and baggage door. Immediately to the right was the left engine's propeller. To the left of the middle crater was the right engine's propeller. A portion of the left wing tip fuel tank was found on the far right side of the initial impact area, and a portion of the right wing tip fuel tank was found on the far left side of the initial impact area. The main wreckage came to rest upright and oriented southeast about 30 ft from the initial impact craters. The fuselage was mostly consumed by fire and the empennage remained mostly intact with significant thermal damage. Both engines separated from the airplane and came to rest near the main wreckage. Airplane debris was found on the taxiway northeast of the main wreckage. The nose landing gear was separated from the airplane and found about 200 ft northeast of the main wreckage.

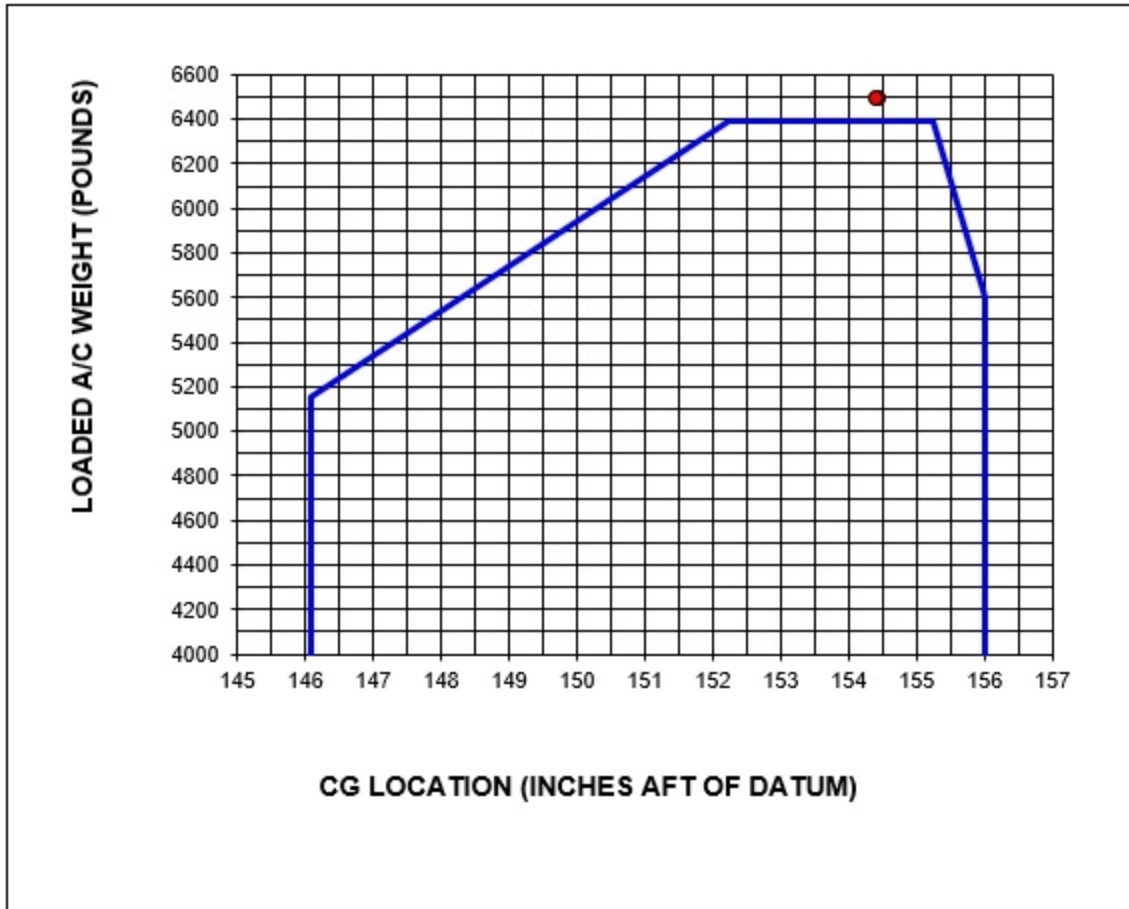
Figure 3 – Center of Gravity Moment Envelope

The airplane's maximum gross takeoff weight was 6,390 lbs. The weight at the time of the accident takeoff was about 6,495 lbs, about 105 lbs over the maximum takeoff weight (figure 2). Due to the excessive weight, the airplane was outside of its center of gravity moment envelope (figure 3).
