Aviation Investigation Final Report

Location:	Bartow, Florida	Accident Number:	CEN18FA061
Date & Time:	December 24, 2017, 07:17 Local	Registration:	N247AT
Aircraft:	Cessna 340	Aircraft Damage:	Destroyed
Defining Event:	Loss of control in flight	Injuries:	5 Fatal
Flight Conducted Under:	Part 91: General aviation - Personal

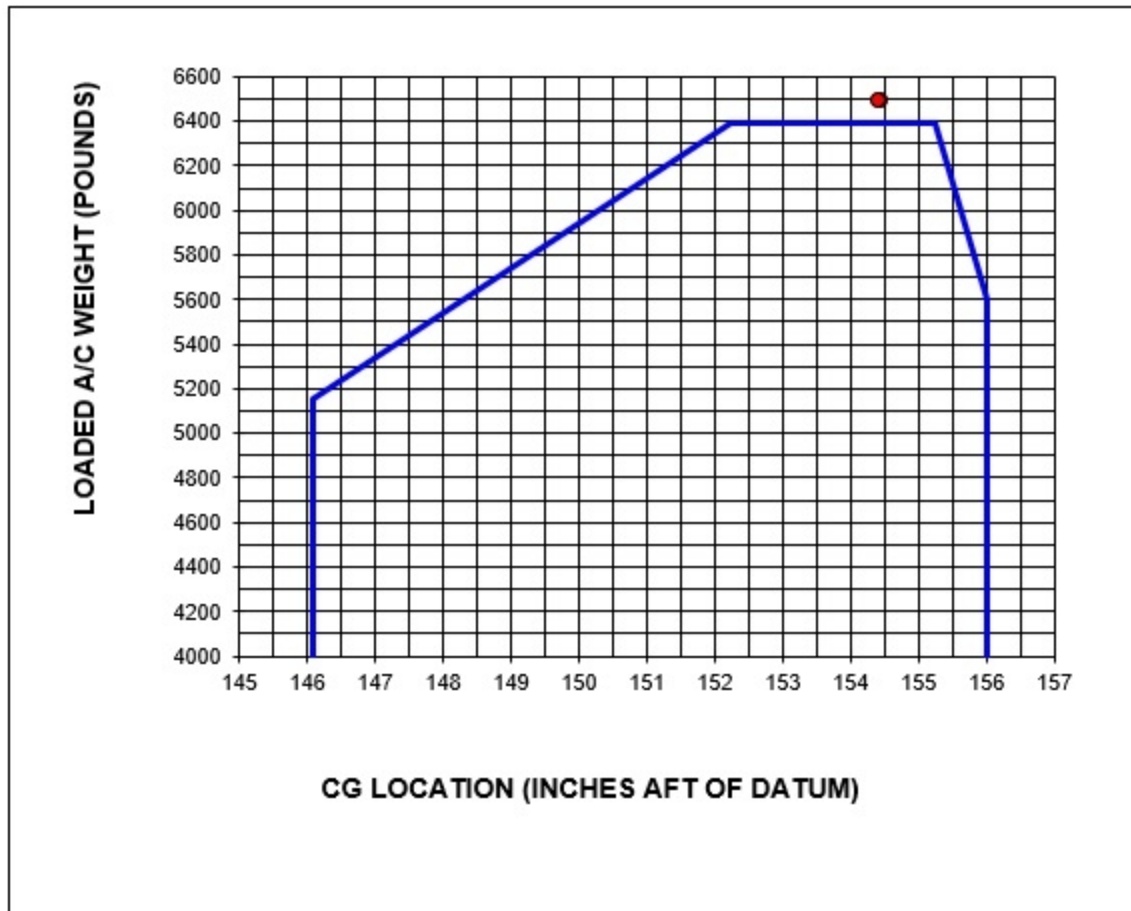
Figure 3 – Center of Gravity Moment Envelope

The airplane's maximum gross takeoff weight was 6,390 lbs. The weight at the time of the accident takeoff was about 6,495 lbs, about 105 lbs over the maximum takeoff weight (figure 2). Due to the excessive weight, the airplane was outside of its center of gravity moment envelope (figure 3).
