Aviation Investigation Final Report

Location:	Punta Islita,	Accident Number:	CEN18FA063
Date & Time:	December 31, 2017, 11:56 Local	Registration:	TI-BEI
Aircraft:	Cessna 208	Aircraft Damage:	Destroyed
Defining Event:	Aerodynamic stall/spin	Injuries:	12 Fatal
Flight Conducted Under:	Non-U.S., commercial

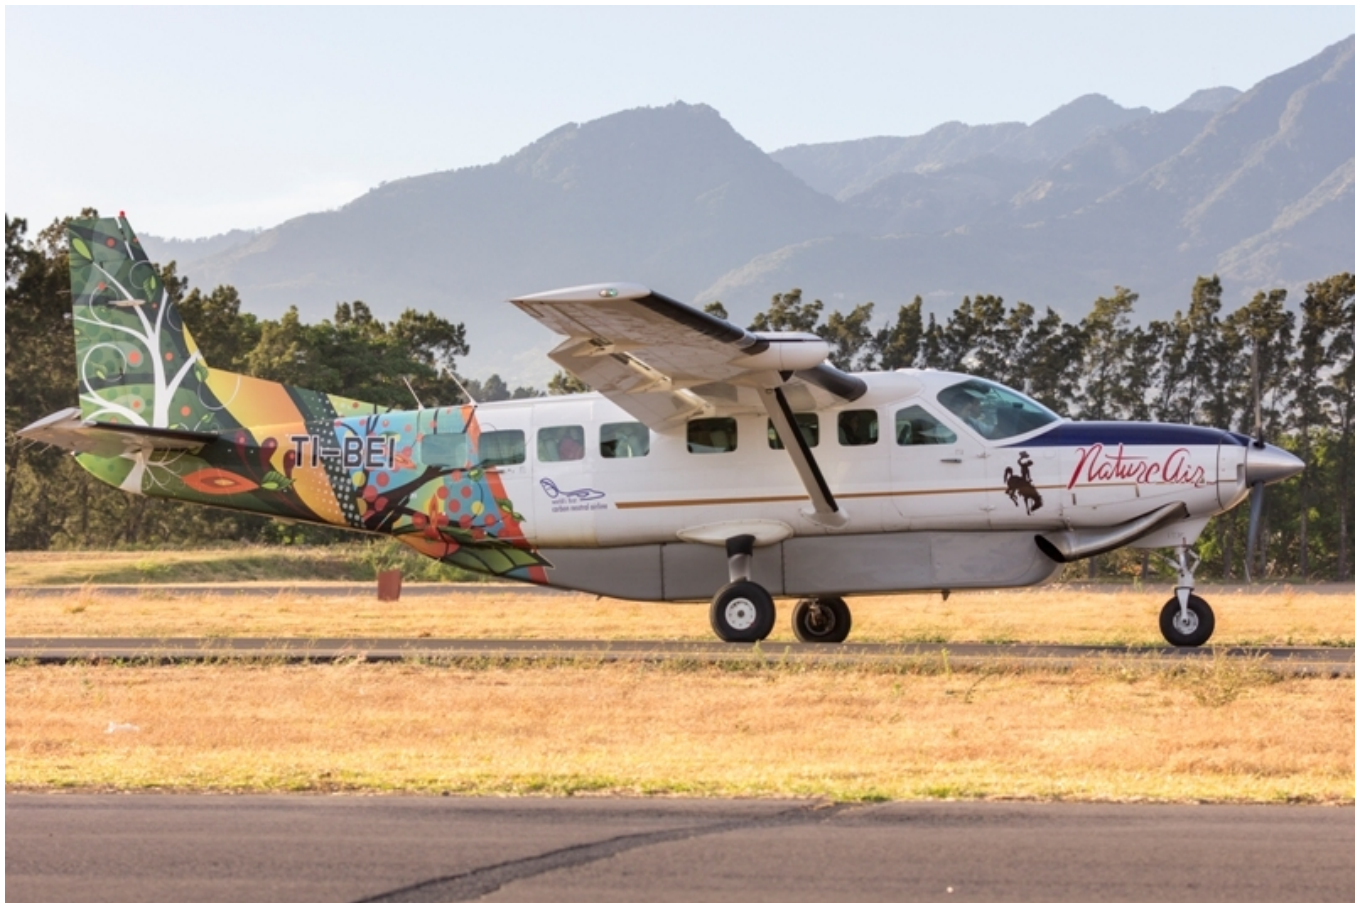
Figure 1 - Photograph of the accident airplane

The accident airplane was a Cessna 208B Caravan, serial number 208B0900 (Figure 1). It was a high-wing, single-turboprop-powered airplane with a fixed, tricycle landing gear configuration. The accident airplane was configured to seat 12 passengers in addition to the 2 flight crewmember seats. The airplane was powered by a 675-horsepower Pratt & Whitney Canada PT6A-114A turboprop engine, serial number PC1545, which drove a constant speed, full-feathering, reversible pitch propeller.

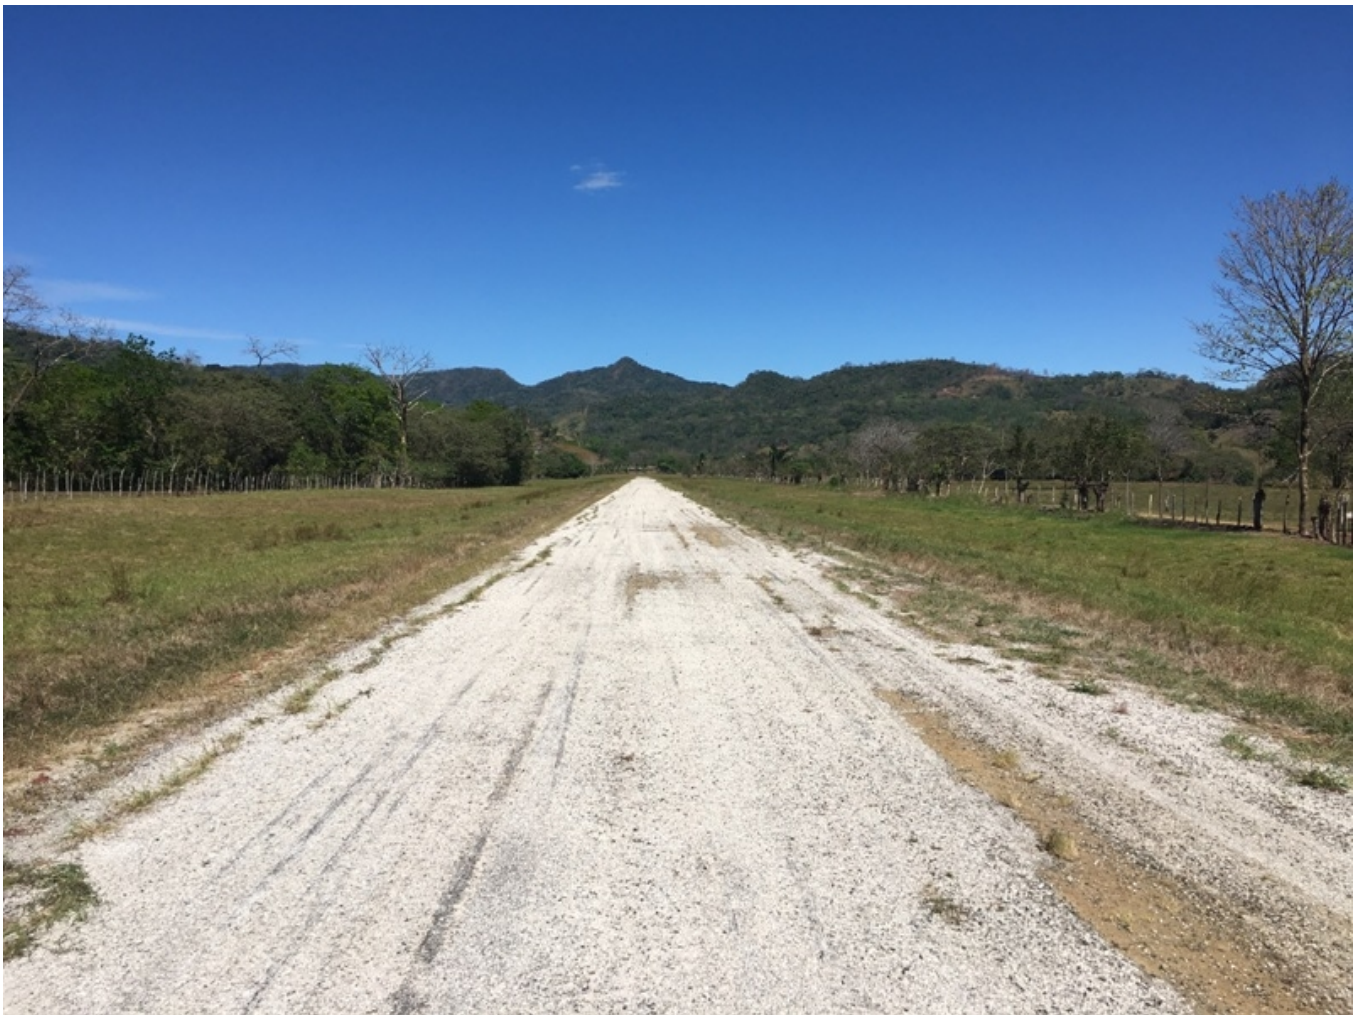
The airport had a single paved runway, runway 3/21, that was about 3,000 ft long and 30 ft wide (Figure

2). The runway pavement was cracked and had vegetation growing through the cracks at the south end. There was a hut located at the northeast end of the runway adjacent to a taxiway turnaround. Other than the turnaround at the north end, there were no other taxiways, requiring airplanes to use the runway for taxi operations. The runway was in a valley with rising terrain on all sides except to the south, which led to the Pacific Ocean. The witness who saw the accident reported that he spoke with the pilots of both airplanes before the flights departed and that the pilots acknowledged the need to use the eastern pass in order to clear terrain when departing from runway 3.

Figure 2 - View from runway looking north toward the mountains

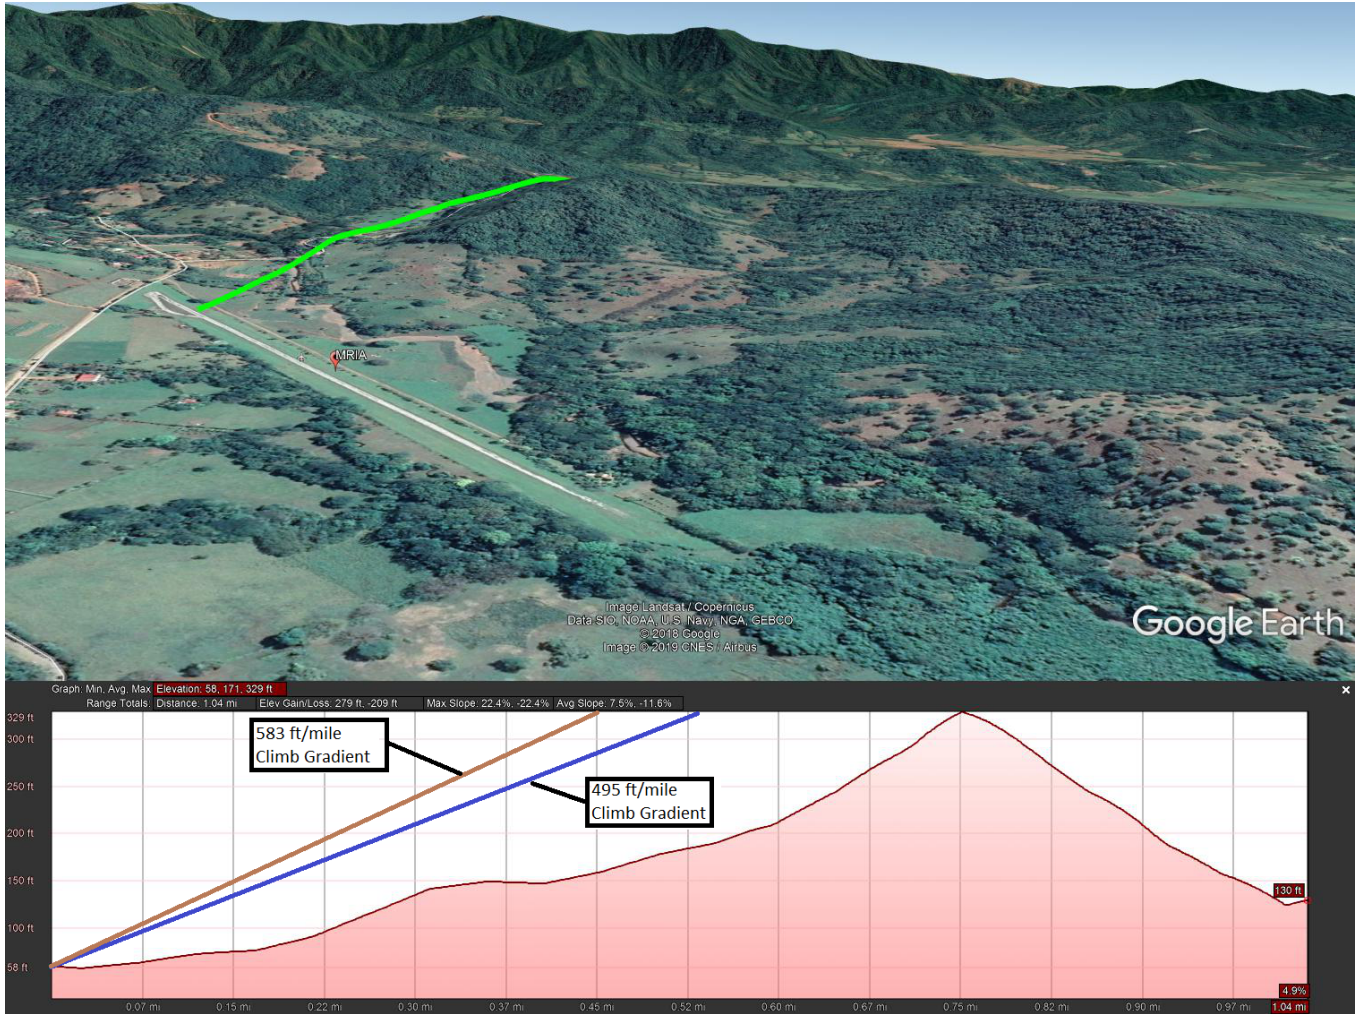
Three different takeoff scenarios were examined to determine if the airplane had sufficient climb performance to clear the terrain surrounding the airport. The first scenario (Figure 4) examined a takeoff using the approximate ground path used by the previous airplane. The calculations showed that the airplane would have had sufficient climb performance along this route, with a minimum climb gradient margin of 40% using 0° flap at the maximum allowable weight, and a 65% margin using 20° flap and the minimum fuel weight. A positive margin indicates that the calculated climb performance exceeded the minimum needed to clear terrain. A 0% margin indicates that the airplane would have cleared terrain with no excess altitude gained. A negative margin indicates that the calculated climb performance was not sufficient to clear the terrain.

Figure 4 – Departure scenario 1 depicting the ground path of the previous airplane and the possible climb performance of the accident airplane overlaid on an elevation profile of the path.

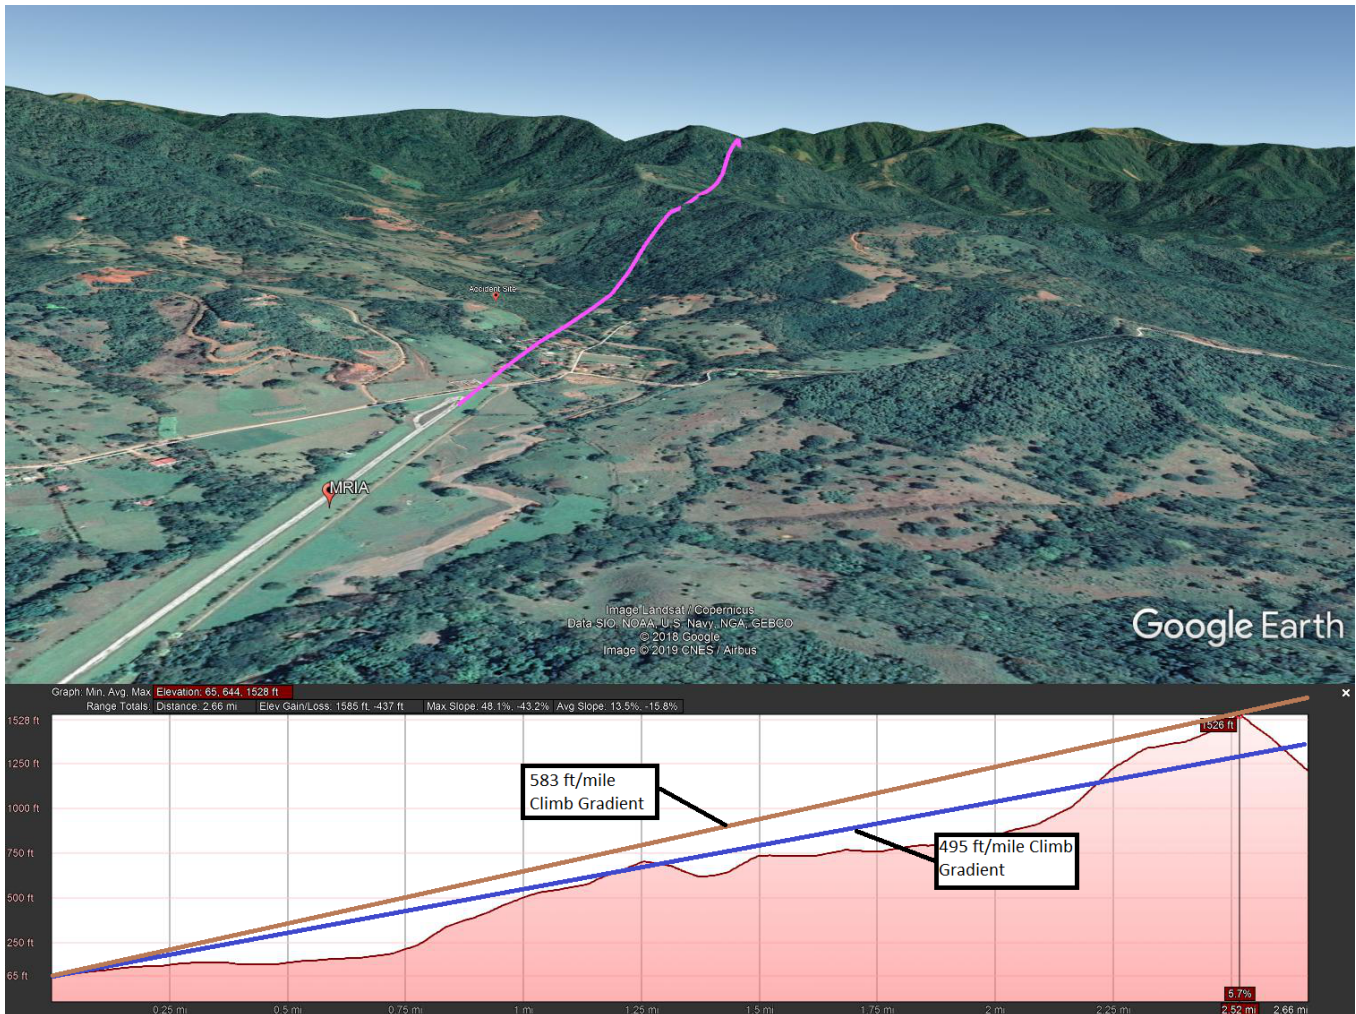
The second scenario was a straight-out departure maintaining runway heading. Calculations showed that the airplane may not have had sufficient climb performance to clear the mountains using this route. The climb gradient margin at the maximum allowable weight and 0° flap setting was -14%, and at the minimum fuel weight using 20° flap setting was 1%.

Figure 5 - Departure scenario 2 showing a takeoff path using a straight-out departure from runway 3, and the possible climb performance of the accident airplane overlaid on an elevation profile of the path.

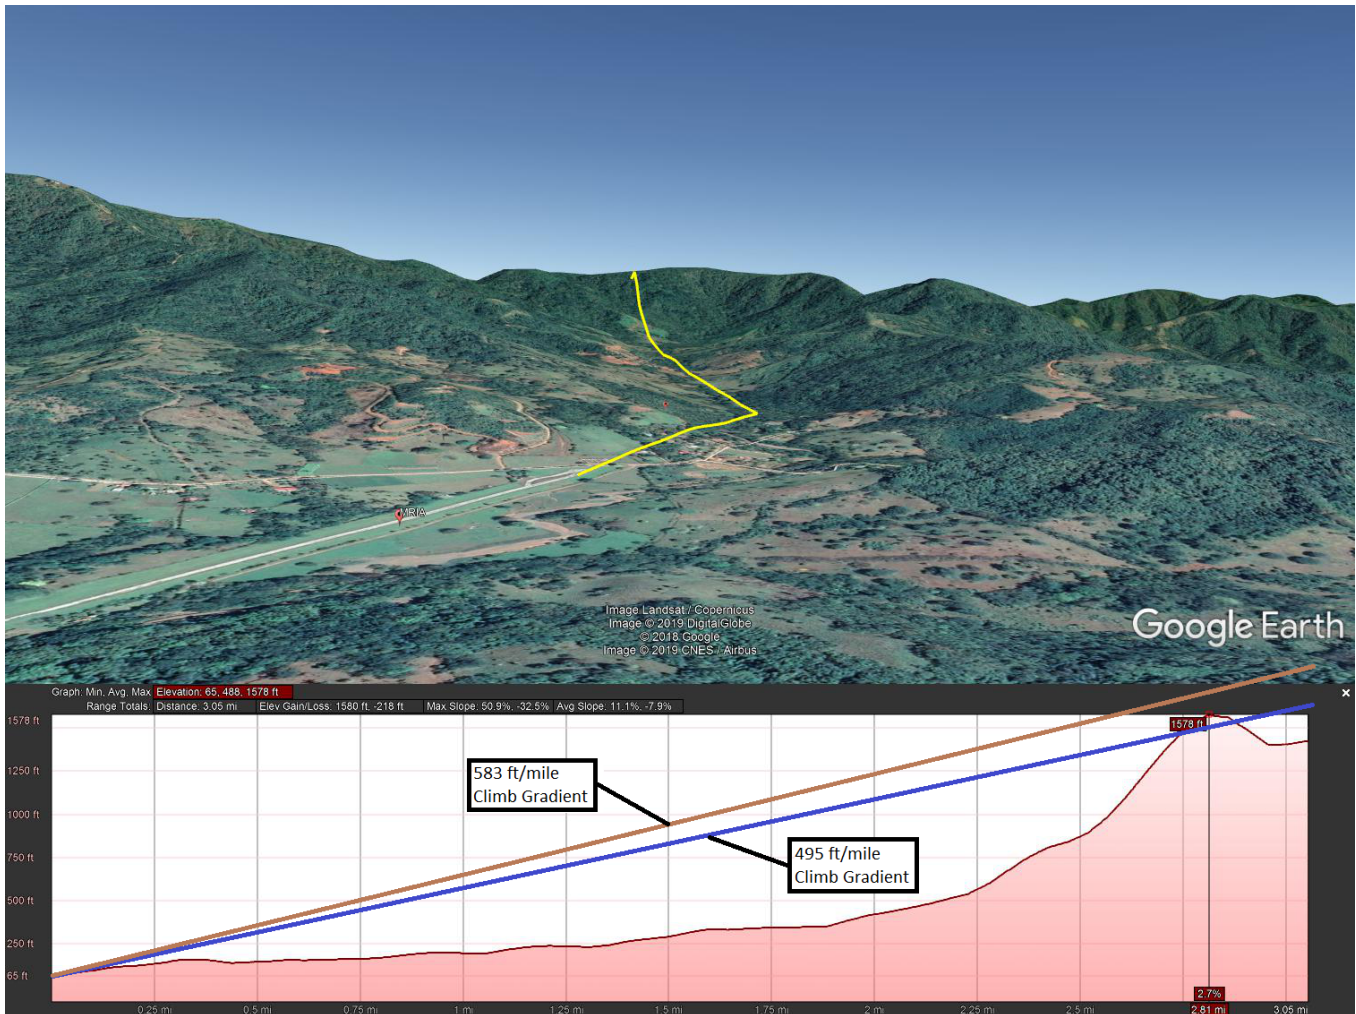
The final scenario was a path that turned left after takeoff, following the valley floor (Figure 6). Calculations showed that the airplane may not have had sufficient climb gradient performance to clear the mountains using this path. The climb gradient margin at the maximum allowable weight and 0° flap setting was -8%, and at the minimum fuel weight using 20° flap setting was 9%.

Figure 6 – Departure scenario 3 showing a takeoff from runway 3 over the valley floor to the north of the airport, and the possible climb performance of the accident airplane overlaid on an elevation profile of the path.

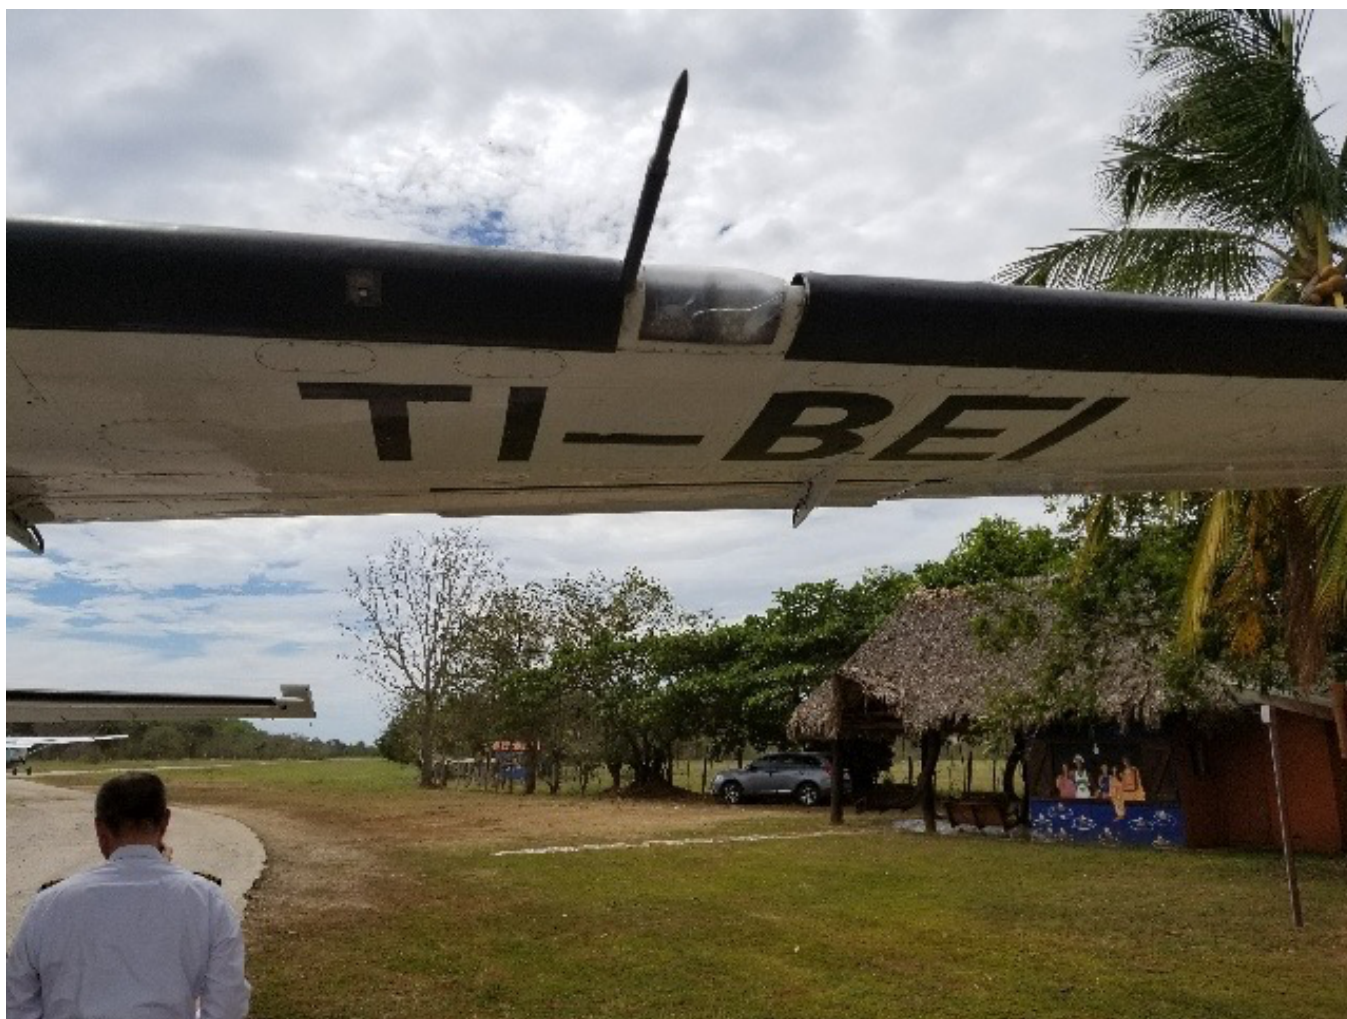
A friend of one of the passengers reported that he had received a text message from the passenger before the flight indicating that the airplane had been involved in a bird strike during its arrival to MRJA. The passenger's friend provided the text messages along with the pictures showing the damage to the airplane. The photographs showed that wing's left leading edge had incurred localized damage near the landing light. The landing light lens was cracked, and the leading edge appeared to display some deformation adjacent to the landing light. The damaged area was located ahead of the landing flaps and inboard of the aileron. Due to the localized extent of the damage, the flight characteristics and

controllability of the airplane would not have been adversely affected.

The witness reported that the flight crew was aware of the damage and that the captain had contacted the operator's maintenance facility to discuss the damage. He stated that the captain waited for a release from maintenance before proceeding with the flight and that this was the reason the accident airplane left about 15 minutes after the first airplane.

Figure 7 - Photograph showing the bird strike damage to the leading edge of the left wing.
