Aviation Investigation Final Report

Location:	Punta Islita,	Accident Number:	CEN18FA063
Date & Time:	December 31, 2017, 11:56 Local	Registration:	TI-BEI
Aircraft:	Cessna 208	Aircraft Damage:	Destroyed
Defining Event:	Aerodynamic stall/spin	Injuries:	12 Fatal
Flight Conducted Under:	Non-U.S., commercial

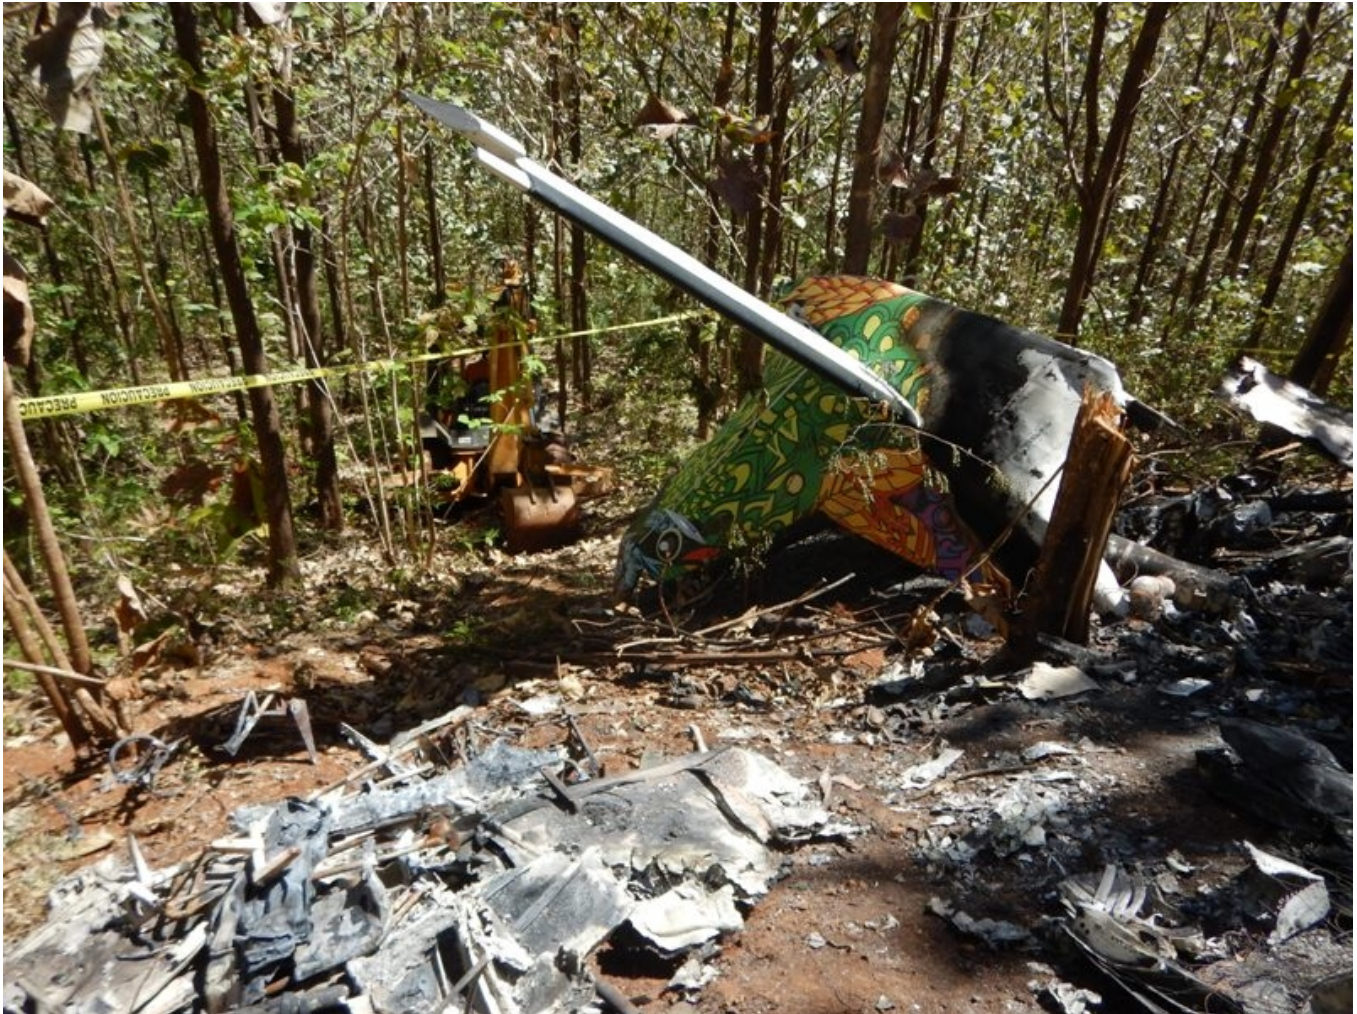
The airplane wreckage was removed from the accident site before NTSB arrival. The accident site was located on a heavily wooded hillside about 0.4 sm northeast (024°) of the departure end of runway 3 at an elevation of 238 ft msl. Several trees and limbs scattered about the accident site, ranging in diameter from a few inches to about 6 inches, displayed relatively clean diagonal cuts consistent with propeller contact. Based on the limited damage to surrounding tree canopy, the airplane impacted the slope in a near-vertical attitude. There was evidence of a postcrash fire (Figure 3).

Figure 3 - View of the airplane's tail section at the accident site.

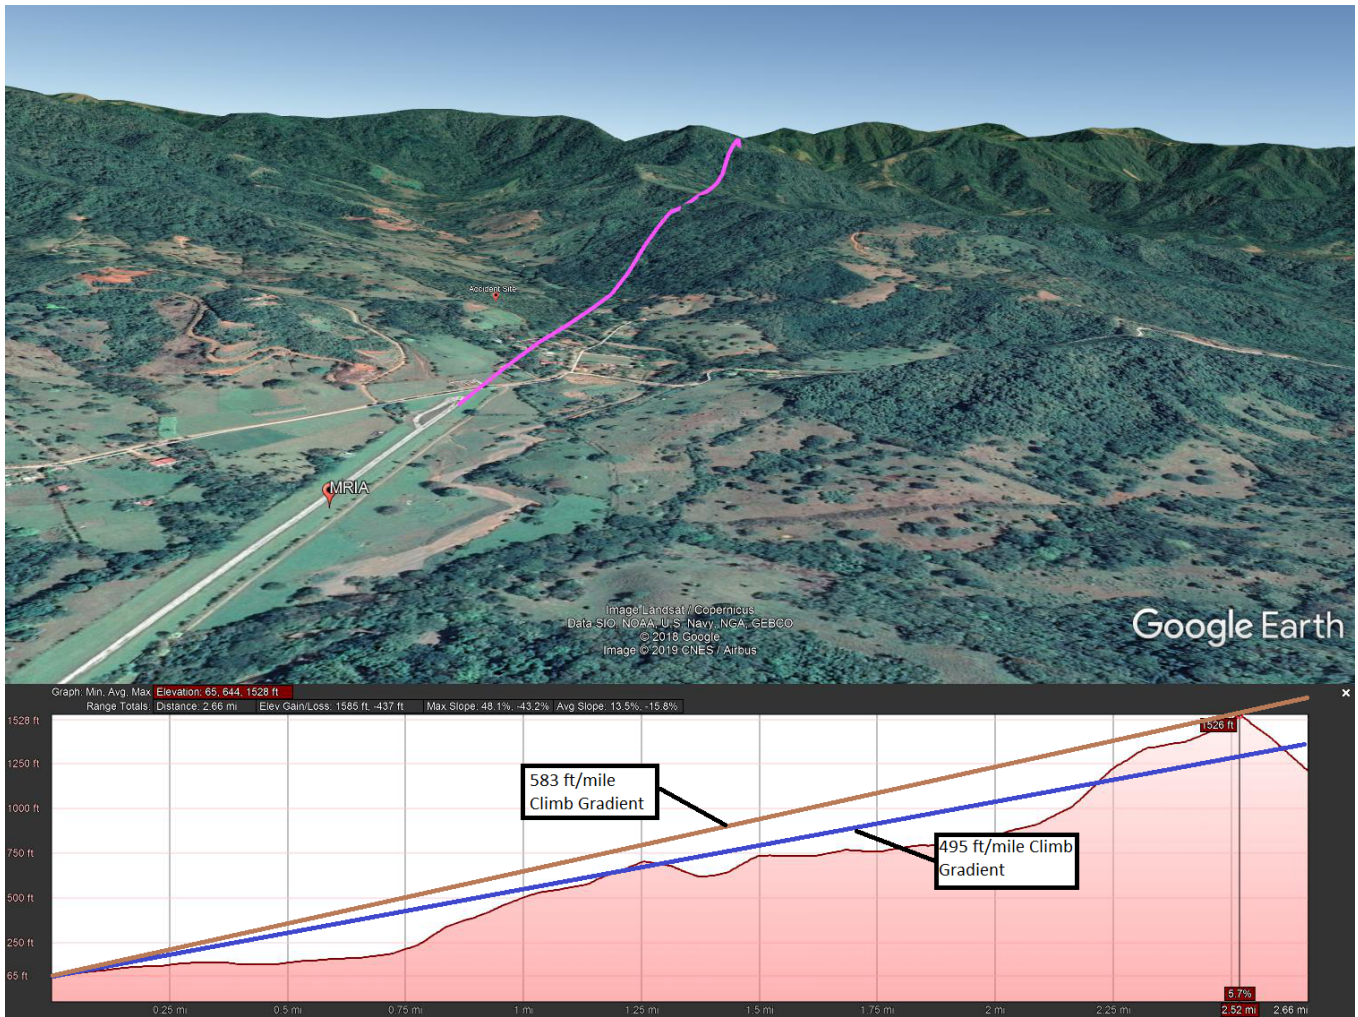
The second scenario was a straight-out departure maintaining runway heading. Calculations showed that the airplane may not have had sufficient climb performance to clear the mountains using this route. The climb gradient margin at the maximum allowable weight and 0° flap setting was -14%, and at the minimum fuel weight using 20° flap setting was 1%.

Figure 5 - Departure scenario 2 showing a takeoff path using a straight-out departure from runway 3, and the possible climb performance of the accident airplane overlaid on an elevation profile of the path.
