# Aviation Investigation Final Report

<b>Location:</b>	Skyforest, California	<b>Accident Number:</b>	WPR18LA069
<b>Date &amp; Time:</b>	January 17, 2018, 11:30 Local	<b>Registration:</b>	N5562Q
<b>Aircraft:</b>	Mooney M20E	<b>Aircraft Damage:</b>	Substantial
<b>Defining Event:</b>	Aerodynamic stall/spin	<b>Injuries:</b>	1 Serious, 1 Minor, 2 None
<b>Flight Conducted Under:</b>	Part 91: General aviation - Personal

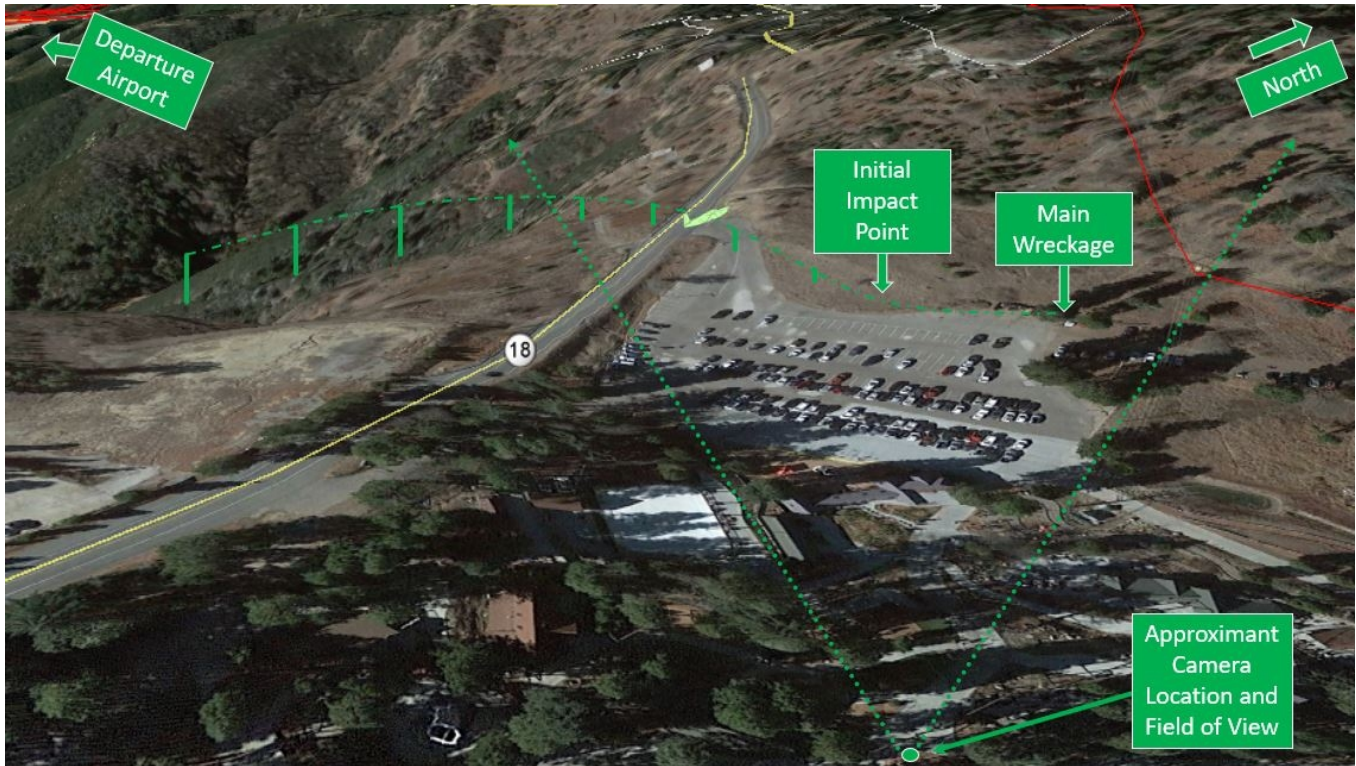
Figure 1- Accident Diagram.

A surveillance video from Santa's Village captured the airplane's final movements and showed it in straight and level flight from the southwest about 25 ft AGL. As the airplane moved into the center of the video frame, its pitch attitude increased, followed by a quick descent. The airplane impacted the ground right wing first, then spun around to the right and came to rest in the parking lot. (see figure 1)
