Aviation Investigation Final Report

Location:	Farmington, Pennsylvania	Accident Number:	ERA18LA072
Date & Time:	January 29, 2018, 16:50 Local	Registration:	N34VF
Aircraft:	Cessna P210N	Aircraft Damage:	Substantial
Defining Event:	Loss of engine power (total)	Injuries:	1 Minor
Flight Conducted Under:	Part 91: General aviation

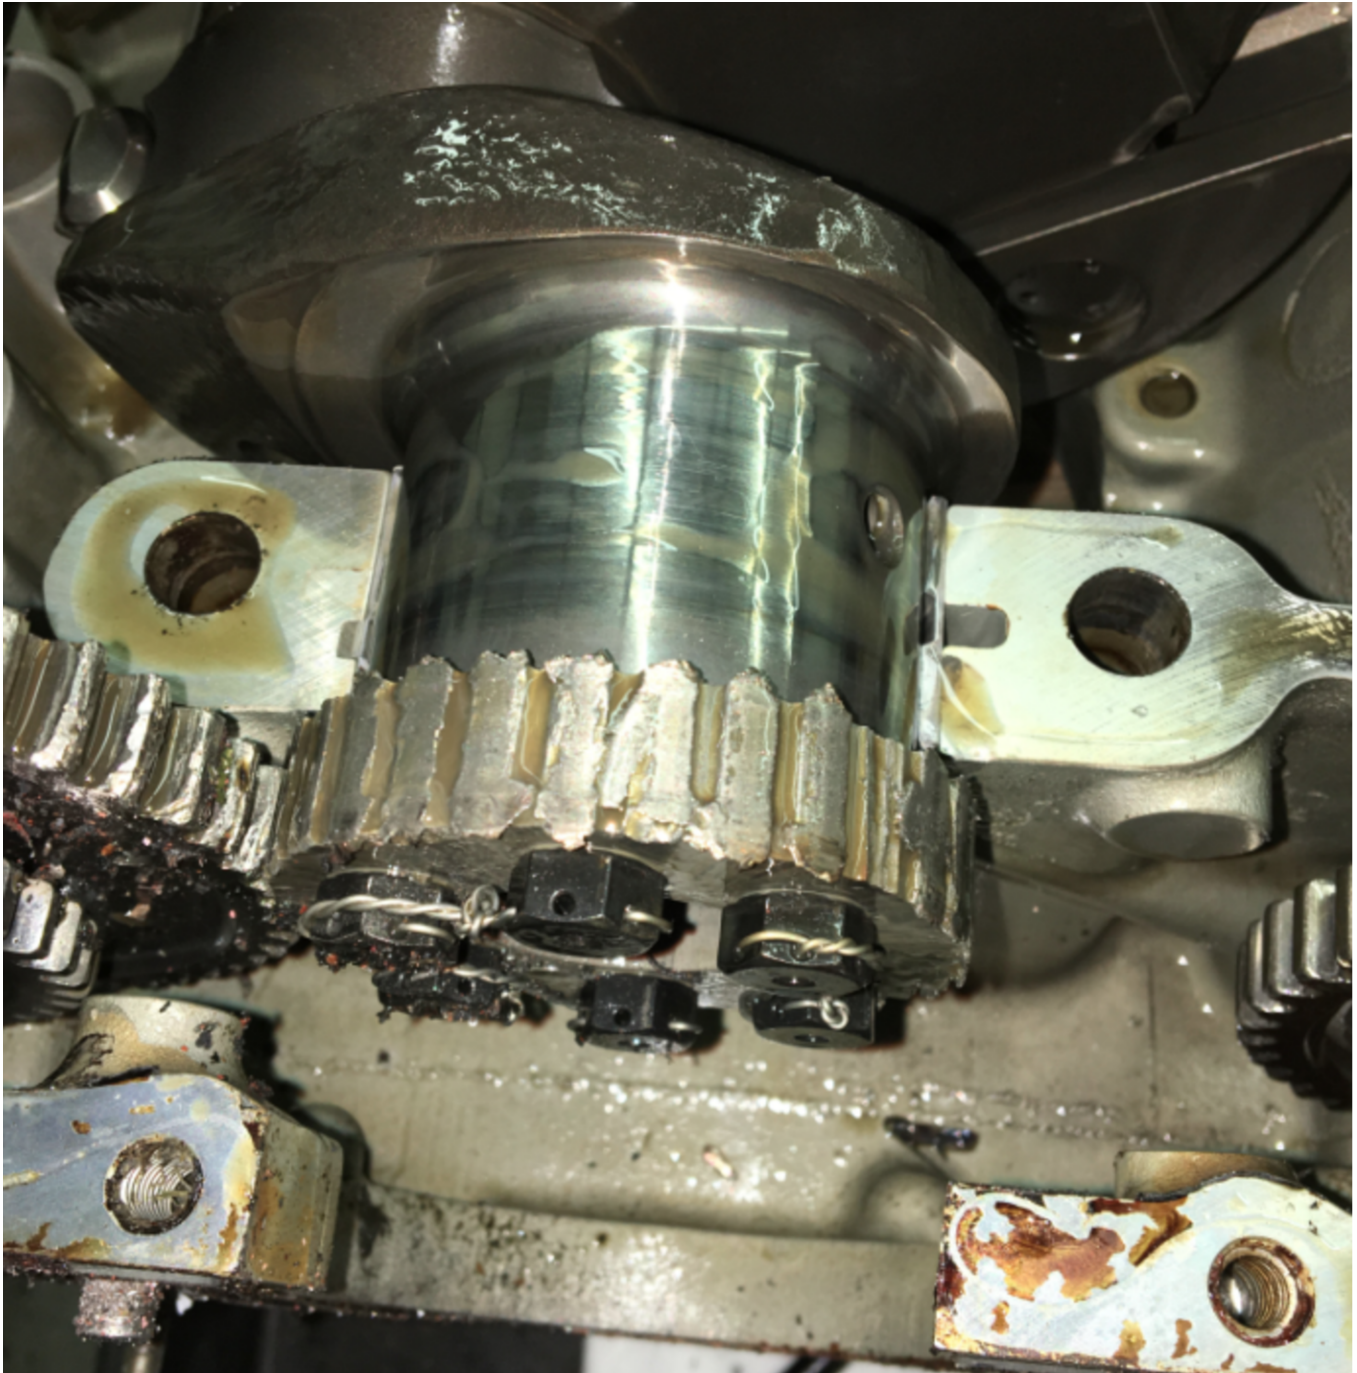
Examination of the engine revealed that the crankshaft drive gear was missing teeth, the camshaft gears were damaged, and each of the six pistons displayed valve impact damage. It is likely that the missing teeth from the drive gear caused an out-of-alignment condition that led to a cascade of additional damage to the mating timing gear on the camshaft. The improper engagement of the crankshaft drive gear to the camshaft compromised the timing of the entire valvetrain, which resulted in the loss of engine power.

A total loss of engine power due to fatigue failure of the crankshaft drive gear teeth.

The crankshaft gear was missing most of its teeth and the remaining teeth were damaged. (see Figure 1.) The gear was removed from the crankshaft and there was no sign of fretting between the mating surfaces. There were no additional pre-accident anomalies noted with the crankshaft, counterweights, or connecting rods. All items appeared to be well lubricated with no signs of thermal distress. Removal and examination of the camshaft showed no pre-accident anomalies with the lobes or lifters, but the camshaft gear teeth sustained mechanical damage.

Figure 1. Crankshaft gear damage.

The crankshaft drive gear, camshaft, timing gear, fractured teeth, and metal debris were sent to the NTSB Materials Laboratory for additional examination. The crankshaft drive gear exhibited features such as crack arrest marks and heat tinting, consistent with fatigue cracking before the final fracture. The crack arrest marks and fatigue striations were consistent with inward crack propagation from the tooth edge located near the thread root. There were ratchet marks present near the initiation side of the crack, consistent with multiple fatigue crack initiation sites. Outside of the fatigue cracking region, the fracture surface exhibited a dimpled rupture, consistent with subsequent overstress fracture. A hardness test was

performed, and the results indicated that the crankshaft gear was within the typical limits of case-hardened alloy steel.

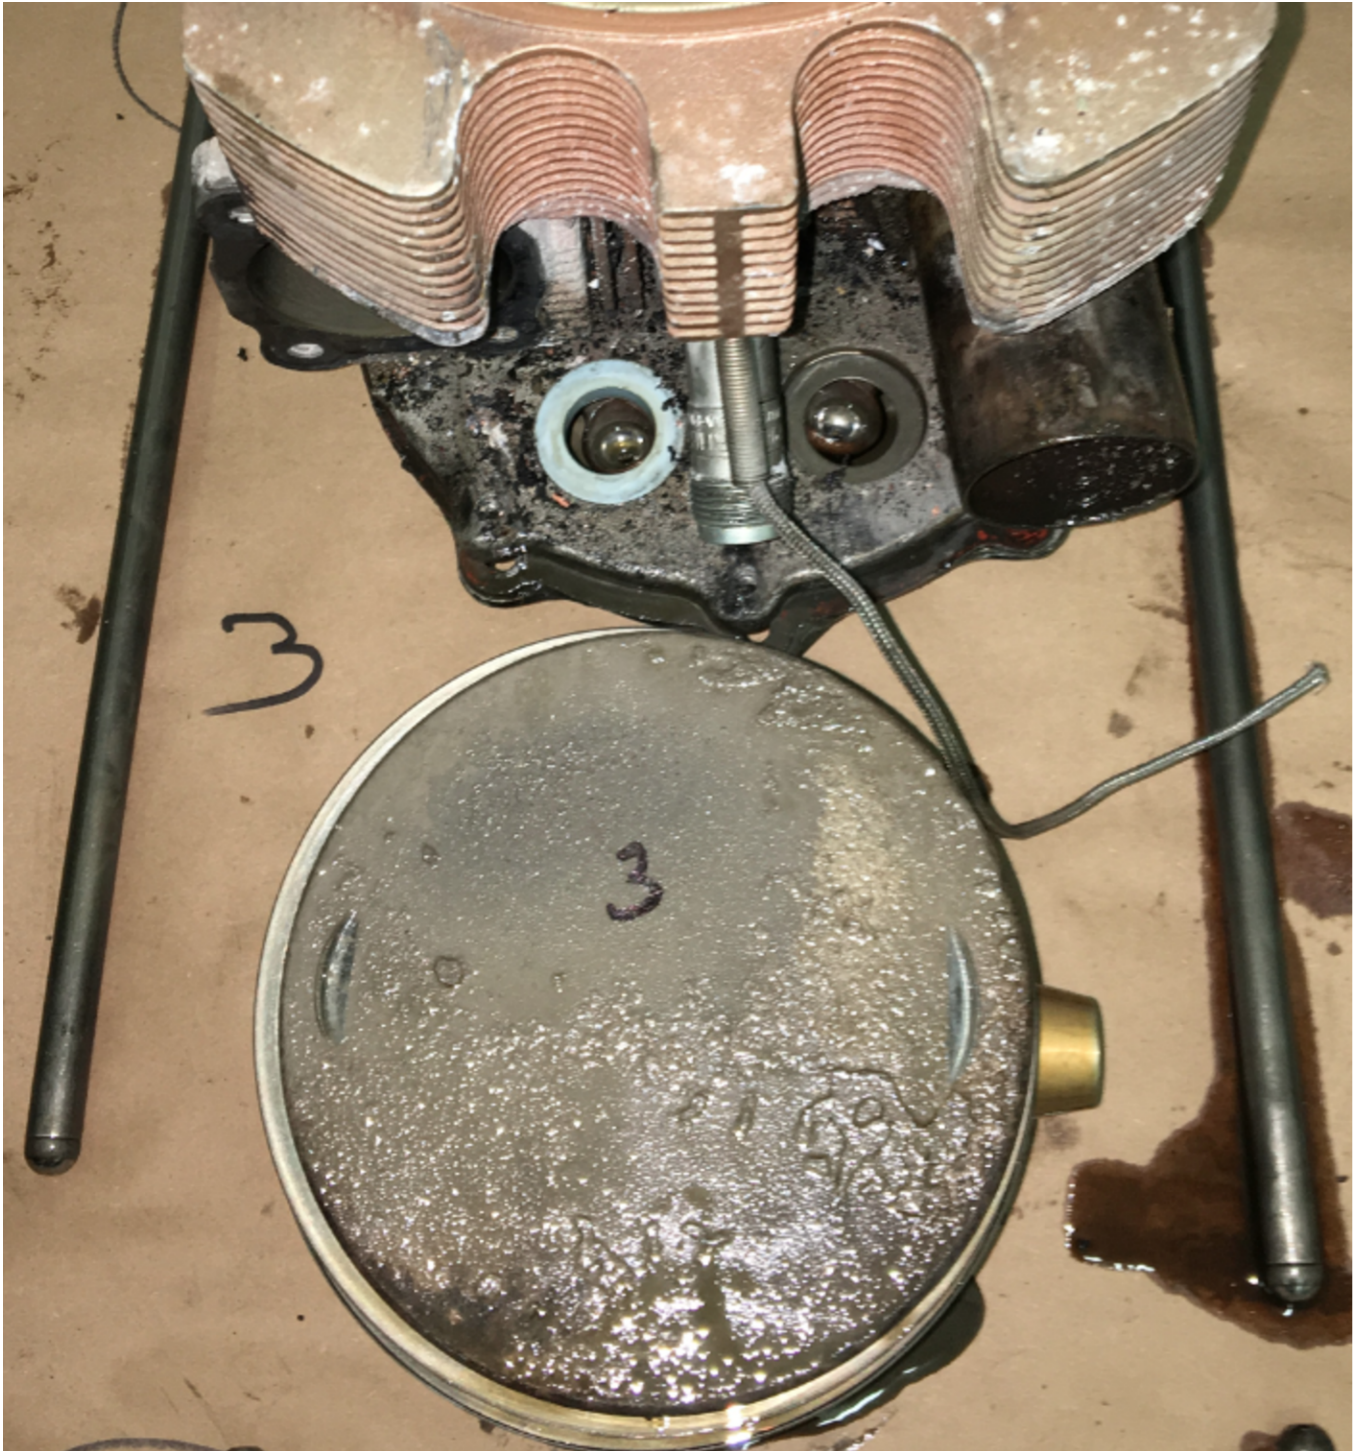
The cylinders all remained attached to their respective locations on the crankcase and revealed no external anomalies; however, further examination revealed valve impact marks (scallops) on each of the six pistons, as shown in Figure 2.

Figure 2. Piston No. 3 "scallop" impact marks from the valves at the 9:00 and 3:00 o'clock position. All 6 pistons exhibited similar signatures.
