Aviation Investigation Final Report

Location:	Peach Springs, Arizona	Accident Number:	WPR18MA087
Date & Time:	February 10, 2018, 17:19 Local	Registration:	N155GC
Aircraft:	Eurocopter EC130	Aircraft Damage:	Destroyed
Defining Event:	Loss of control in flight	Injuries:	5 Fatal, 2 Serious
Flight Conducted Under:	Part 135: Air taxi & commuter - Non-scheduled - Sightseeing

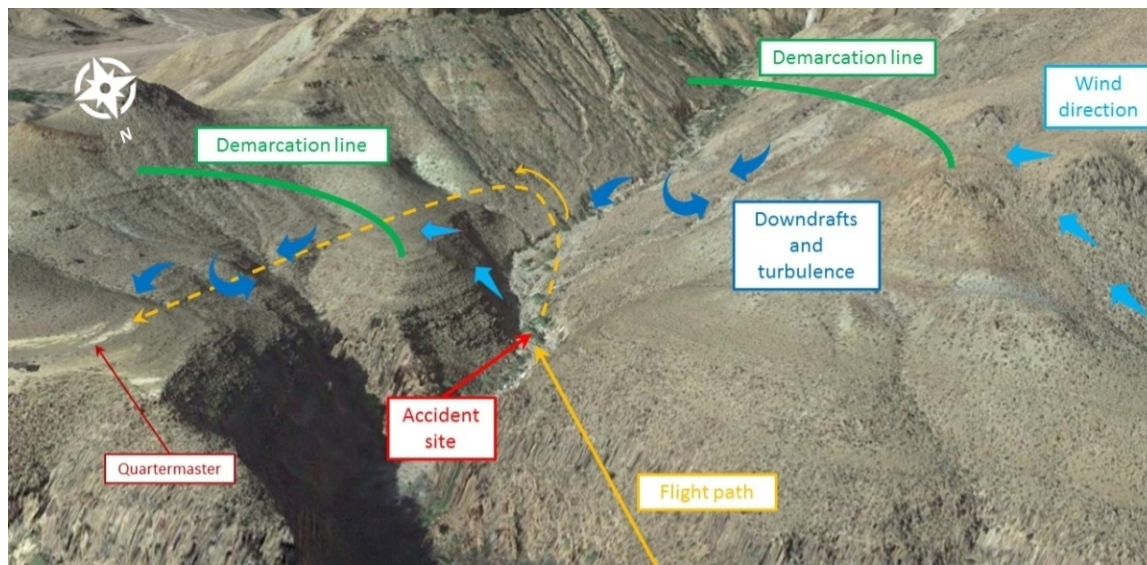
Figure 8. Conceptual display of demarcation lines at accident site

The landing site was located on a plateau and provided limited approach options due to its local topography. At the time of the accident, potential demarcation lines (boundaries of updrafts and downdrafts) would have been on the pinnacles of ridges located along the approach to the Quartermaster west pads. Figure 8 shows a conceptual illustration of potential demarcation lines and wind directions based on the terrain and wind environment present around the accident site at the accident time, and suggests areas where downdrafts, updrafts and turbulence could have impacted the accident flight's approach to the landing site.

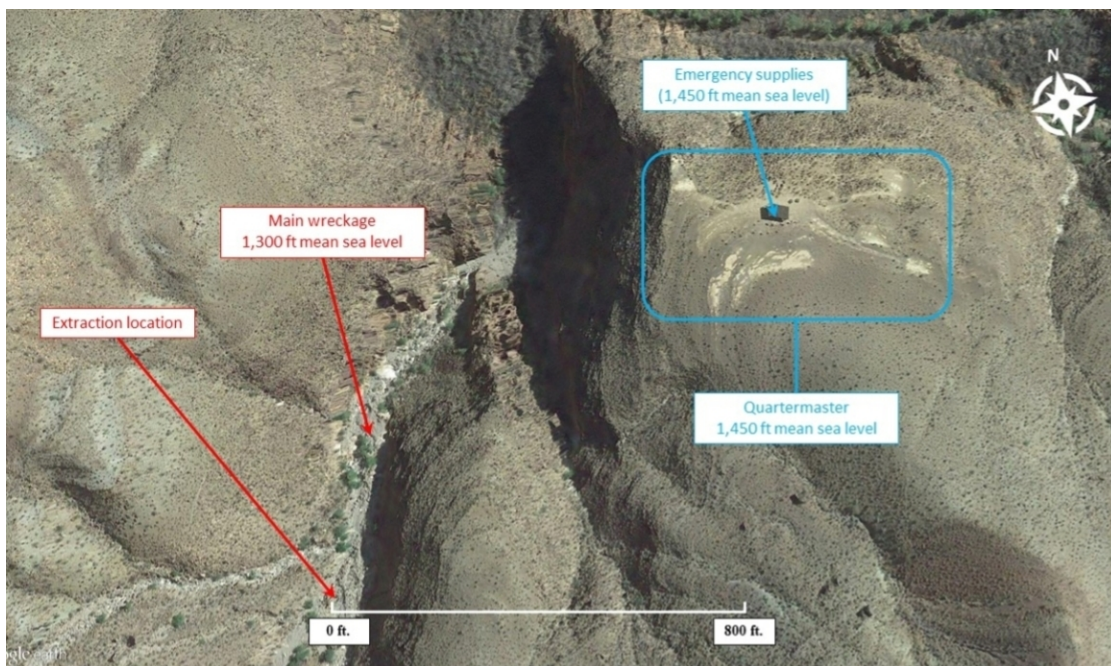
Figure 5. Quartermaster landing zone, accident site, and extraction location

Numerous individuals, including pilots and passengers from other helicopters, were at Quartermaster at the time of the accident. Several Papillon pilots and members of the Royal Australian Air Force (RAAF) retrieved first aid kits from other helicopters and responded to the accident site, arriving about 20 minutes after the accident. They observed the burning helicopter and the pilot and three seriously injured passengers who were outside the helicopter. (See figure 5.)

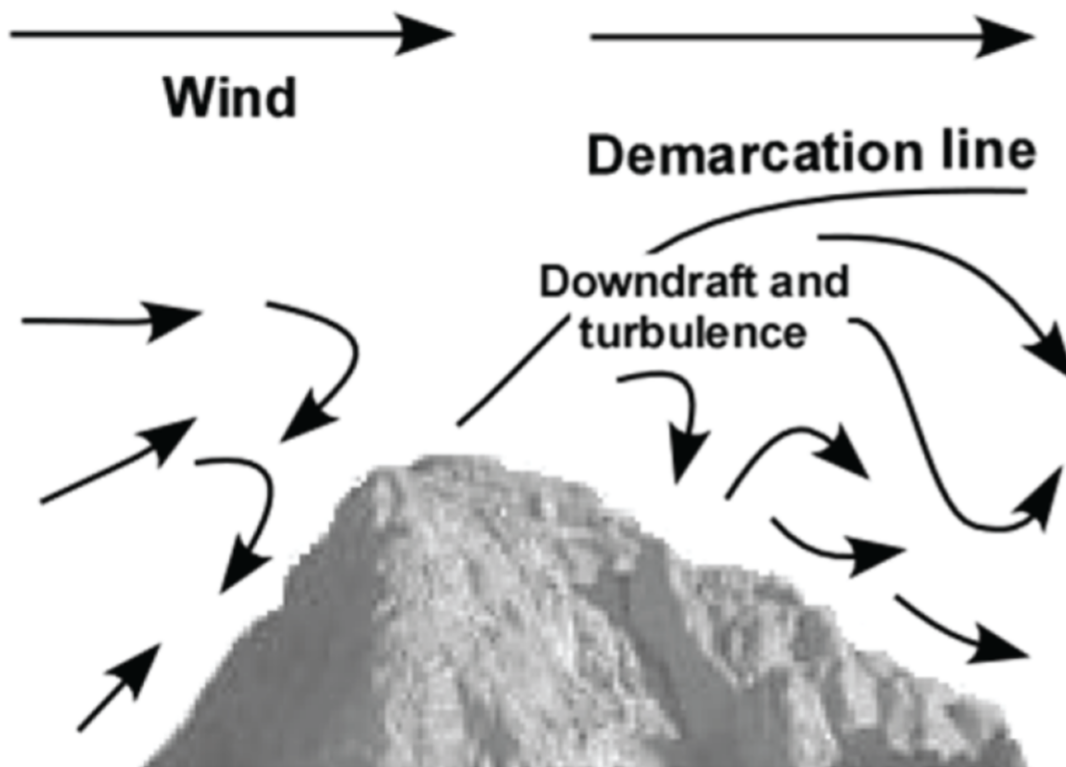
Figure 7: Excerpt showing demarcation line in strong wind from United States Army Helicopter Manual

The demarcation line is the point separating upflow air from downflow air. It forms at the mountain’s highest point and extends diagonally upward. The velocity of the wind and steepness of the uplift slope determines the position of the demarcation line. Generally, the higher the wind speed and steeper the terrain, the steeper the demarcation line...As wind increases above 20 kts, the demarcation line moves forward to the crest’s leading edge. It then matches the slope’s steepness. The severity of updrafts, downdrafts, and turbulence also increase. Under these conditions, the best landing spot is close to the forward edge (windward side) of the terrain feature. (See figure 7.)
