# Aviation Investigation Final Report

<b>Location:</b>	Peach Springs, Arizona	<b>Accident Number:</b>	WPR18MA087
<b>Date &amp; Time:</b>	February 10, 2018, 17:19 Local	<b>Registration:</b>	N155GC
<b>Aircraft:</b>	Eurocopter EC130	<b>Aircraft Damage:</b>	Destroyed
<b>Defining Event:</b>	Loss of control in flight	<b>Injuries:</b>	5 Fatal, 2 Serious
<b>Flight Conducted Under:</b>	Part 135: Air taxi & commuter - Non-scheduled - Sightseeing

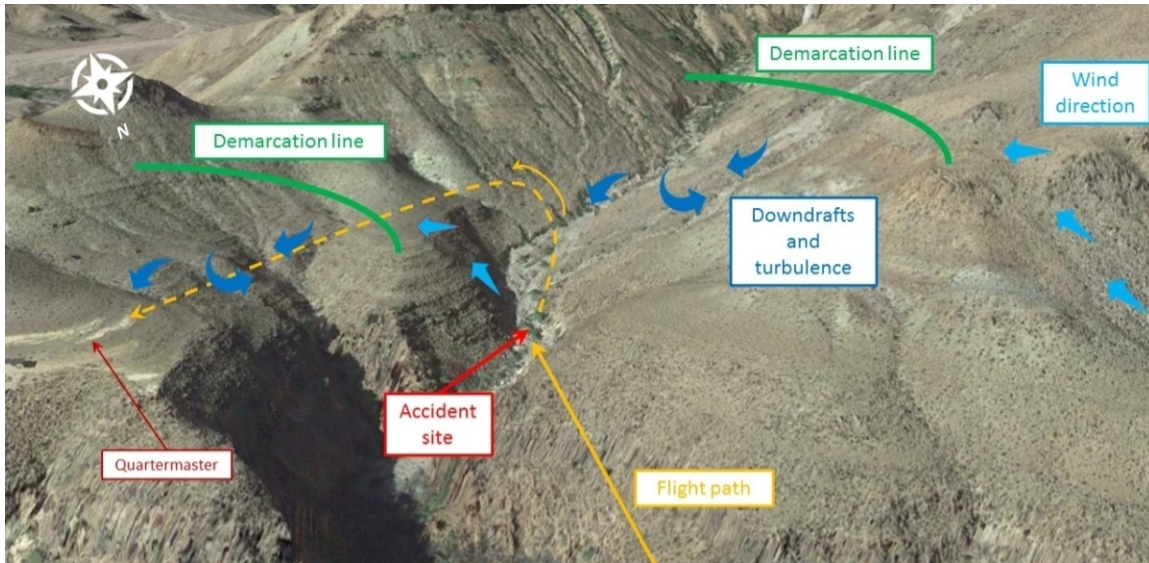
The landing site was located on a plateau and provided limited approach options due to its local topography. At the time of the accident, potential demarcation lines (boundaries of updrafts and downdrafts) would have been on the pinnacles of ridges located along the approach to the Quartermaster west pads. Figure 8 shows a conceptual illustration of potential demarcation lines and wind directions based on the terrain and wind environment present around the accident site at the accident time, and suggests areas where downdrafts, updrafts and turbulence could have impacted the accident flight's approach to the landing site.

Figure 8. Conceptual display of demarcation lines at accident site

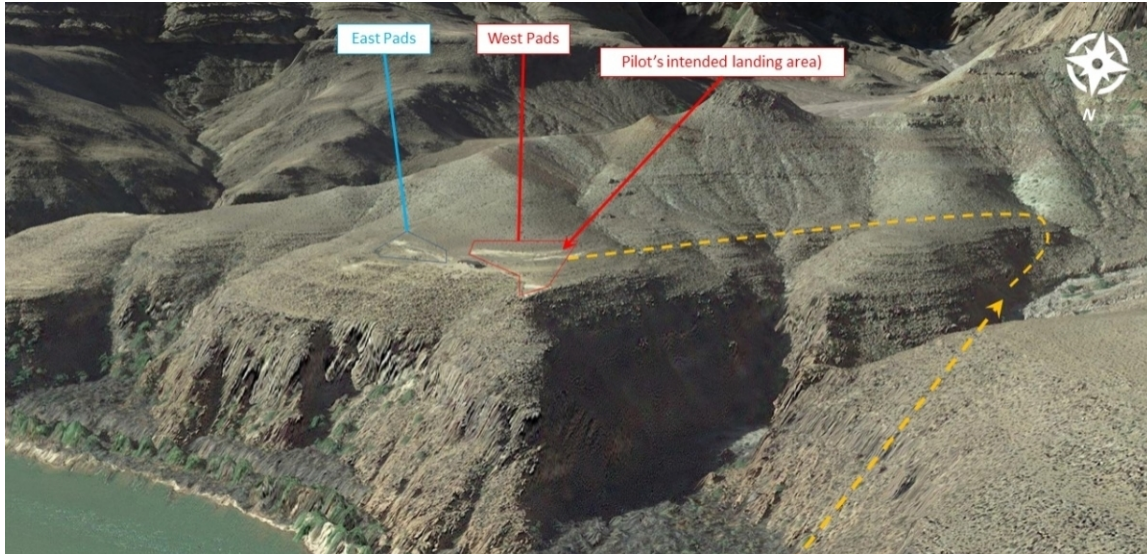
The pilot stated that he normally remained on the north side of the Colorado River, crossing the river between 200 and 300 ft above ground level (agl) while approaching Quartermaster for landing. After crossing the river, he entered a left turning descent toward the landing area. (See figure 1.) He stated

that, as he made the left turn, the helicopter encountered what he described as a “violent gust of wind” and began to spin, and as a result he was unable to maintain directional control.

Figure 1. Graphical representation of typical approach to west pads

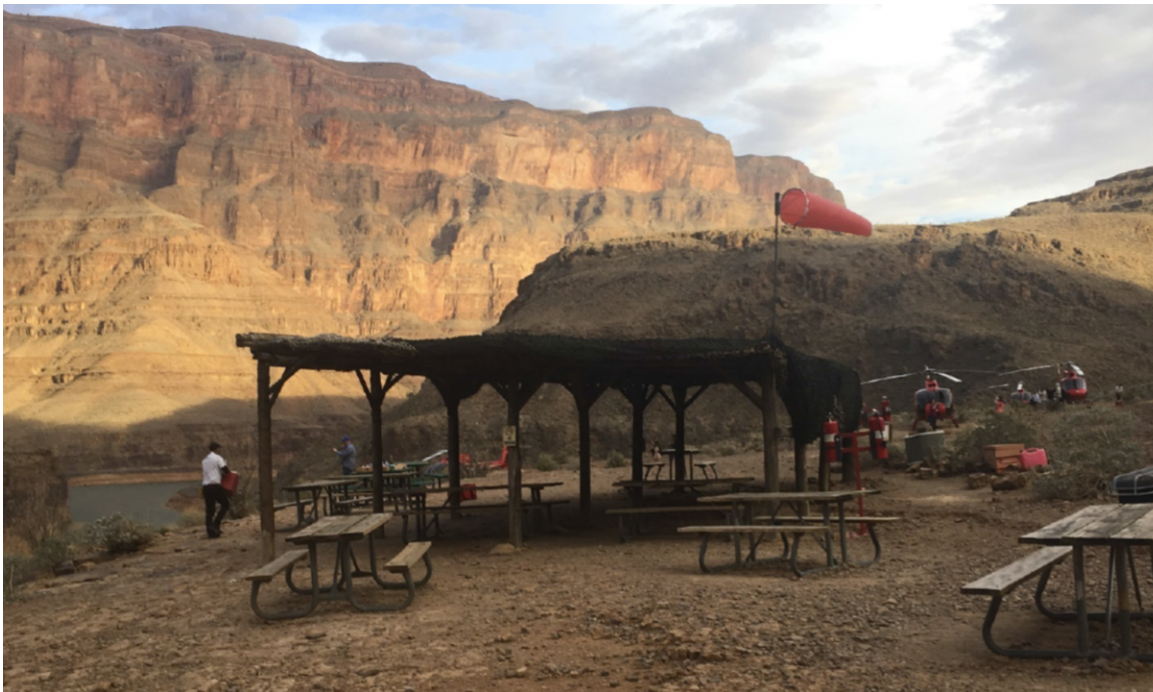
Quartermaster was equipped with a windsock that was located near the landing pads. A photo of the windsock taken about 1713 showed the windsock in its fully extended position, consistent with a wind velocity of 15 kts or greater. (See figure 2.)

*Figure 2. Photograph taken at 1713 MST of windsock at Quartermaster*

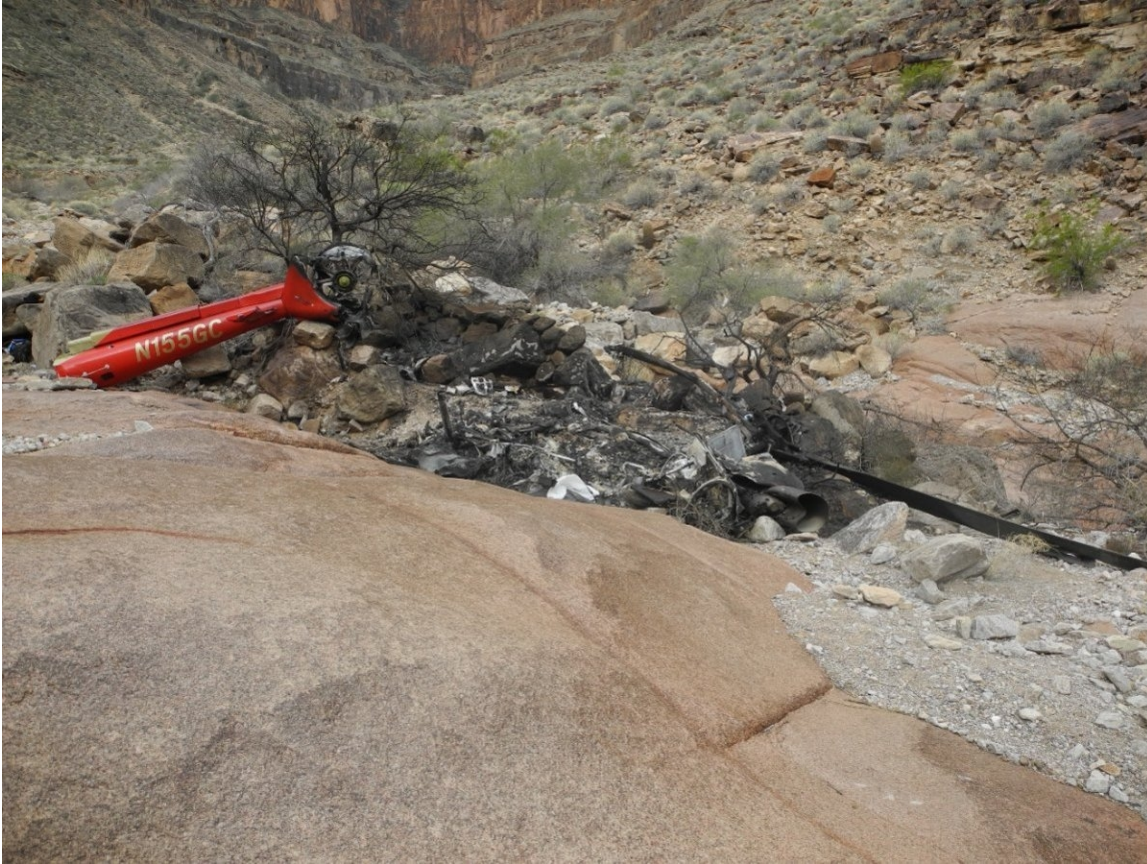
The helicopter came to rest upright in rocky terrain about 300 ft below the landing site on a heading of 222° magnetic. Most of the wreckage was consumed by the postcrash fire except for the tail boom and fenestron, which had separated from but were collocated with the fuselage. (See figure 3.) The engine, still attached to the engine deck, was found in the main wreckage and sustained fire damage. All three main rotor blades remained attached to the main rotor hub and exhibited damage consistent with high rotational energy. The tail stinger, fenestron hub cover, a toe from a skid step, and small pieces of transparent windshield were found on a canyon slope east of the main wreckage.

Figure 3. Photograph of accident site

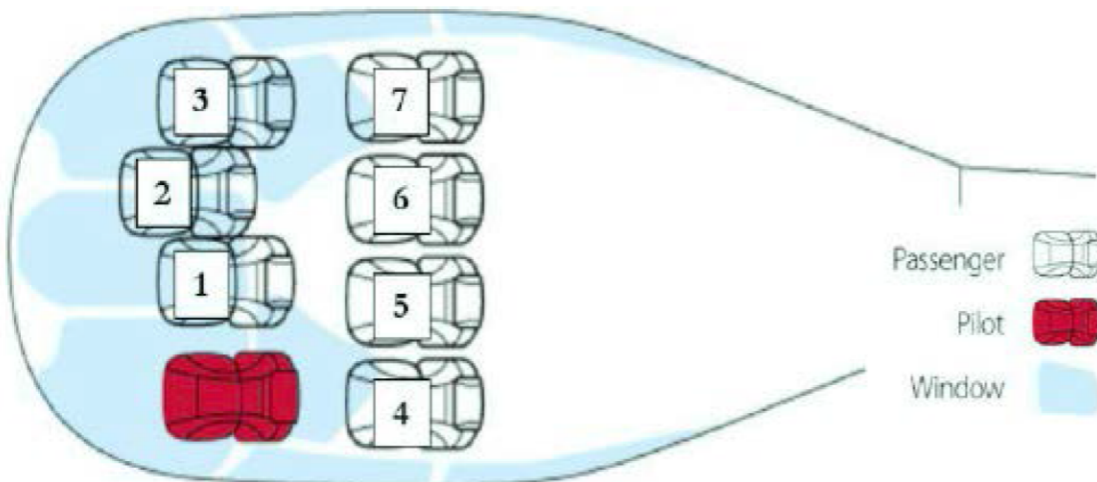
Figure 4: Accident Helicopter Seat Configuration

Passengers in seat Nos. 2, 6, and 7 did not have either the ability or opportunity to evacuate and died due to burns and smoke inhalation injuries; no blunt force traumatic injuries were noted by the medical examiner.

The pilot and passengers in seat Nos. 3, 4, and 5 sustained serious thermal injuries. Passengers in seat Nos. 3 and 4 succumbed to their burn injuries several days after the accident. In addition to their thermal injuries, the passenger in seat No. 5 sustained a spinal fracture. The pilot sustained an open left leg fracture.

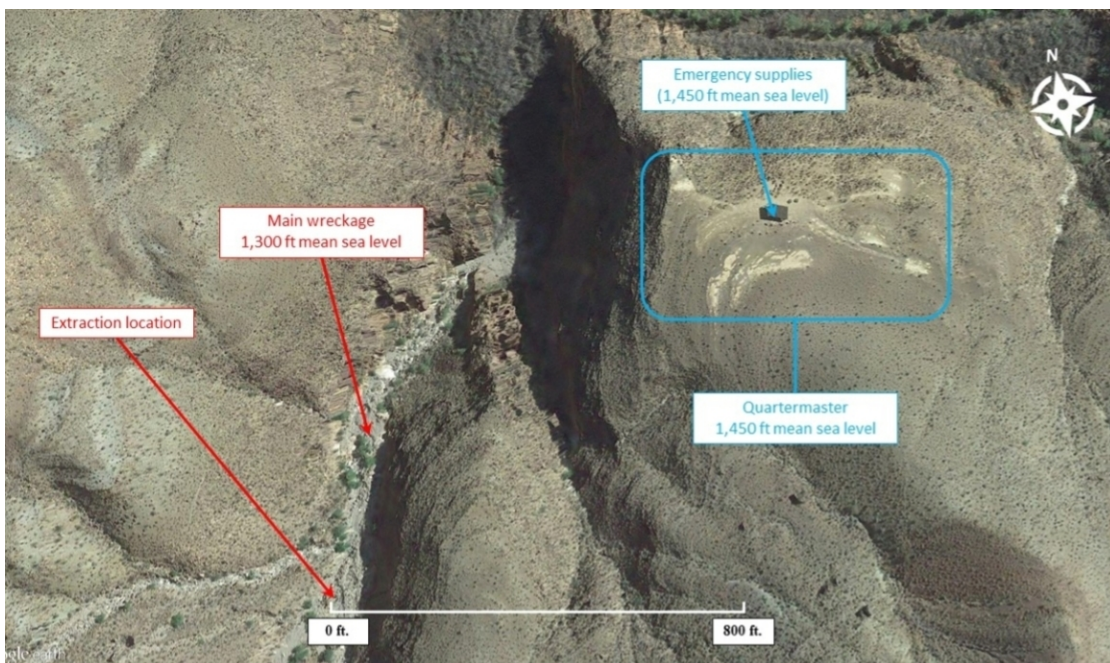
Numerous individuals, including pilots and passengers from other helicopters, were at Quartermaster at the time of the accident. Several Papillon pilots and members of the Royal Australian Air Force (RAAF) retrieved first aid kits from other helicopters and responded to the accident site, arriving about 20 minutes after the accident. They observed the burning helicopter and the pilot and three seriously injured passengers who were outside the helicopter. (See figure 5.)

Figure 5. Quartermaster landing zone, accident site, and extraction location

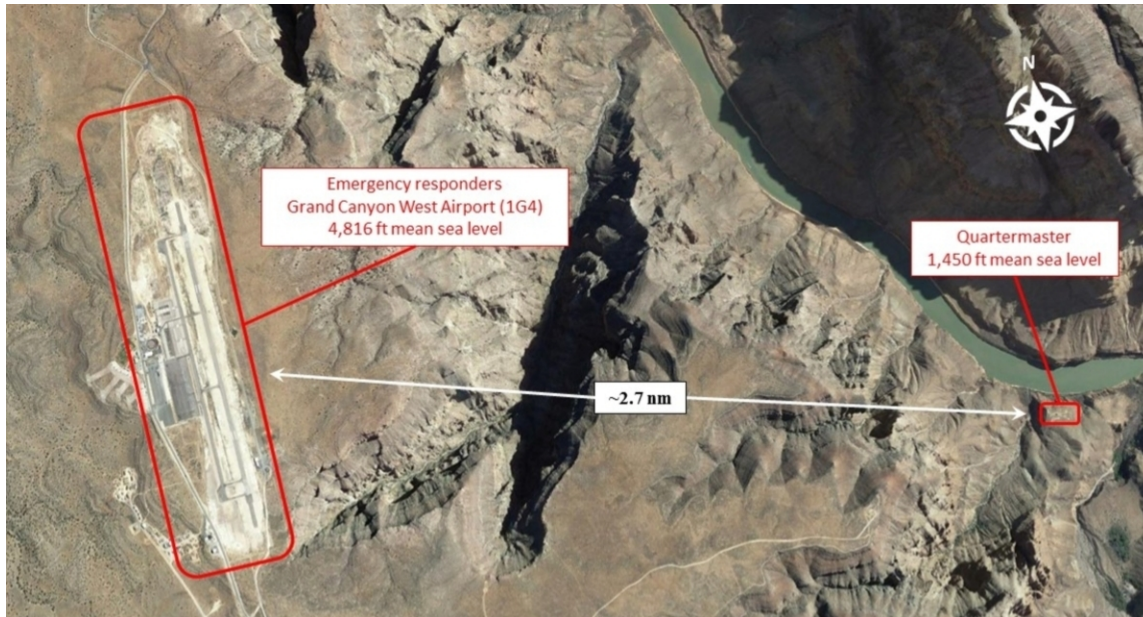
The location of the accident site posed significant challenges and extended the response time for emergency personnel, who had to be flown in by helicopter. (See figure 6.) These first responders reached the accident site about 45 minutes after the accident.

Figure 6. The location and terrain elevation difference between first responders at Grand Canyon West Airport and Quartermaster

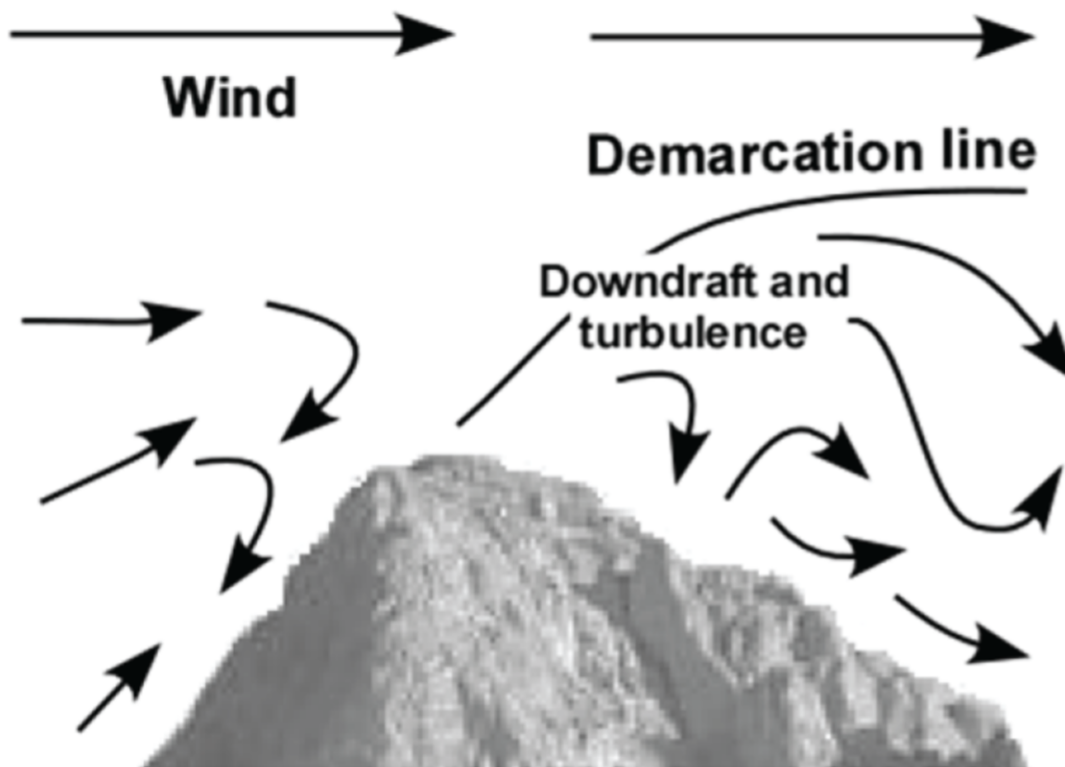
*The demarcation line is the point separating upflow air from downflow air. It forms at the mountain’s highest point and extends diagonally upward. The velocity of the wind and steepness of the uplift slope determines the position of the demarcation line. Generally, the higher the wind speed and steeper the terrain, the steeper the demarcation line...As wind increases above 20 kts, the demarcation line moves forward to the crest’s leading edge. It then matches the slope’s steepness. The severity of updrafts, downdrafts, and turbulence also increase. Under these conditions, the best landing spot is close to the forward edge (windward side) of the terrain feature. (See figure 7.)*

Figure 7: Excerpt showing demarcation line in strong wind from United States Army Helicopter Manual
