Aviation Investigation Final Report

Location:	Ulysses, Kansas	Accident Number:	CEN18FA108
Date & Time:	February 22, 2018, 21:08 Local	Registration:	N678DD
Aircraft:	Beech 58	Aircraft Damage:	Destroyed
Defining Event:	Loss of control in flight	Injuries:	2 Fatal
Flight Conducted Under:	Part 91: General aviation - Personal

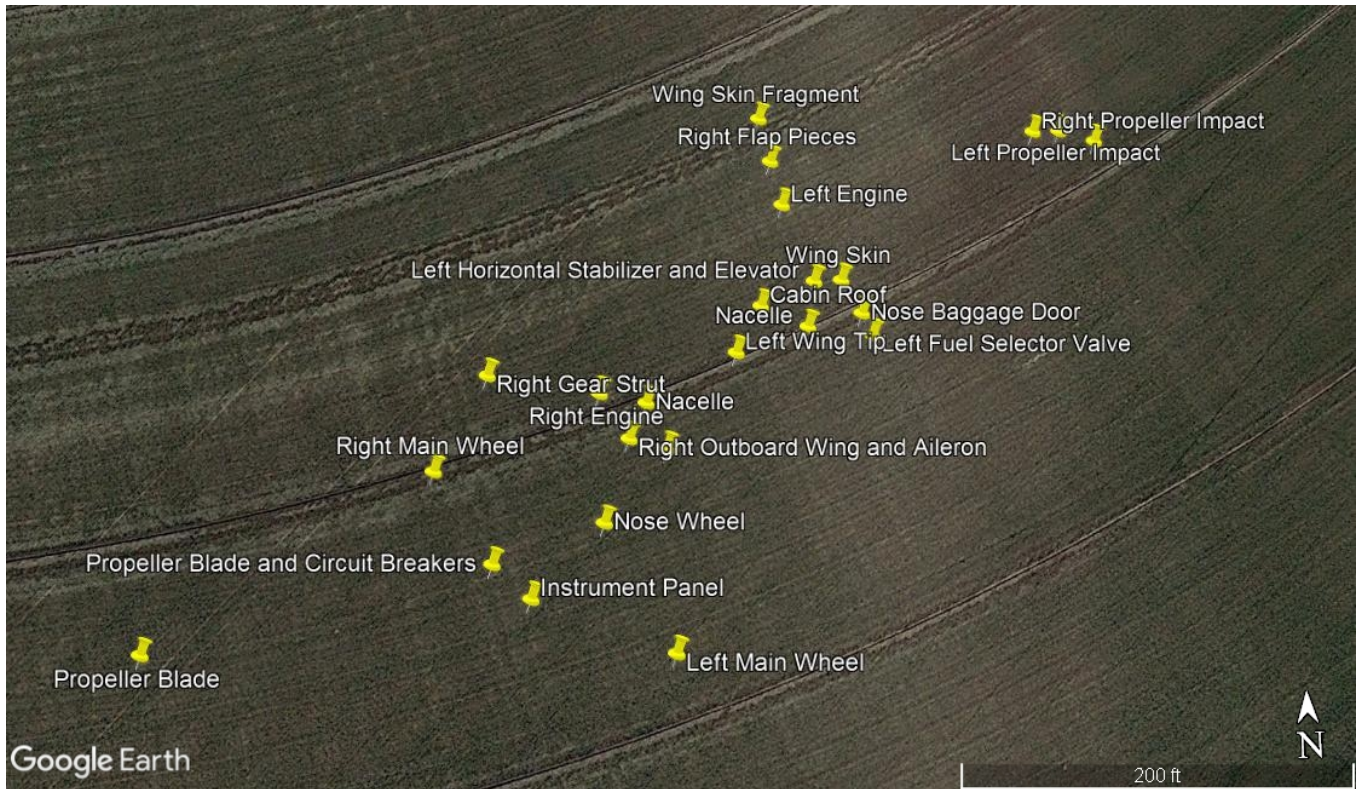
Figure 1: Wreckage Diagram

The airplane impacted the ground in a left-wing-low, nose-down attitude and was severely fragmented. A postimpact fire consumed several portions of the airframe. The main wreckage came to rest on a heading of 230° at an elevation of 3,060 ft mean sea level; the engines were separated from the airframe. The wreckage path was about 570 ft long and was oriented on a heading of about 235°.
