Aviation Investigation Final Report

Location:	Daytona Beach, Florida	Accident Number:	ERA18FA120
Date & Time:	April 4, 2018, 09:53 Local	Registration:	N106ER
Aircraft:	Piper PA28R	Aircraft Damage:	Destroyed
Defining Event:	Aircraft structural failure	Injuries:	2 Fatal
Flight Conducted Under:	Part 91: General aviation - Instructional

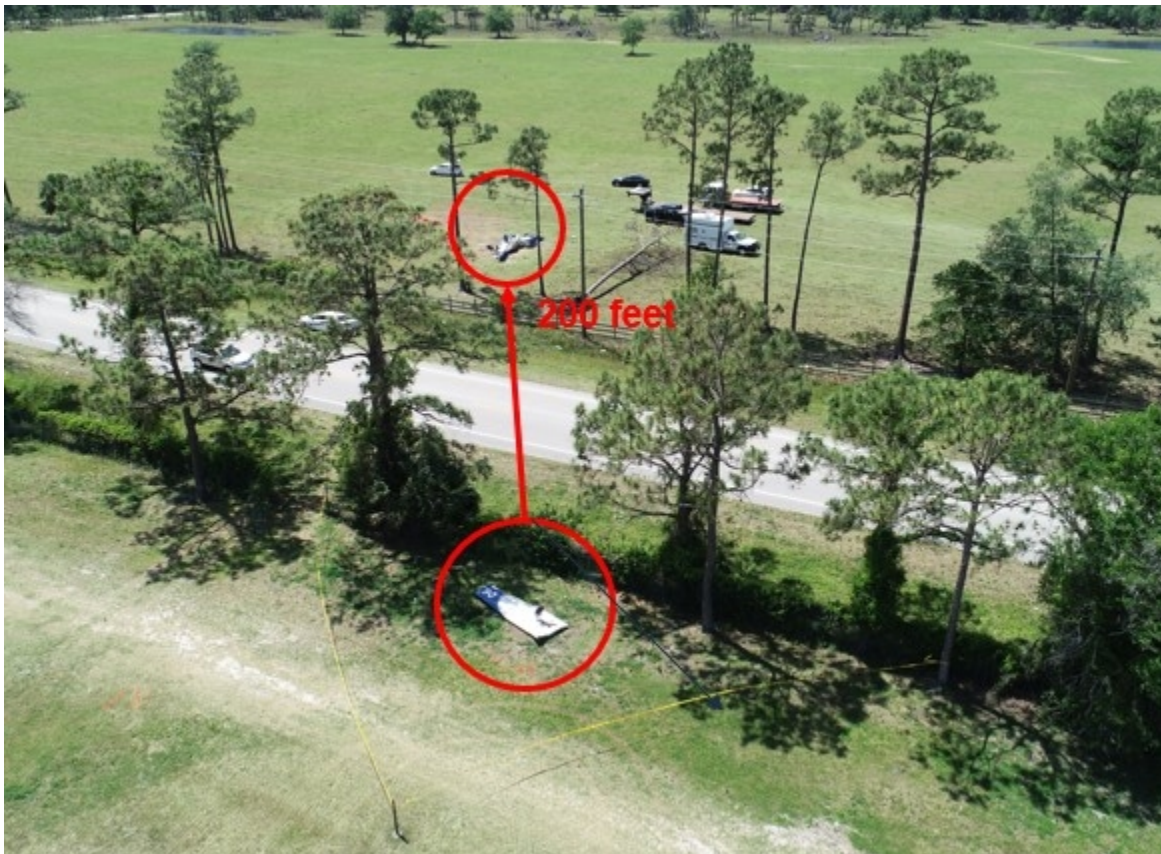
The debris path was about 570 ft long and began about 2 sm southwest of the departure end of runway 25L. The first items discovered along the debris path were a rubber wing root seal and fractured window plexiglass; the left wing was discovered 270 ft farther southwest adjacent to a road and tree line. About 200 ft from the wing on a magnetic heading of about 230°, the main wreckage rested in an adjacent field on the opposite side of the road (see figure 2).

Figure 2. Photograph (looking toward the southwest) showing the separated left wing in foreground and main wreckage in background

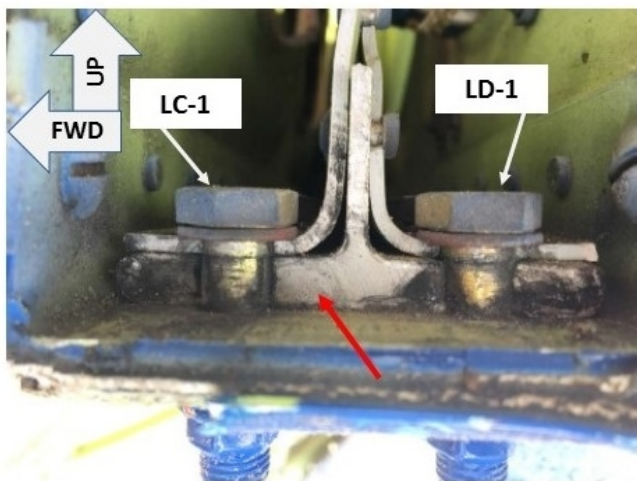
On-scene visual examination of the left-wing main spar found indications of a significant fatigue crack. Further analysis at the NTSB's Materials Laboratory found that more than 90% of the main spar lower cap and portions of the forward and aft spar web doublers exhibited fracture features consistent with metal fatigue (see figure 3). The remainder of the main spar lower cap, spar web doublers, and upper spar cap displayed fracture features consistent with overstress fracture. The fatigue features originated at or near the outboard forward wing main spar attachment bolt holes LC-1 and LD-1.

Figure 3. Left-wing main spar lower cap inboard side of the fracture (left frame) and outboard side of the fracture (right frame) with red arrows highlighting areas visually inspected on scene that showed fatigue regions
