# Aviation Investigation Final Report

<b>Location:</b>	Daytona Beach, Florida	<b>Accident Number:</b>	ERA18FA120
<b>Date &amp; Time:</b>	April 4, 2018, 09:53 Local	<b>Registration:</b>	N106ER
<b>Aircraft:</b>	Piper PA28R	<b>Aircraft Damage:</b>	Destroyed
<b>Defining Event:</b>	Aircraft structural failure	<b>Injuries:</b>	2 Fatal
<b>Flight Conducted Under:</b>	Part 91: General aviation - Instructional

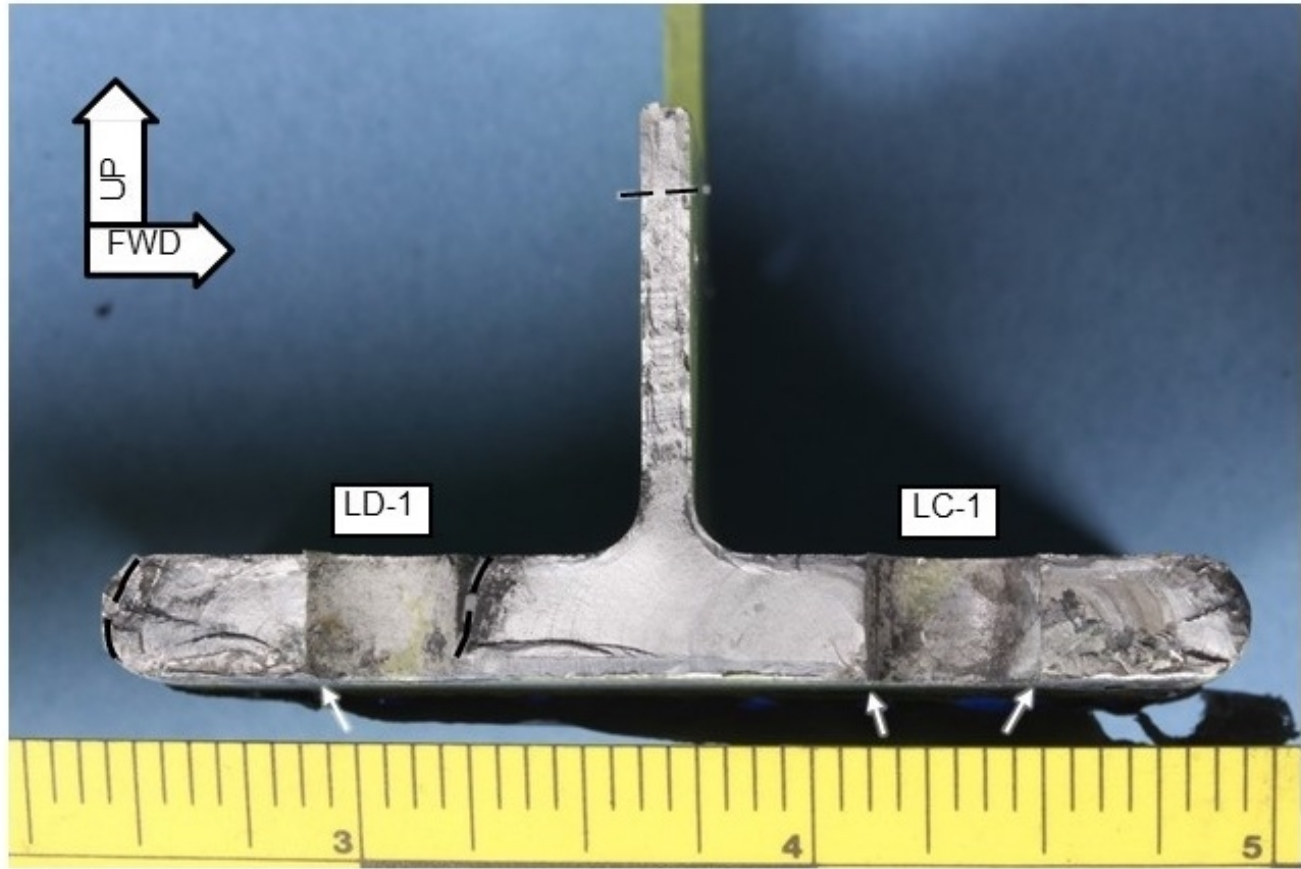
Metallurgical examination of the accident airplane's left-wing main spar lower cap found that it exhibited fracture features consistent with fatigue through more than 90% of the cross-section, reducing its residual strength capabilities almost completely. The examination identified three fatigue cracks in the left-wing main spar lower cap (see figure 1). One fatigue crack initiated near the lower forward corner of the outboard forward wing attachment bolt hole (designated as bolt hole LC-1) and propagated forward to the forward edge of the cap. A second fatigue crack initiated near the lower aft corner of bolt hole LC-1 and propagated aft toward the lower aft wing attachment bolt hole (designated as bolt hole LD-1) and up the cap web almost to the edges. A third fatigue crack initiated near the lower aft corner of bolt hole LD-1 and propagated aft almost to the aft edge of the cap. Fatigue cracks also originated in the forward and aft doublers from both sides of the bolt holes (see figure 2).

Figure 1. Close view of the fracture surfaces in the left-wing main spar lower cap. Unlabeled arrows indicate fatigue origin areas and dashed lines indicate approximate fatigue boundaries

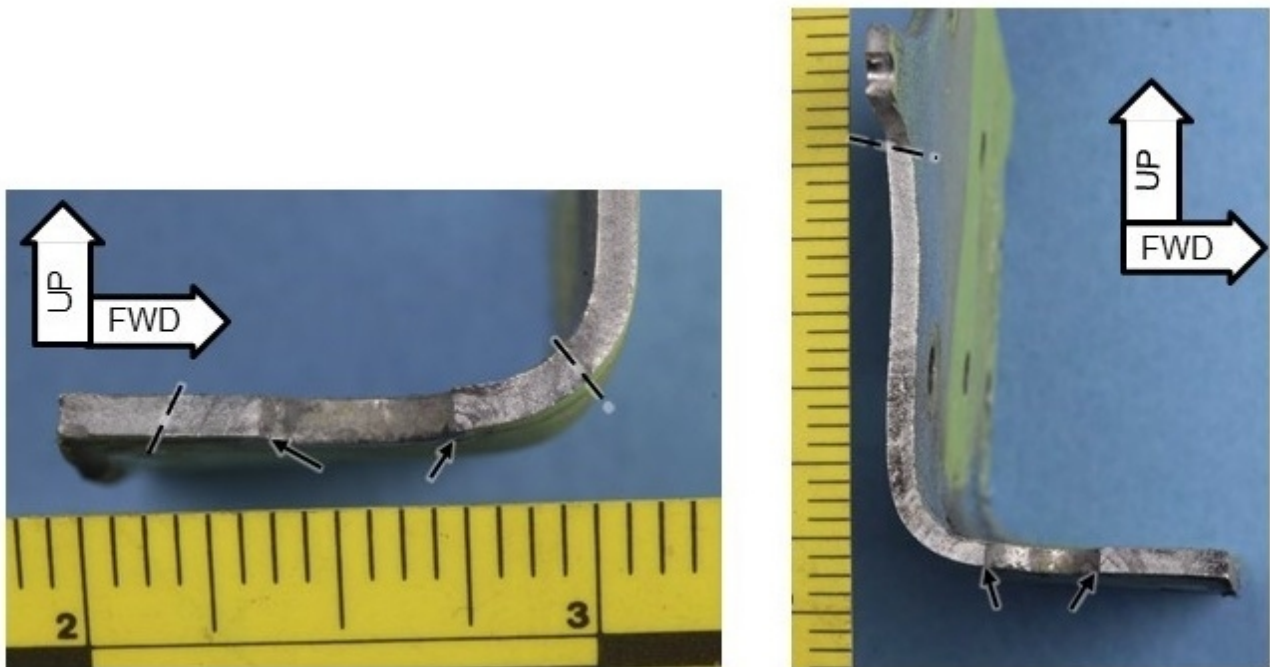
Figure 2. Close views of the fracture surfaces in the aft (left) and forward (right) doublers. Unlabeled arrows indicate fatigue origin areas and dashed lines indicate approximate fatigue boundaries

In the doublers, fatigue origins were noted on the lower sides of the doublers both forward and aft of the attachment holes. The fatigue region in the forward doubler was larger than in the aft doubler, extending to the forward edge of the doubler and upward about 1.25 inches from the aft side of the hole. In the aft doubler, the fatigue regions extended from each side of the hole to where they were about 0.88 inch apart.

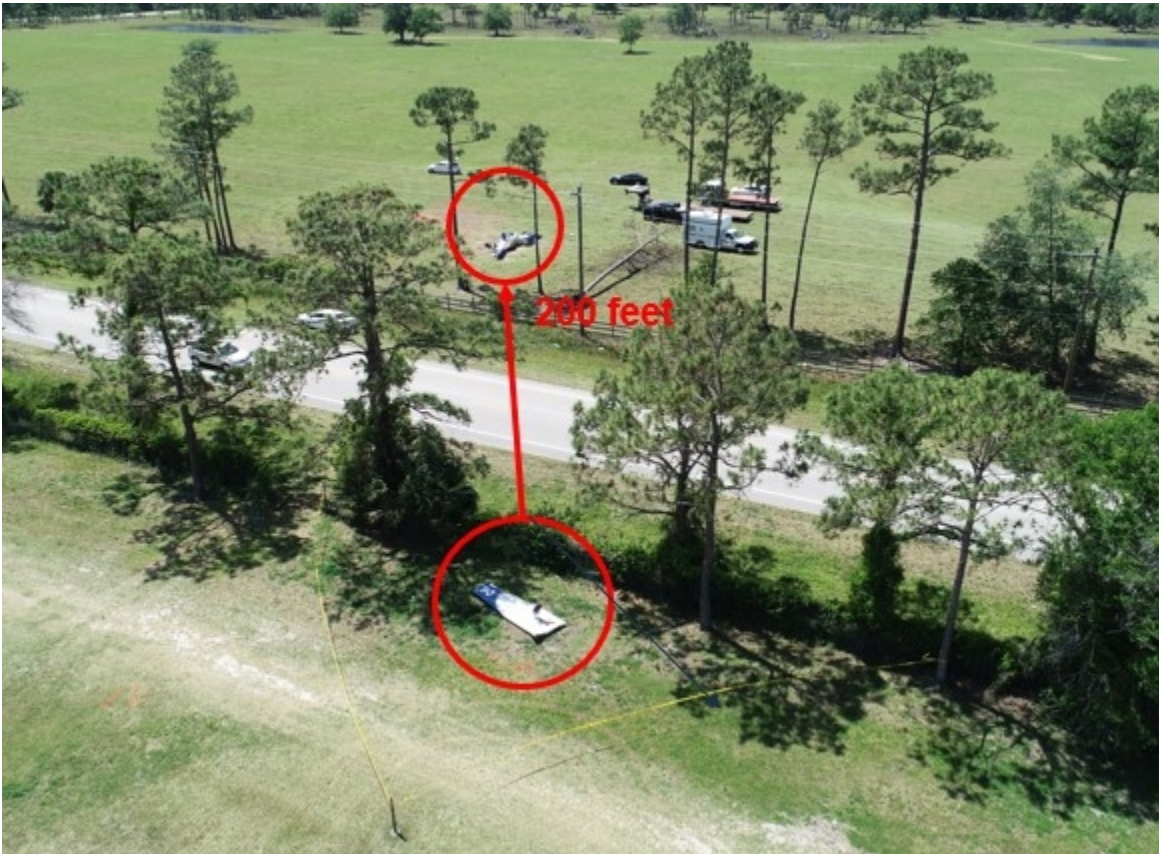
The debris path was about 570 ft long and began about 2 sm southwest of the departure end of runway 25L. The first items discovered along the debris path were a rubber wing root seal and fractured window plexiglass; the left wing was discovered 270 ft farther southwest adjacent to a road and tree line. About 200 ft from the wing on a magnetic heading of about 230°, the main wreckage rested in an adjacent field on the opposite side of the road (see figure 2).

Figure 2. Photograph (looking toward the southwest) showing the separated left wing in foreground and main wreckage in background

The left wing separated from the fuselage near the wing root and exhibited mid-span buckling of the surface skin. The left-wing flap and aileron remained connected and moved freely with little resistance. The left-wing fuel tank remained intact and contained about 15 gallons of fuel. The left main landing gear was in the down and locked position.

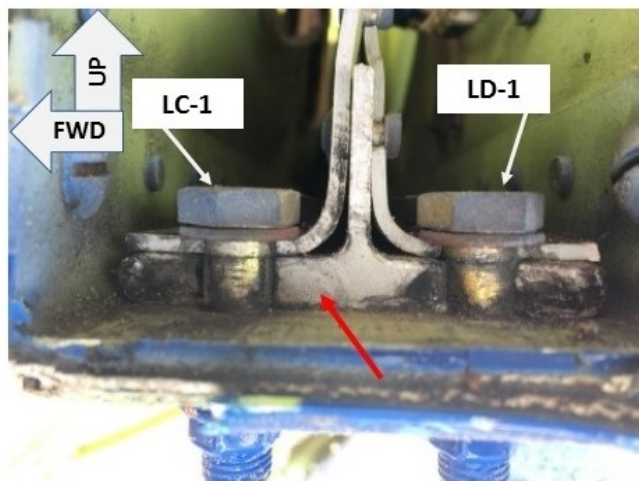
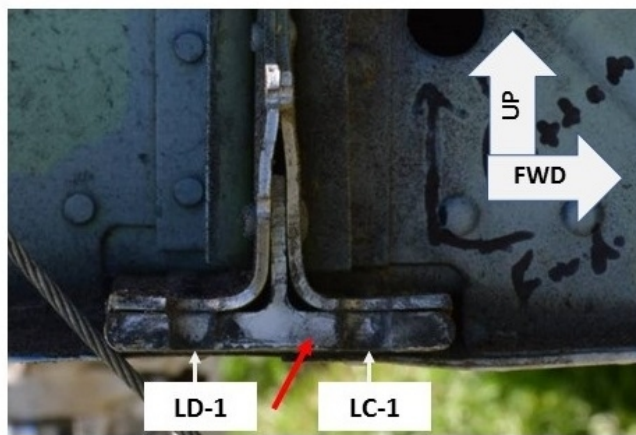
On-scene visual examination of the left-wing main spar found indications of a significant fatigue crack. Further analysis at the NTSB's Materials Laboratory found that more than 90% of the main spar lower cap and portions of the forward and aft spar web doublers exhibited fracture features consistent with metal fatigue (see figure 3). The remainder of the main spar lower cap, spar web doublers, and upper spar cap displayed fracture features consistent with overstress fracture. The fatigue features originated at or near the outboard forward wing main spar attachment bolt holes LC-1 and LD-1.

Figure 3. Left-wing main spar lower cap inboard side of the fracture (left frame) and outboard side of the fracture (right frame) with red arrows highlighting areas visually inspected on scene that showed fatigue regions

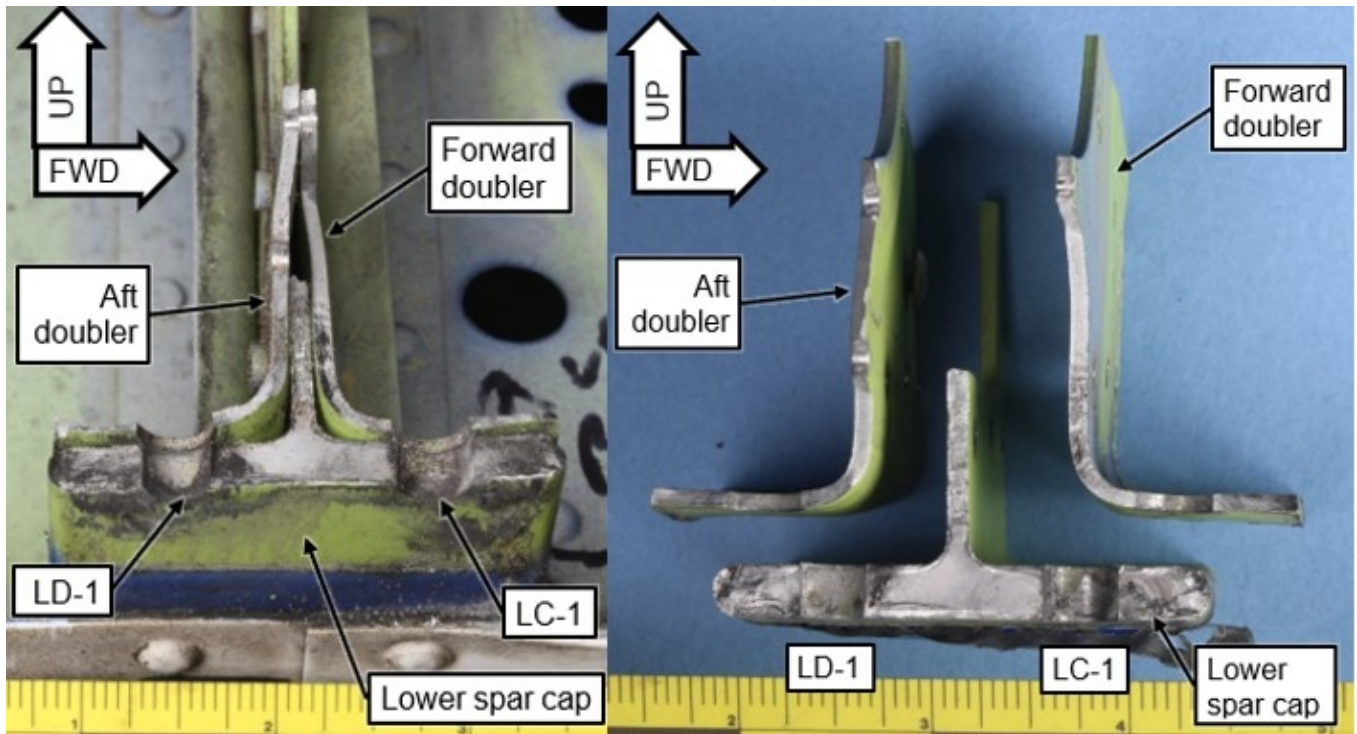
The left-wing main spar lower cap (shown in figure 4) had a fracture that intersected holes for attachment bolts LC-1 and LD-1. Portions of the fracture surface had relatively smooth features in a transverse plane, which is consistent with fatigue fracture. Crack arrest lines were visible on the fracture surfaces of the main spar lower cap and on the forward and aft doublers, also consistent with fatigue fracture. The upper spar cap displayed rough matte gray features consistent with ductile overstress fracture. Deformation associated with the fracture in the upper spar cap was observed, consistent with an upward bending load.

Figure 4. Photographs showing pieces of the accident left-wing main spar lower cap and doublers before (left) and after (right) sectioning and rivet removal to facilitate examination.

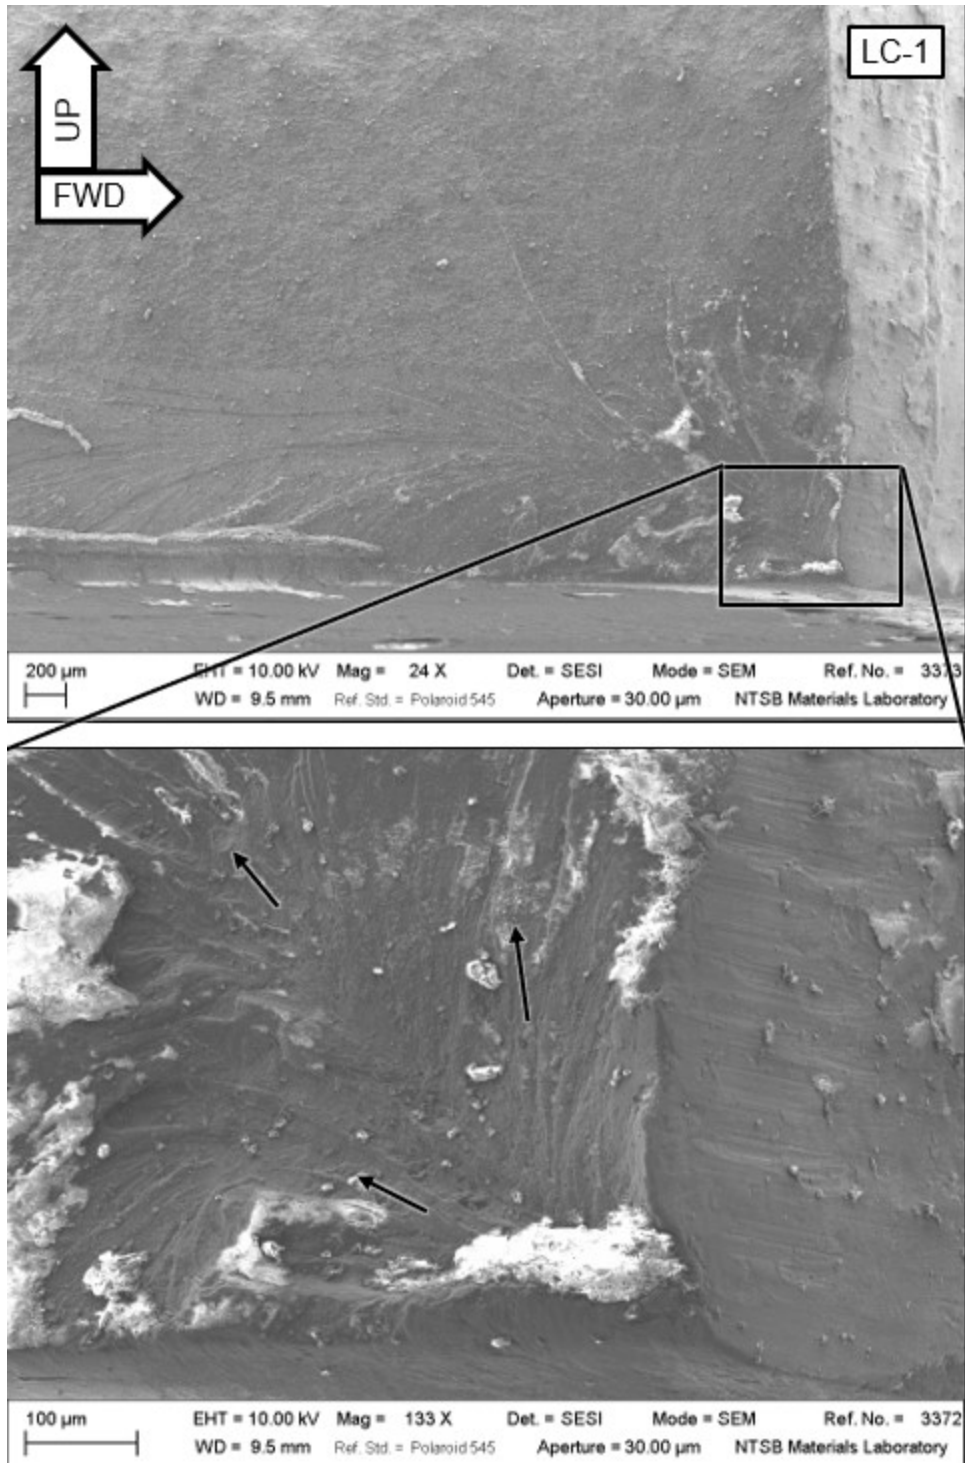
The left-wing main spar lower cap was examined using a scanning electron microscope (SEM). SEM images of the origin areas at the forward and aft sides of attachment bolt hole LC-1 are shown in figure 5. Arrows indicate local directions of fatigue crack propagation based on available fracture features in the images. Fracture features appeared to emanate from origins at the lower surface of the spar cap adjacent to attachment bolt hole LC-1.

Figure 5. SEM images of fracture features at the aft side of hole LC-1 with a view of the origin area shown at higher magnification (lower image). Unlabeled arrows indicate local directions of fatigue crack propagation

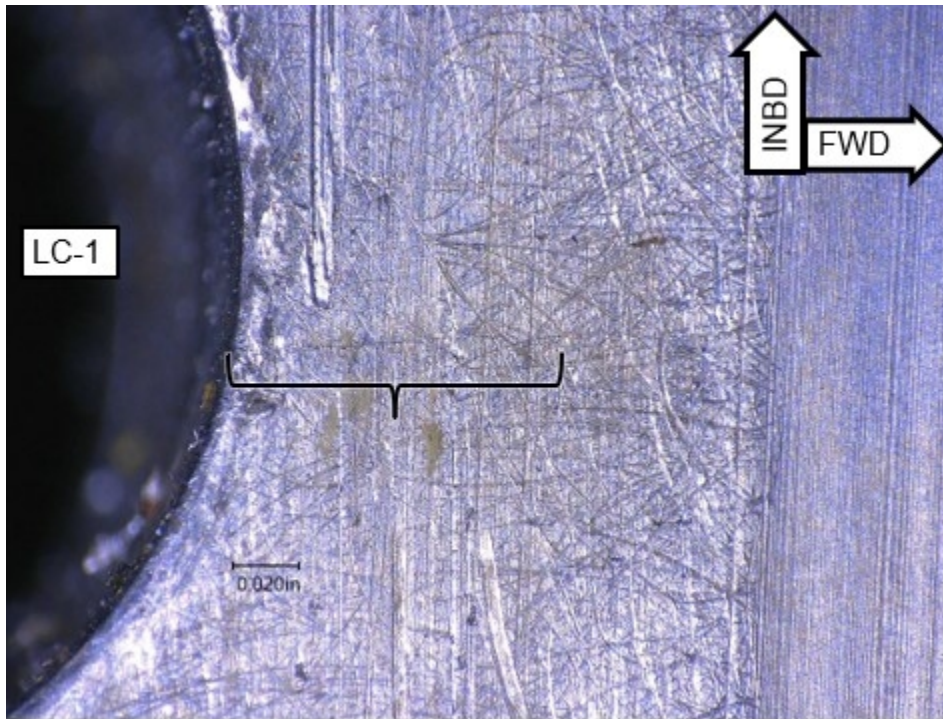
The NTSB structures group proposed that the wings be reinstalled on N104ER by the same personnel and inspectors to help Piper and FAA evaluate an HFEC inspection procedure developed by Piper that would use a bolt hole probe instead of the surface probe used in the previous examination. The inspection confirmed the crack indication in attachment bolt hole LC-1. The inboard portion of the left-wing main spar was cut from the wing of N104ER and sent to the NTSB Materials Laboratory for additional examination. As shown in figure 6, a crack feature was visible under optical magnification (the bracket in figure 6 indicates the location of a crack feature extending from the forward side of attachment bolt hole LC-1). No crack features were detected under optical magnification at the aft side of attachment bolt hole LC-1.

Figure 6. Magnified image showing a faintly visible crack feature extending from the forward side of attachment bolt hole LC-1

SEM examination of a sectioned piece of the fractured left-wing main spar from N104ER found the crack fracture surface had relatively smooth features with curving crack arrest lines, which are features consistent with fatigue. The fatigue region extended up to 0.126 inch forward from the hole surface and up to 0.115 inch upward from the lower surface. Where the fatigue region intersected the lower surface, the length from the hole surface to the fatigue boundary was 0.119 inch. A closer view of the fatigue origin area showed ratchet marks indicating multiple fatigue origins in the area located within the corner radius between the bore of attachment bolt hole LC-1 and main spar lower surface.
