Aviation Investigation Final Report

Location:	Anchorage, Alaska	Accident Number:	ANC18LA030
Date & Time:	March 25, 2018, 17:30 Local	Registration:	N4844E
Aircraft:	Champion 7GC	Aircraft Damage:	Substantial
Defining Event:	Loss of control on ground	Injuries:	2 None
Flight Conducted Under:	Part 91: General aviation - Personal

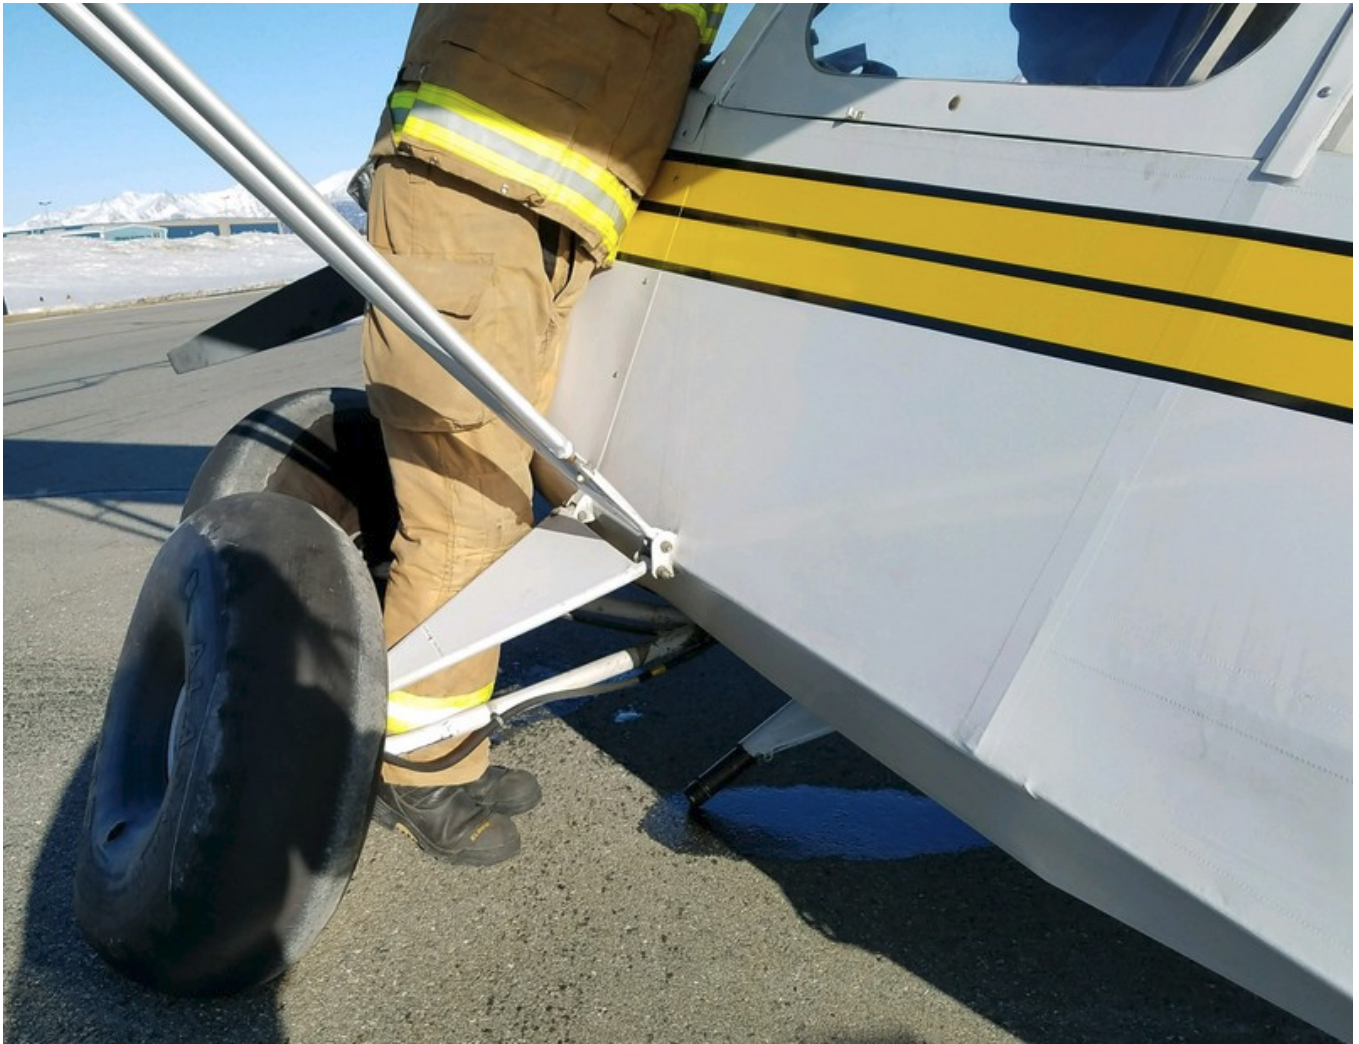
The pilot reported that the approach was stable. Upon touchdown, the airplane began to ground loop to the left, so she applied rudder and brake inputs as a corrective action, with no success. Subsequently, the right main landing gear separated, and the right wing impacted the runway; the airplane sustained substantial damage to the right wing and right aileron.

Figure 1 – View of the intact left main landing gear and the separated right main landing gear (courtesy of the pilot).

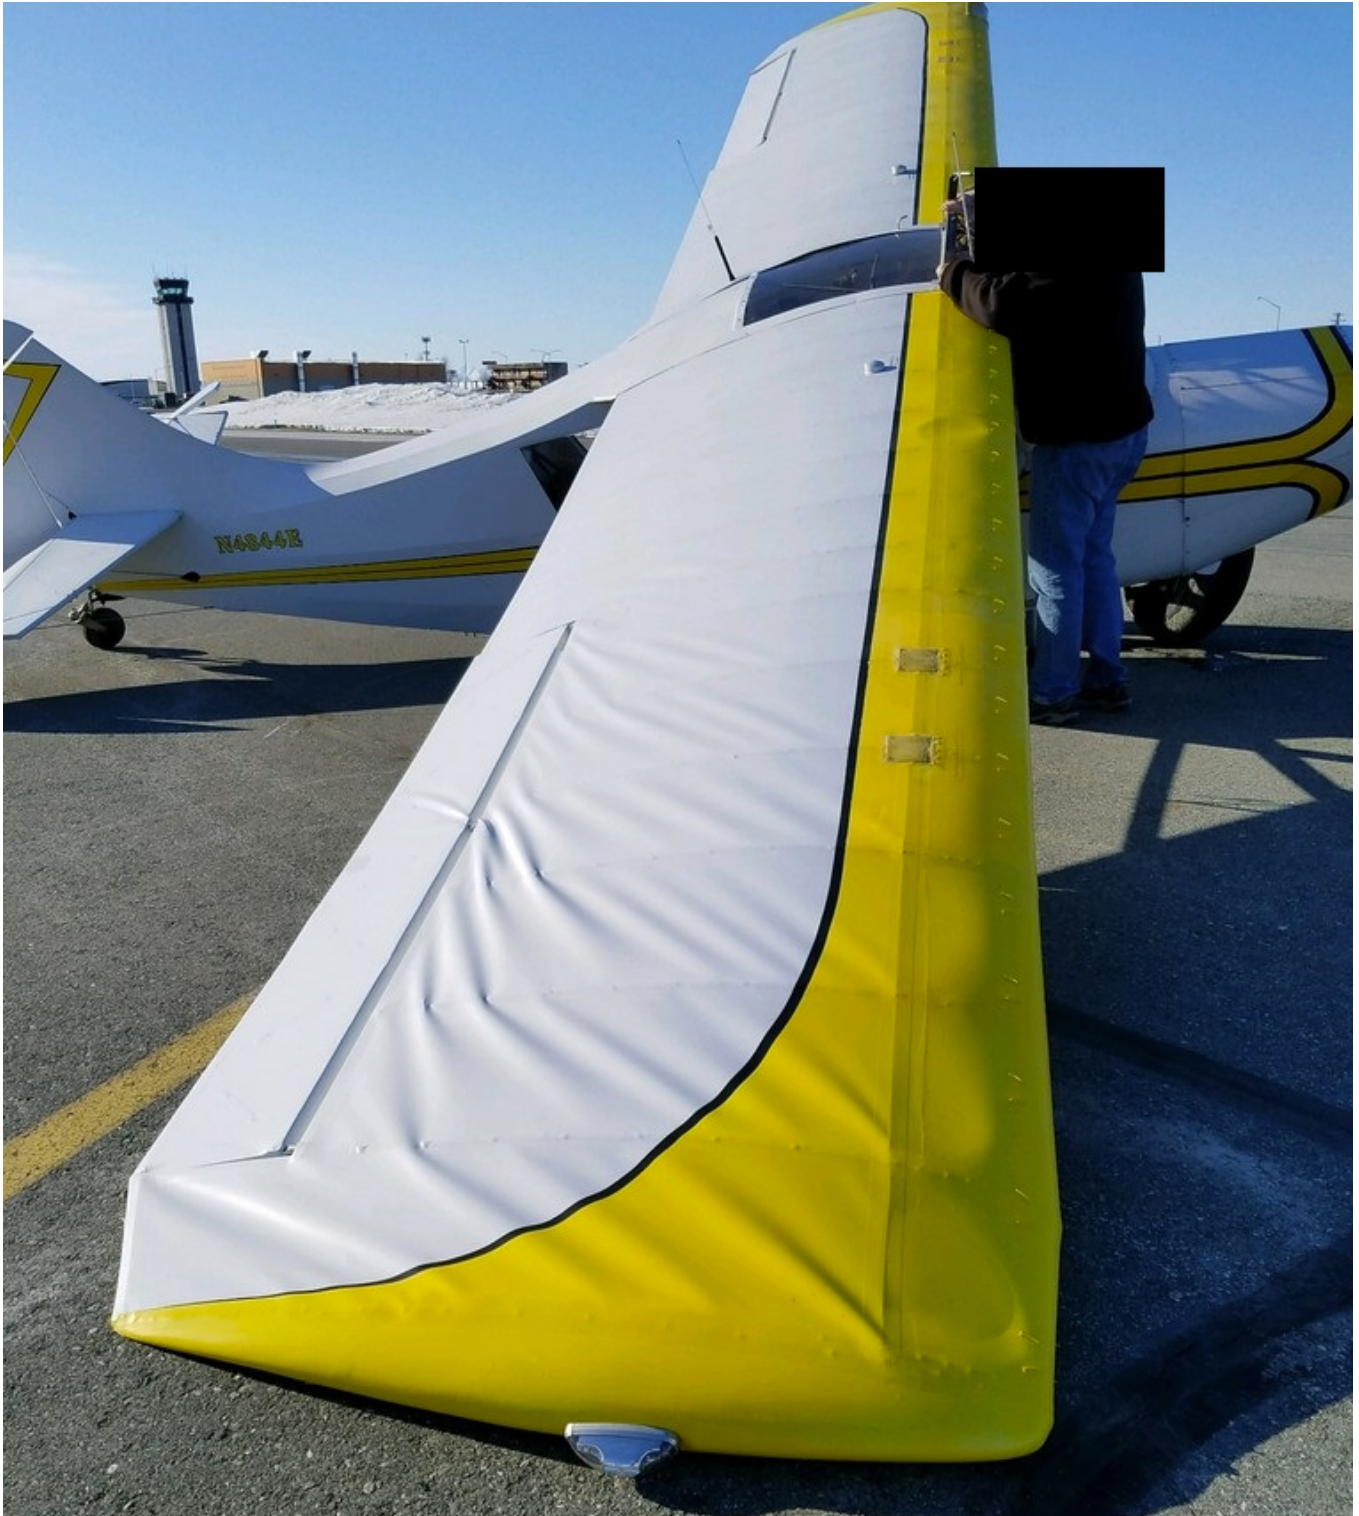
The airplane sustained substantial damage to the right wing and the right aileron as shown below in figure 2.

Figure 2 – View of the substantial damage to the right wing and the right aileron (courtesy of the pilot).

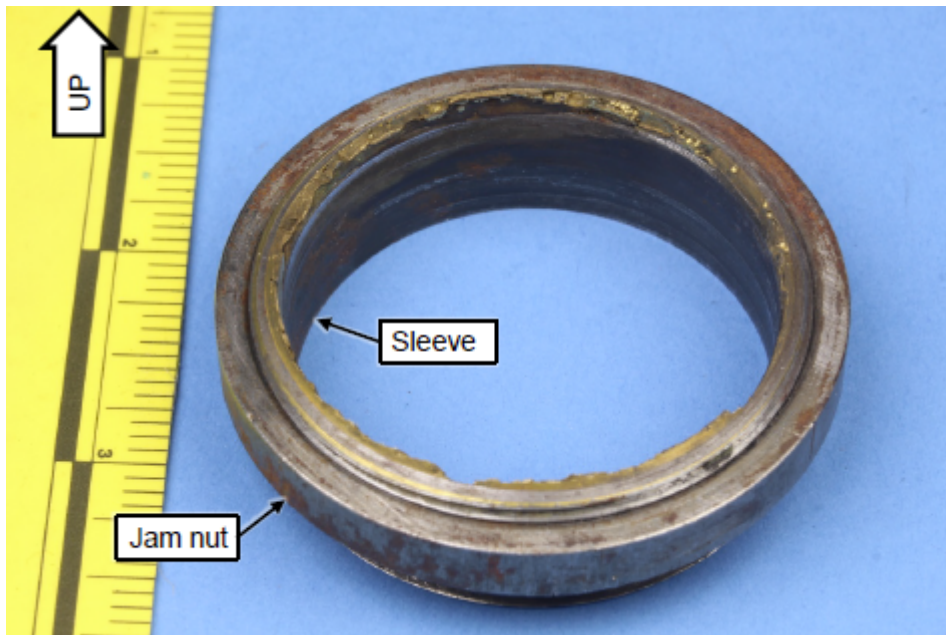
An examination of the main landing gear (right side) strut threaded sleeve and jam nut found that the oleo strut had fractured. Overstress fracture features were consistent with the sleeve fracturing from the end of the oleo strut assembly with the assembly loaded in tension.

The main landing gear (right side) strut threaded sleeve and jam nut (as shown below in figure 3) were recovered and transported to the National Transportation Safety Board Materials Laboratory in Washington, District of Columbia, for an examination. The complete examination report with photographs is in the public docket for this accident.

Figure 3 – View of the threaded sleeve with attached jam nut.

The sleeve had fractured from the lower end of the oleo strut tube. The jam nut was in place on the sleeve, and the external threads on the sleeve were intact.

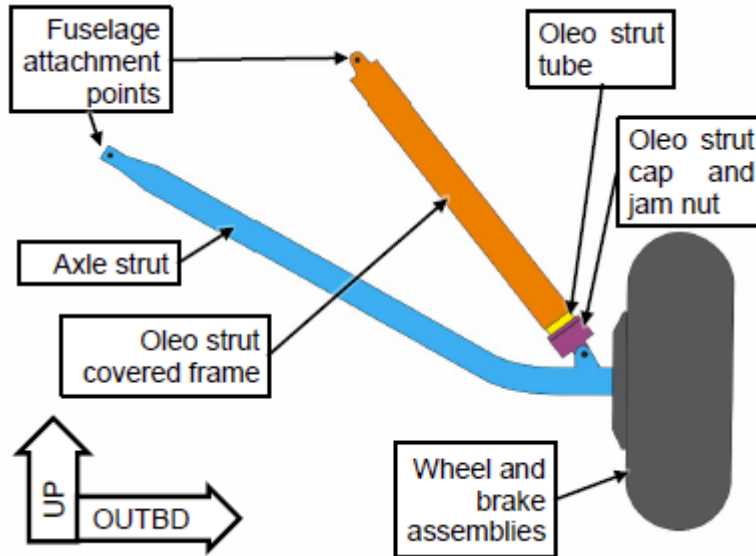
The sleeve fractured from the lower end of the right main landing gear during the accident landing sequence. As assembled on the airplane (as shown below in figure 4), the oil-filled oleo strut tube extends and retracts within the oleo strut covered frame to provide shock-absorbing movement for the axle strut and wheel assembly. The oleo strut cap and jam nut are attached to the lower end of the oleo strut tube. The lower end of the oleo strut assembly is attached to the axle strut, and the upper ends of both the axle strut and the oleo strut assembly are attached to the fuselage.

Figure 4 – Schematic drawing looking forward illustrating the right main landing gear components with the oleo strut assembly in the static position.

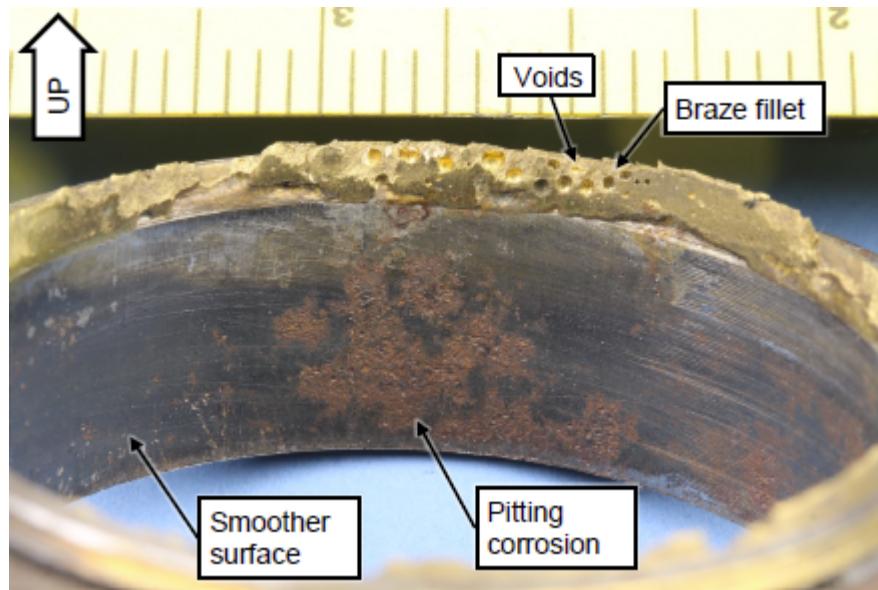
No evidence of progressive or long-term cracking was observed on the fracture surface, which indicates that no cracks developed in the braze due to the low-tension loads during flight or due to attachment loads from assembly of the cap onto the strut cylinder assembly. Although the brazed joint between the sleeve and the oleo strut tube did not conform to the engineering drawing and the strength would have been substantially less than a properly brazed joint, there was no evidence to indicate that the joint would have separated if loaded as designed; the joint appeared to be strong enough to perform under normal operation given that there was no evidence of progressive fracture. Therefore, the strut likely fractured due to abnormal side loading of the wheel with little or no loads in the upward direction as the airplane tipped to the right during the landing sequence involving the ground loop to the left.

The fracture occurred through the braze fillet at the upper side of the sleeve. The fracture surface and sleeve interior are shown below in figure 5. The interior surface of the sleeve had relatively prominent circumferential machining marks that extended around most of the circumference. However, a relatively smooth area where the circumferential machining marks were absent was observed. Pits with orange-colored oxidation was observed in the smooth area and an adjacent area with circumferential machining marks. The orange oxidation and pits extended around approximately 1/3 of the circumference. A chamfer between the inner diameter and the upper end of the sleeve was mostly covered by the braze fillet but was partially visible in areas.

Figure 5 – View of the interior face of the sleeve in a smoother area with pitting corrosion.

The braze material had a light-yellow color in contrast to the silver and dark gray color of the sleeve surfaces. Fracture of the braze material occurred through middle of the fillet, near the upper side of the fillet, and close to the chamfer surface. Large voids were present at the interior surface of the fillet in some areas. The fracture also intersected smaller spherical voids in the fillet. Fracture features were generally uniform in color with no evidence of post-fracture rubbing or long-term oxidation. Secondary crack openings and deformation to the fillet material was consistent with ductile overstress fracture with the sleeve moving downward relative to the oleo strut tube.

Most of the interior surface of the sleeve had a dark gray color with areas of oxidation. However, the upper end of the sleeve had a yellow color consistent with a thin coating of braze material. The circumferential machining marks remained visible on the interior surface in the coated area, and none of the machining grooves on the interior surface of the sleeve were filled with braze material. According to the engineering drawing for the oleo strut tube assembly provided by a representative of American Champion Aircraft Corporation, the sleeve-to-tube joint should have a continuous braze fillet around the circumference of the tube. A note in the engineering drawing pertaining to the sleeve-to-tube joint stated the braze must penetrate and be evident on the opposite side of the sleeve and be continuous around the circumference.
