Aviation Investigation Final Report

Location:	Atkasuk, Alaska	Accident Number:	ANC18LA031
Date & Time:	April 11, 2018, 08:18 Local	Registration:	N814GV
Aircraft:	Cessna 208B	Aircraft Damage:	Substantial
Defining Event:	VFR encounter with IMC	Injuries:	1 Minor
Flight Conducted Under:	Part 135: Air taxi & commuter - Non-scheduled

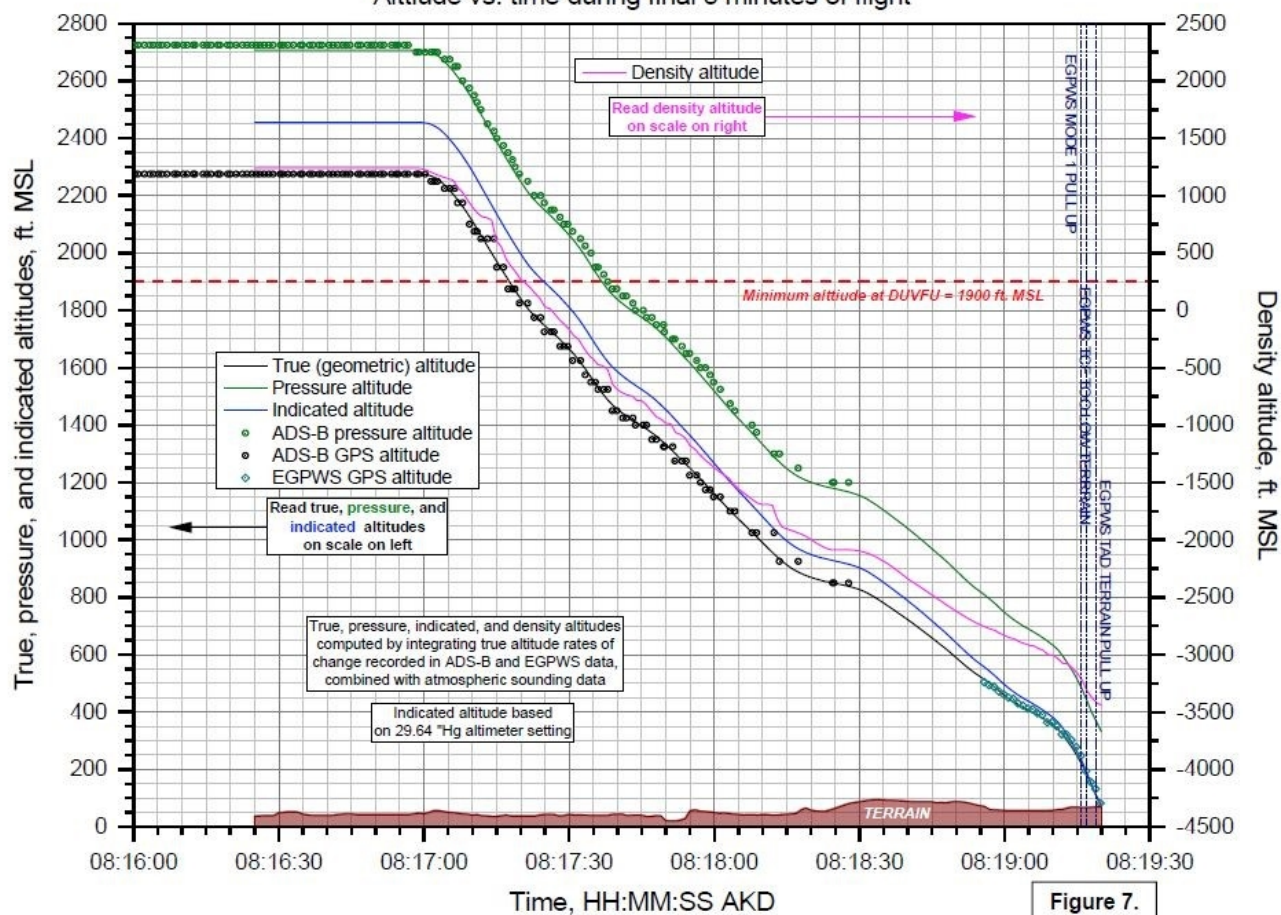
Figure 1. Airplane performance chart during last 3 minutes of flight.

An airplane performance study indicated that the airplane was in a continuous descent from 2,500 ft until the final data point about 12 ft above the surface; the airplane was not leveled off at any time during the descent. In the final 15 seconds of recorded data, the rate of descent increased from about 500 fpm to about 2,300 fpm before decreasing to 1,460 fpm at the last recorded data point.

The performance study indicated a continuous descent from about 2,500 ft msl to the last data point about 12ft above the surface. (See figure 1.)

Altitude vs. time during final 3 minutes of flight
