Aviation Investigation Final Report

Location:	Atkasuk, Alaska	Accident Number:	ANC18LA031
Date & Time:	April 11, 2018, 08:18 Local	Registration:	N814GV
Aircraft:	Cessna 208B	Aircraft Damage:	Substantial
Defining Event:	VFR encounter with IMC	Injuries:	1 Minor
Flight Conducted Under:	Part 135: Air taxi & commuter - Non-scheduled

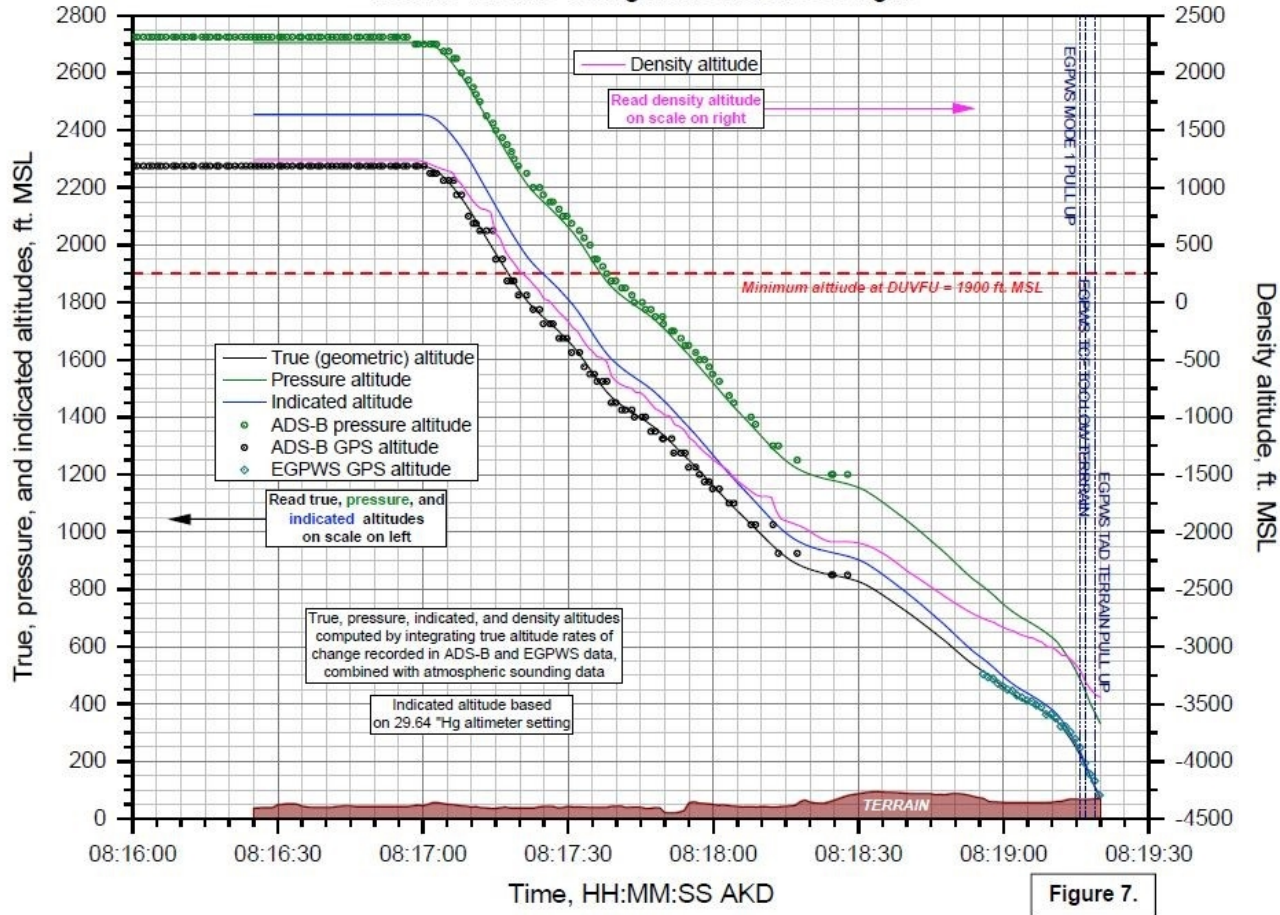
Figure 1. Airplane performance chart during last 3 minutes of flight.

An airplane performance study indicated that the airplane was in a continuous descent from 2,500 ft until the final data point about 12 ft above the surface; the airplane was not leveled off at any time during the descent. In the final 15 seconds of recorded data, the rate of descent increased from about 500 fpm to about 2,300 fpm before decreasing to 1,460 fpm at the last recorded data point.

The performance study indicated a continuous descent from about 2,500 ft msl to the last data point about 12ft above the surface. (See figure 1.)
