# Aviation Investigation Final Report

<b>Location:</b>	Atlanta, Georgia	<b>Accident Number:</b>	DCA18LA163
<b>Date &amp; Time:</b>	April 18, 2018, 18:09 Local	<b>Registration:</b>	N806NW
<b>Aircraft:</b>	Airbus A330 323	<b>Aircraft Damage:</b>	Substantial
<b>Defining Event:</b>	Fire/smoke (non-impact)	<b>Injuries:</b>	288 None
<b>Flight Conducted Under:</b>	Part 121: Air carrier - Scheduled

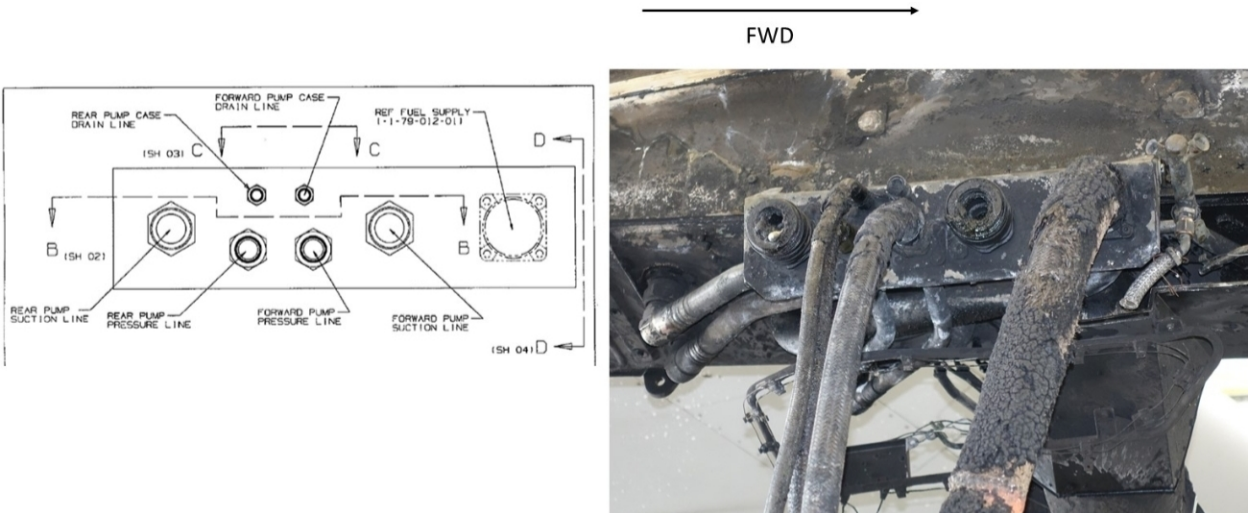
DAL aviation maintenance technicians at Amsterdam Airport Schiphol (AMS), Schiphol, Netherlands, provided written statements that summarized the maintenance actions performed on the airplane on April 15, 2018 (3 days before the accident flight). The technicians noticed that fuel was puddling on the ground under the right engine drain mast during predeparture checks. The cowls were opened, and fuel was observed dripping from the main fuel supply hose (FM-13) to the pylon hydraulic interface panel connection, which are shown in figure 1.

Figure 1. Pylon hydraulic interface panel connections (left) and hardware from the accident engine (right) (Source: left figure is from Pratt and Whitney’s “Hydraulic Interface Panel” part drawing).

Note: The red circles show where dripping was first observed. The blue arrow shows the FM-13 hose.

The FM-13 hose upper flange seal was replaced, and a right engine motor leak test was performed. No fuel leaks were observed during the leak test or subsequent postmaintenance/predeparture checks, and the airplane was returned to service.

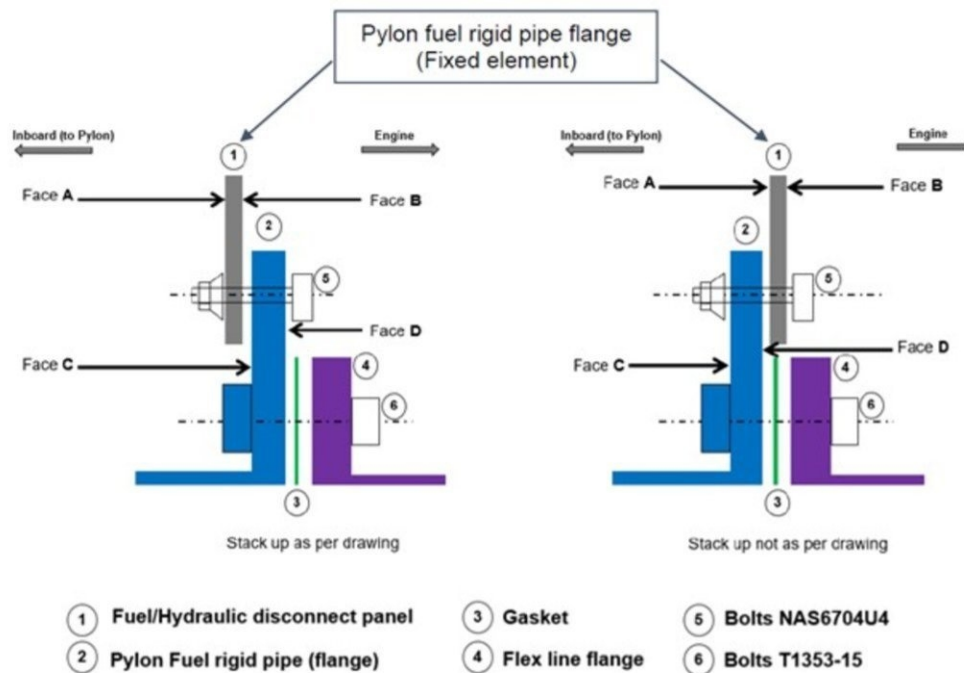
An improper seal fitting may have allowed fuel to leak from the FM-13 hose to the rigid fuel pipe interface, enabling fuel to run down the right side of the engine and pool at the bottom of the nacelle. The diffuser, turbine, and exhaust cases temperatures were hot enough to ignite the fuel. At ignition, an over-pressurization occurred, which opened all four pressure relief doors on the thrust reverser inner fixed structure. Because the fire was not due to an internal engine failure, the key engine parameters would have remained nominal.

Examination of the rigid fuel pipe, hydraulic interface panel, and FM-13 hose by the Airbus Materials Laboratory in Bremen, Germany, found that the FM-13 hose and rigid fuel pipe flange faces were deformed, the rigid fuel pipe was mounted on the wrong side of the hydraulic interface panel, and the radial offset due to the improper rigid fuel pipe installation was about 6.27 mm. According to an FM-13 hose drawing, the hose had an installation offset tolerance of  $\pm 17$  mm. The rigid fuel pipe lower flange that mates to the FM-13 hose upper flange at the

pylon interface panel was installed on the outboard (engine) side of the pylon hydraulic interface panel rather than on the inboard (pylon) side, as shown in figure 2.

Figure 2.: FM-13 hose to rigid fuel pipe connection (Source: Airbus).

Note: The Airbus A330-300 installation drawing appears on the left; the accident configuration appears on the right.

To determine whether additional stress might have been placed on the rigid fuel pipe due to installation position, fluorescent penetrant and eddy current inspections were performed. These inspections did not identify any cracks in the pipe. When a straight-edge ruler was placed against the inboard side of the lower rigid fuel pipe flange, deformation was visible at all four corners.
