Aviation Investigation Final Report

Location:	Williamsburg, Pennsylvania	Accident Number:	CEN18FA144
Date & Time:	April 19, 2018, 08:43 Local	Registration:	N451TD
Aircraft:	CIRRUS DESIGN CORP SR22	Aircraft Damage:	Destroyed
Defining Event:	Loss of control in flight	Injuries:	2 Fatal
Flight Conducted Under:	Part 91: General aviation - Personal

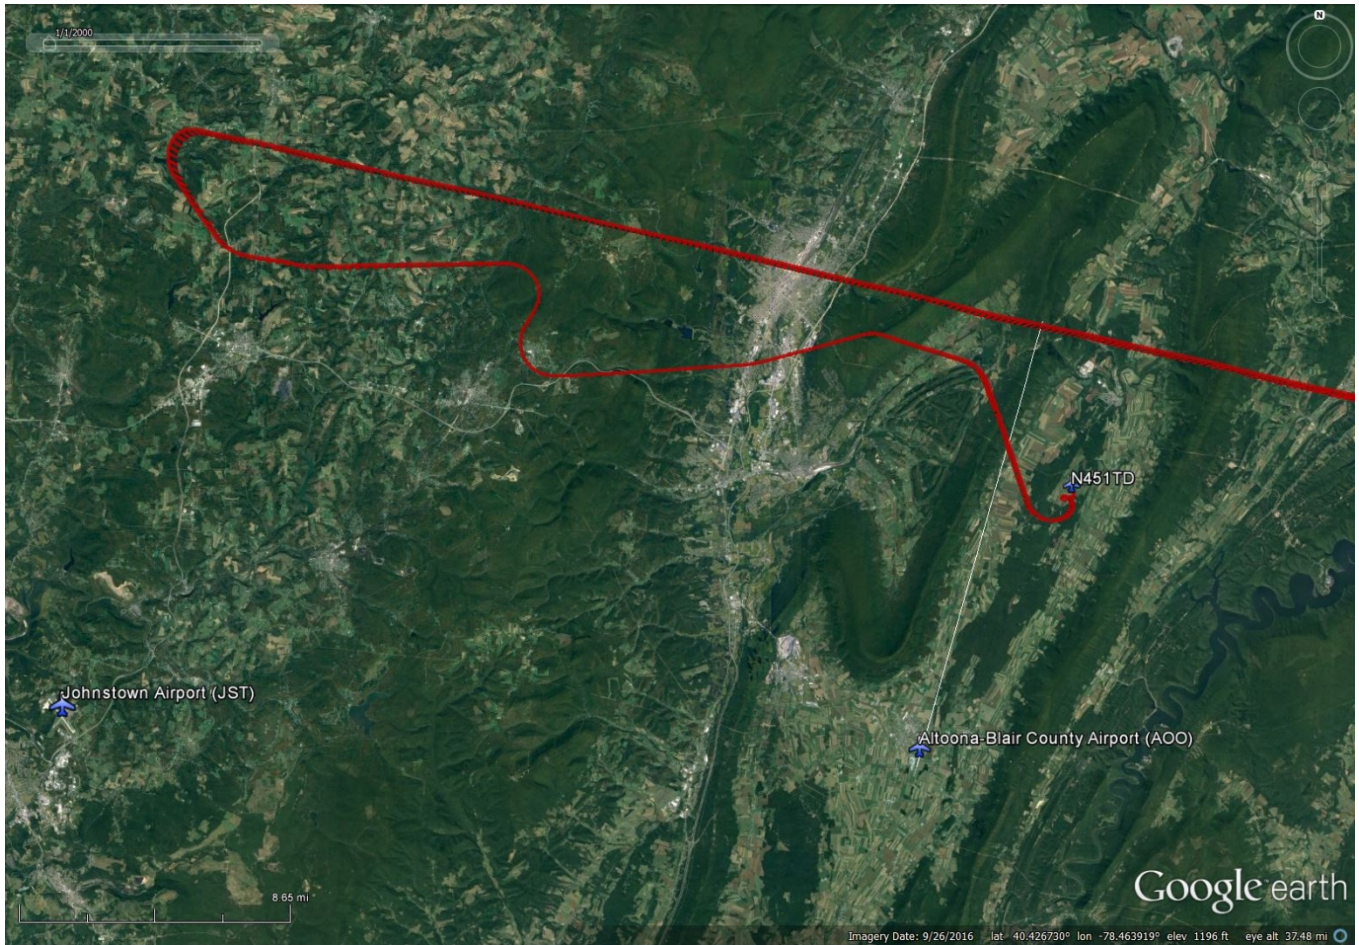
Figure 1. Radar track and accident location (Google Earth overlay)

The pilot received a weather briefing the night before the accident and filed a flight plan. Refer to the Meteorological Information section for more information. A review of air traffic control (ATC) communications and radar data provided by the Federal Aviation Administration (FAA) revealed that, about 0828, while the airplane was en route to SBN on a 284° heading and about 5,425 ft mean sea level (msl), the pilot contacted an approach controller at John Murtha Johnstown-Cambria County Airport (JST), Johnstown, Pennsylvania, and requested to divert to JST (18 miles southwest of the airplane's position) due to ice accumulation on the airplane. The controller advised the pilot that the clouds at JST were overcast at 200 ft above ground level (agl) and that the clouds at AOO (30 miles southeast of the airplane's position) were overcast at 500 ft agl. About 0831, the pilot requested vectors to AOO for an instrument landing system (ILS) approach. After the controller provided the vectors, the pilot requested to descend to 4,000 ft msl, but the controller cleared him to 4,500 ft msl, which was the lowest altitude he could clear the airplane to descend to in that geographical area. Figure 1 shows a Google Earth overlay of the airplane's radar track in red, the AOO approach localizer path in white.

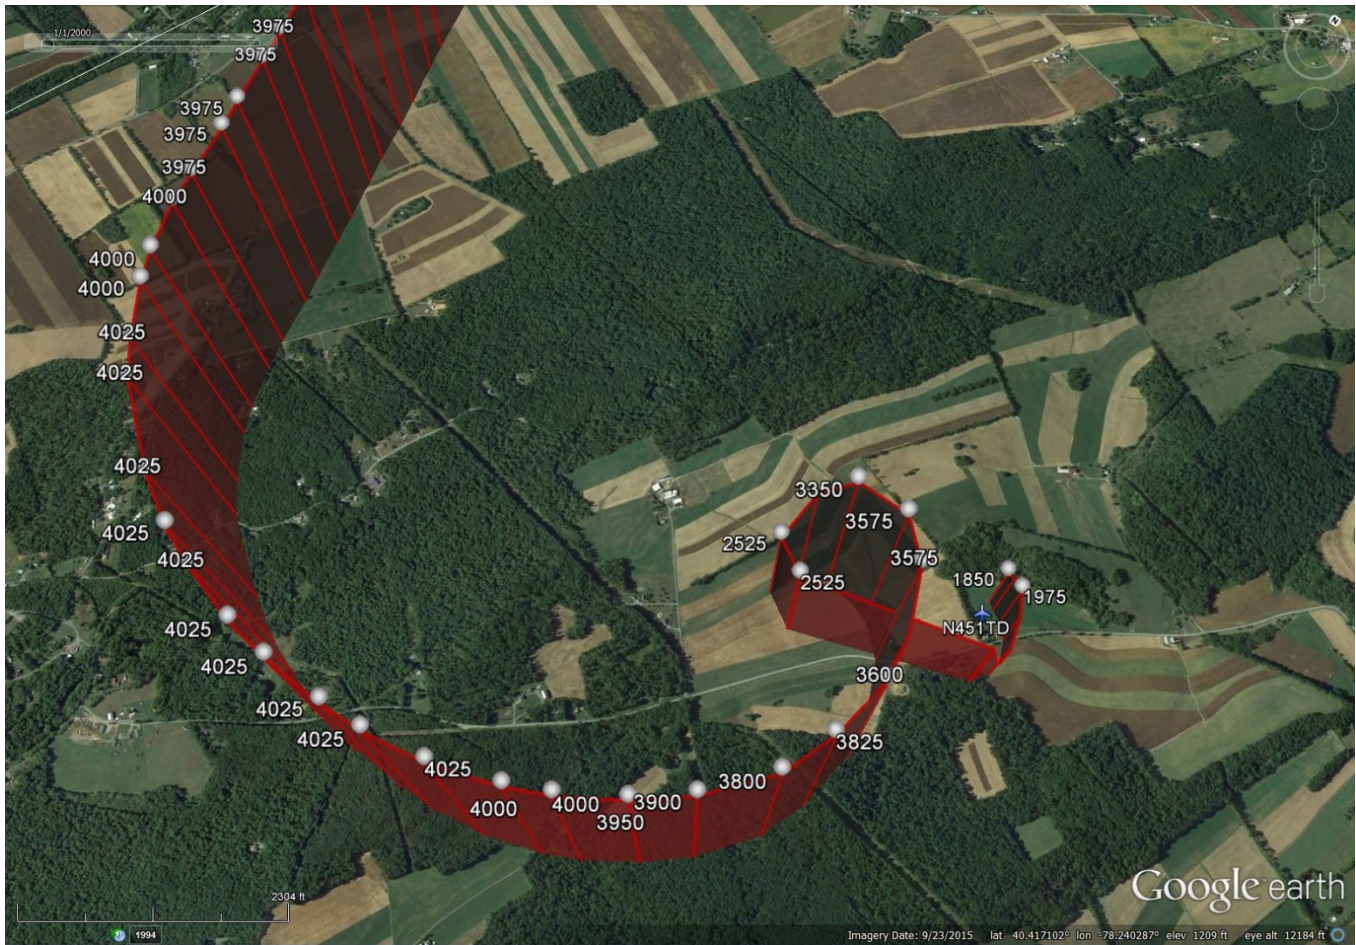
About 0842, the controller advised the pilot that the airplane had passed through the localizer for the ILS approach to runway 21 at AOO, and the pilot stated that he still wanted to land at AOO and requested vectors to intercept the localizer. The controller issued additional vectors for the pilot to make a box pattern to intercept the localizer; the airplane then turned left turn toward the north. At 0842:33, the airplane began a left standard rate turn and remained about 4,000 ft msl. At 0843:12, the airplane started to descend, and the airspeed increased. At 0843:38, the airplane descended through 2,525 ft msl and continued in a tight, left spiral turn. The final radar point was recorded at 0843:52 at 1,850 ft msl, at which point the airplane was still in a tight, left spiraling turn. Subsequently, radar contact was lost, and no additional communications were received from the pilot. See figure 2 for a radar track showing the initial left turn followed by the spiraling left turns.

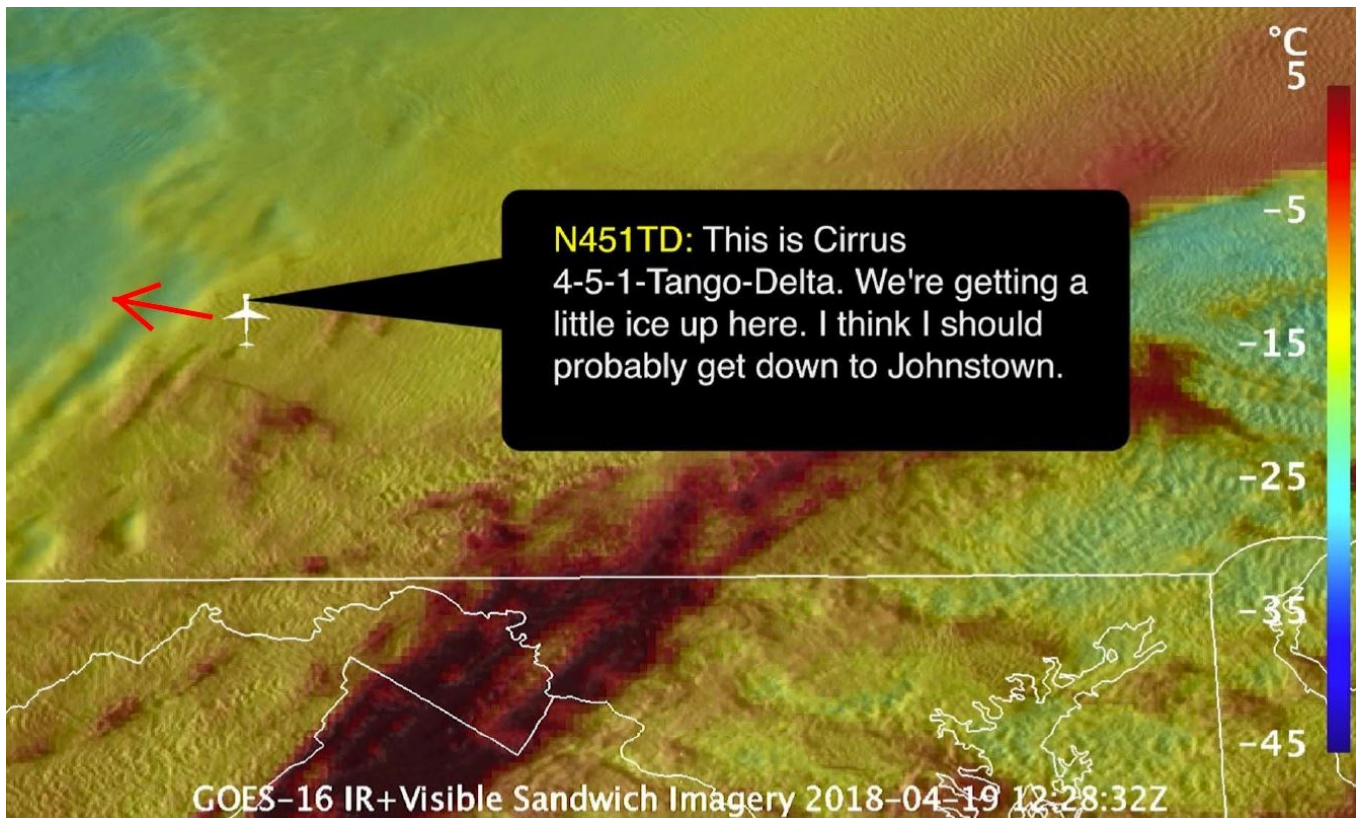
Figure 3. GOES-16 satellite imagery with the airplane's position when the pilot diverted

Figure 3 shows the compiled Geostationary Operational Environmental Satellite 16 (GOES-16) infrared and visible data and the pilot's communication with ATC at the time he requested to divert with the direction of travel indicated with a red arrow. This imagery indicated that the airplane was in areas of abundant cloud cover with cloud top temperatures between -5° and -15°C throughout the flight. The airplane turned back toward the east before reaching an area of cloud top temperatures between -15° and -25°C . The cloud-top heights above the accident site at around the time of the accident were about 10,400 ft msl. The IMC and icing conditions would have ended above the cloud layer.

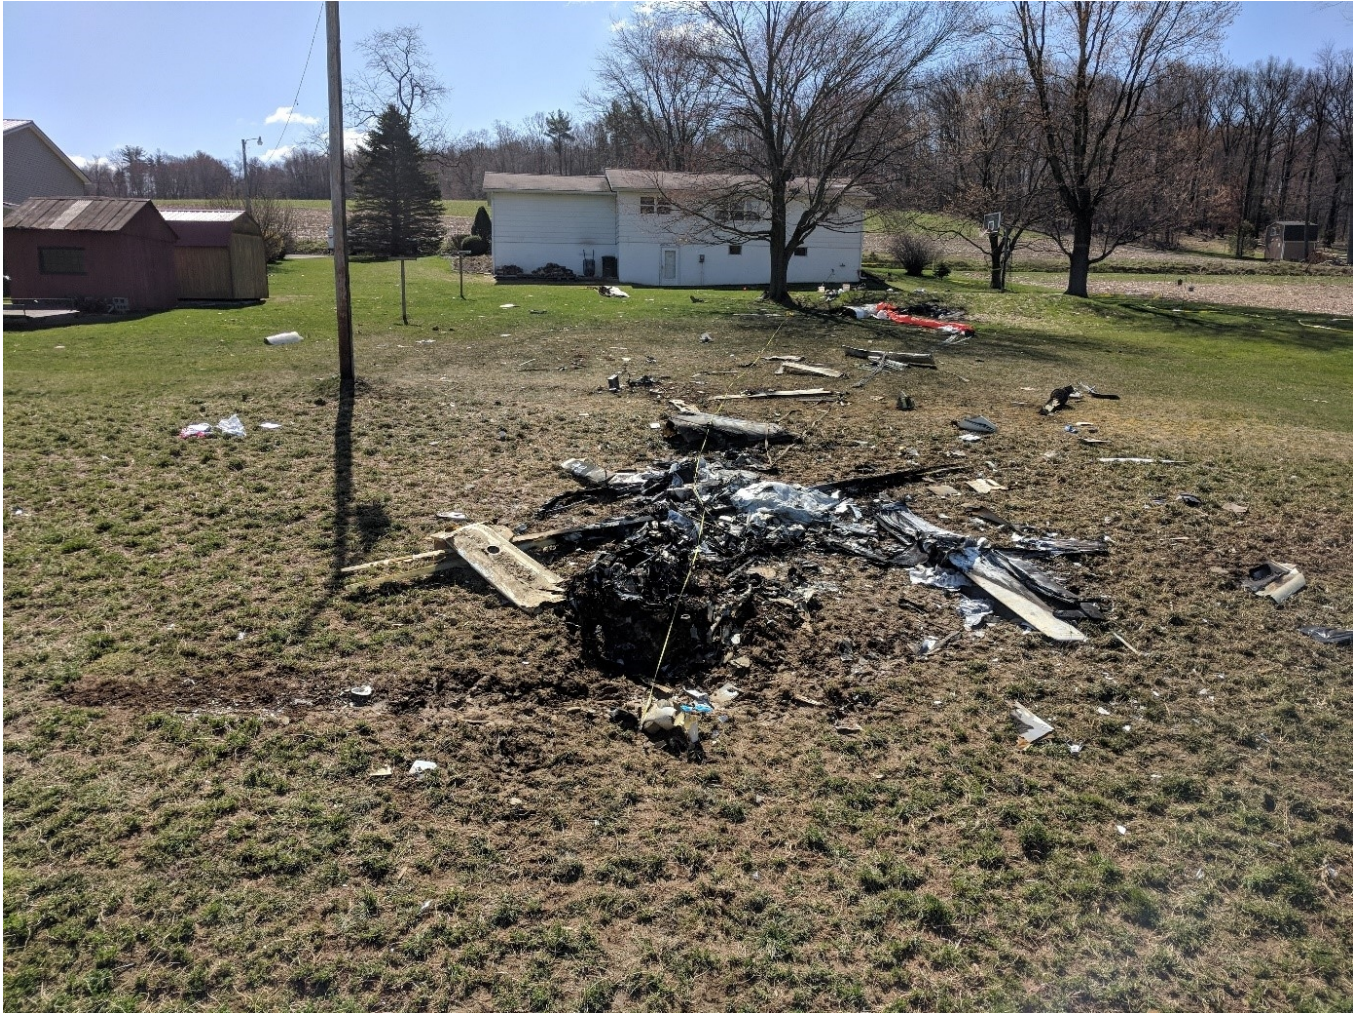
Figure 4. Initial impact point and airplane wreckage

The airplane impacted a field behind a residential property 9.5 miles northeast of AOO (see figure 4, which shows the initial impact point and the airplane wreckage). The wreckage debris path was about 200 ft long, on a magnetic heading of 150°, and at an elevation 1,025 ft msl.

Ground scars at the accident site and damage to the airplane were consistent with the airplane impacting terrain in a steep, nose-low, wings-level attitude. The left wing inspection panels and the pitot tube were found in the horizontal ground scar, which can be seen on the lower left side of figure 4. The ground scars surrounding the center impact crater were consistent with the shape of the wing leading edges and the tricycle landing gear. The engine, firewall, and all three propeller blades were found in the center impact crater, which was about 3 ft deep. A postimpact fire consumed most of the wreckage, but all major airplane structural components were located within the debris field.

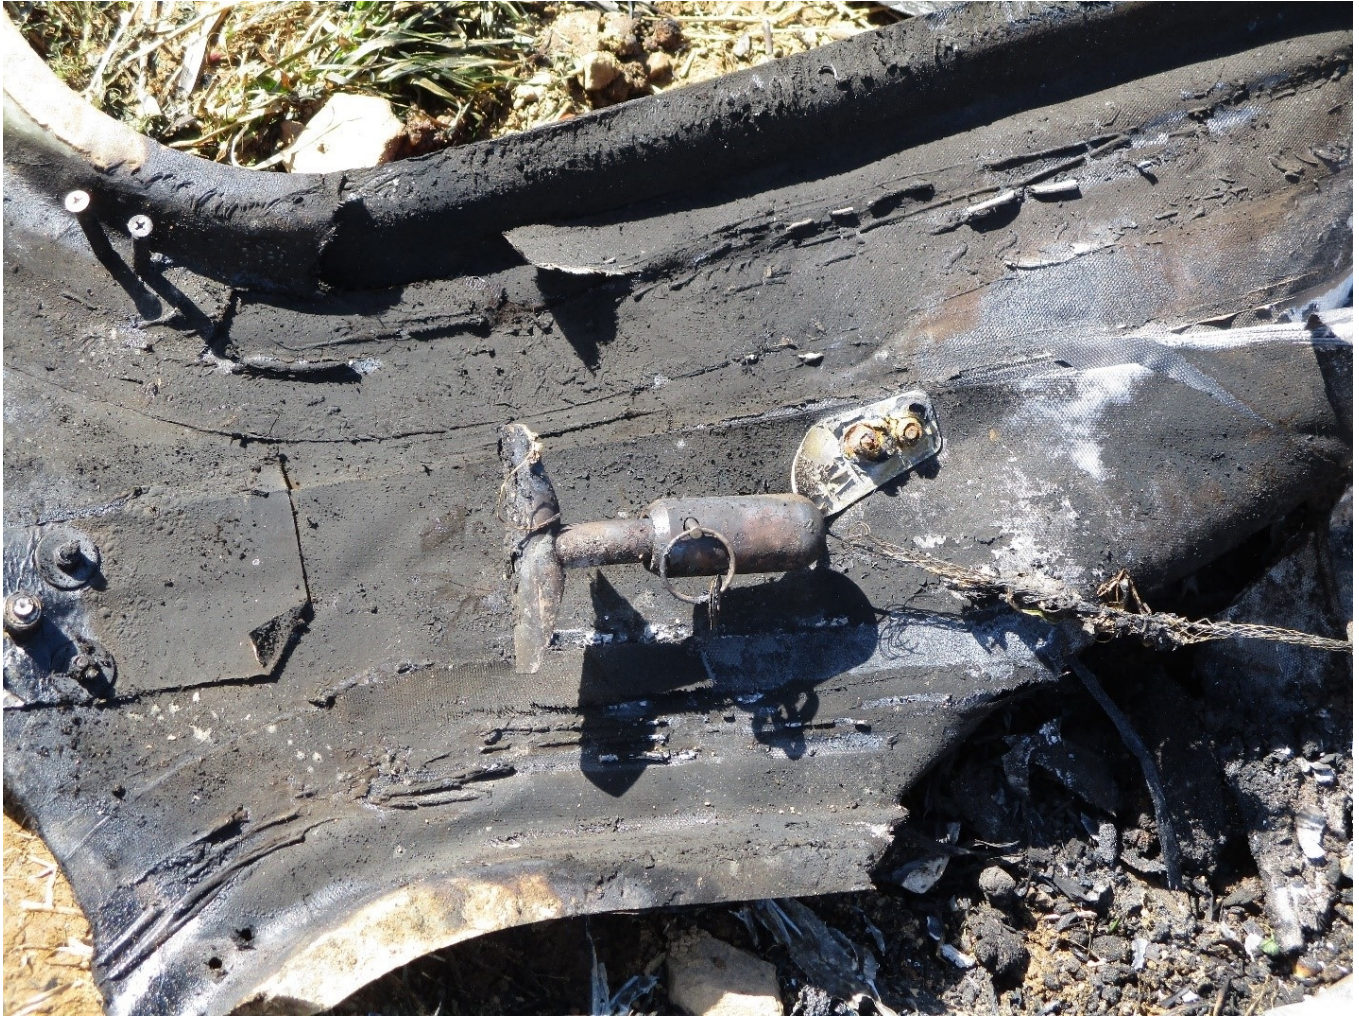
Figure 5. Safety pin installed in the CAPS activation handle

The CAPS activation handle remained in its holder with the safety pin installed as shown in figure 5. The CAPS was found deployed, and the CAPS solid rocket propellant was expended. The parachute was found deployed, and it extended along the debris path. Portions of the CAPS that remained within the main wreckage were consumed by fire. All evidence revealed that the CAPS was not activated in flight but rather that it deployed due to impact forces and thermal exposure.
