Aviation Investigation Final Report

Location:	Williamsburg, Pennsylvania	Accident Number:	CEN18FA144
Date & Time:	April 19, 2018, 08:43 Local	Registration:	N451TD
Aircraft:	CIRRUS DESIGN CORP SR22	Aircraft Damage:	Destroyed
Defining Event:	Loss of control in flight	Injuries:	2 Fatal
Flight Conducted Under:	Part 91: General aviation - Personal

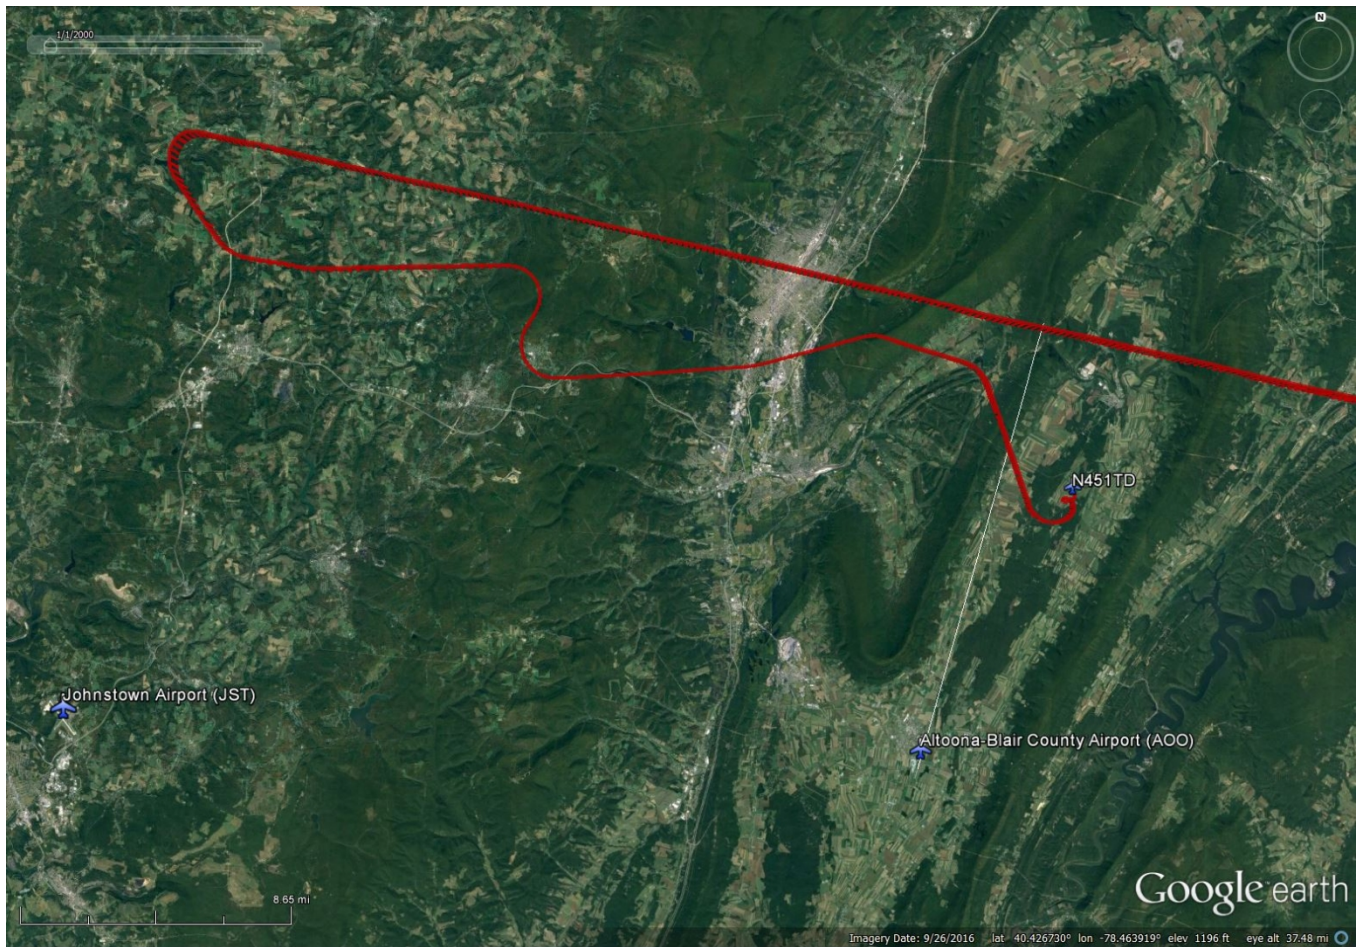
The pilot received a weather briefing the night before the accident and filed a flight plan. Refer to the Meteorological Information section for more information. A review of air traffic control (ATC) communications and radar data provided by the Federal Aviation Administration (FAA) revealed that, about 0828, while the airplane was en route to SBN on a 284° heading and about 5,425 ft mean sea level (msl), the pilot contacted an approach controller at John Murtha Johnstown-Cambria County Airport (JST), Johnstown, Pennsylvania, and requested to divert to JST (18 miles southwest of the airplane's position) due to ice accumulation on the airplane. The controller advised the pilot that the clouds at JST were overcast at 200 ft above ground level (agl) and that the clouds at AOO (30 miles southeast of the airplane's position) were overcast at 500 ft agl. About 0831, the pilot requested vectors to AOO for an instrument landing system (ILS) approach. After the controller provided the vectors, the pilot requested to descend to 4,000 ft msl, but the controller cleared him to 4,500 ft msl, which was the lowest altitude he could clear the airplane to descend to in that geographical area. Figure 1 shows a Google Earth overlay of the airplane's radar track in red, the AOO approach localizer path in white.

Figure 1. Radar track and accident location (Google Earth overlay)

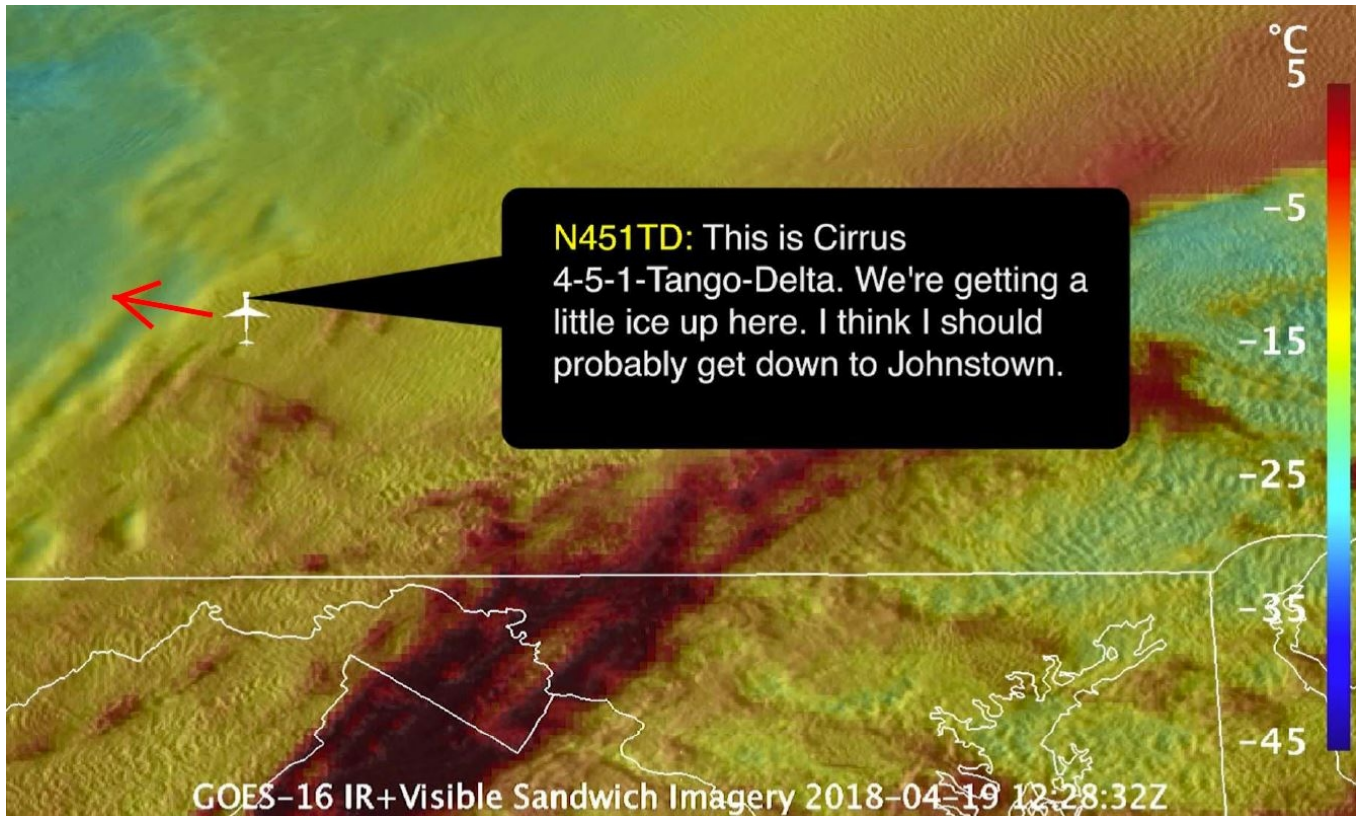
Figure 3 shows the compiled Geostationary Operational Environmental Satellite 16 (GOES-16) infrared and visible data and the pilot's communication with ATC at the time he requested to divert with the direction of travel indicated with a red arrow. This imagery indicated that the airplane was in areas of abundant cloud cover with cloud top temperatures between -5° and -15°C throughout the flight. The airplane turned back toward the east before reaching an area of cloud top temperatures between -15° and -25°C . The cloud-top heights above the accident site at around the time of the accident were about 10,400 ft msl. The IMC and icing conditions would have ended above the cloud layer.

Figure 3. GOES-16 satellite imagery with the airplane's position when the pilot diverted

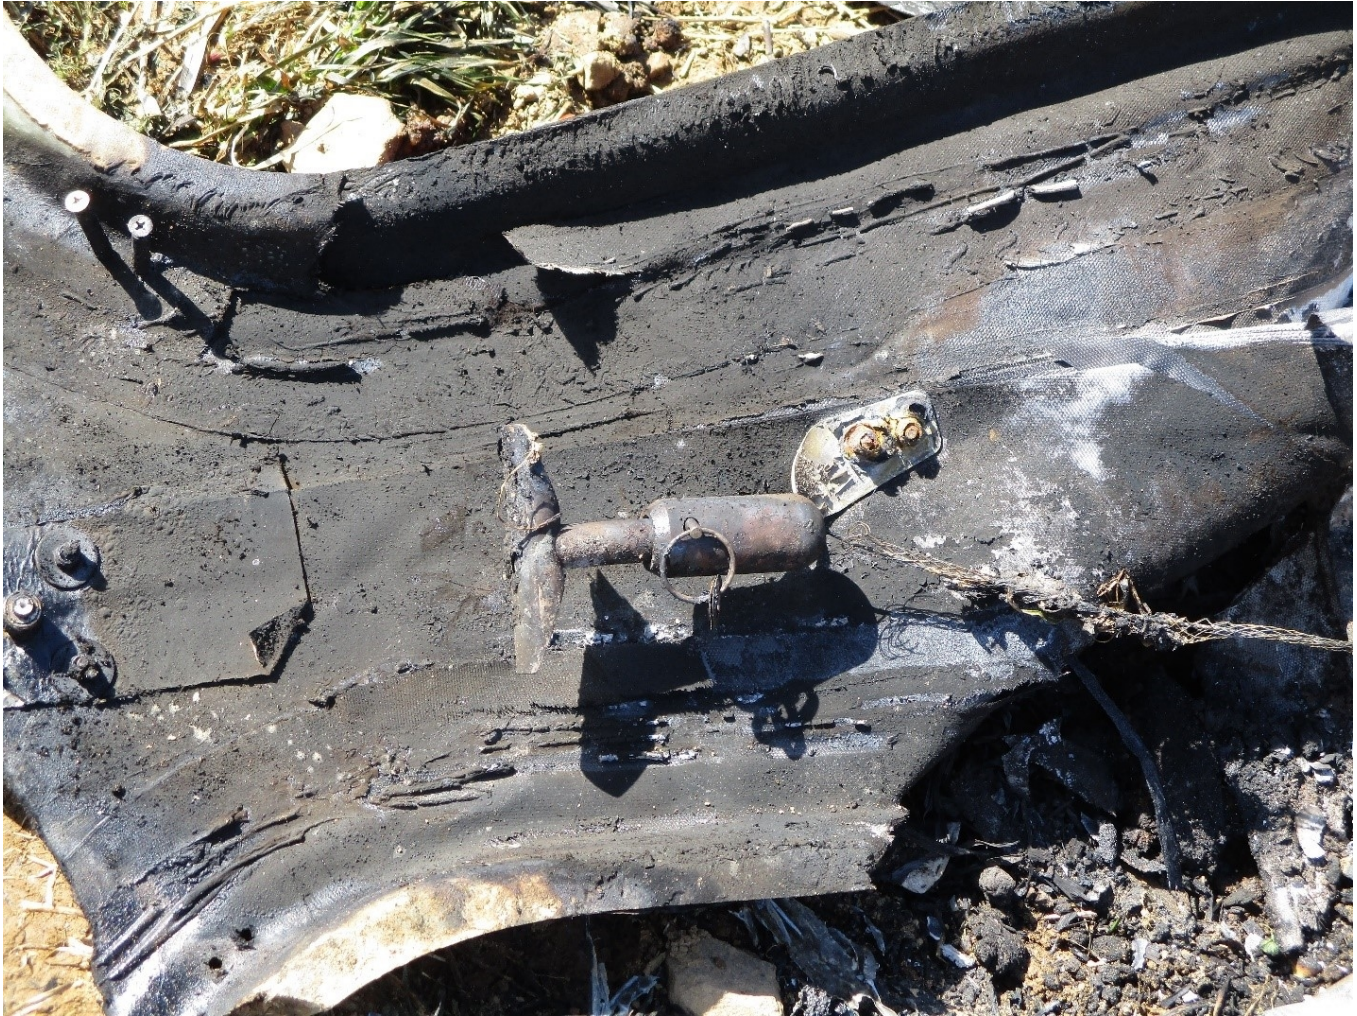
The CAPS activation handle remained in its holder with the safety pin installed as shown in figure 5. The CAPS was found deployed, and the CAPS solid rocket propellant was expended. The parachute was found deployed, and it extended along the debris path. Portions of the CAPS that remained within the main wreckage were consumed by fire. All evidence revealed that the CAPS was not activated in flight but rather that it deployed due to impact forces and thermal exposure.

Figure 5. Safety pin installed in the CAPS activation handle
