Aviation Investigation Final Report

Location:	Kingsville, Texas	Accident Number:	CEN18FA147
Date & Time:	April 25, 2018, 12:25 Local	Registration:	N12377
Aircraft:	North American SNJ 5	Aircraft Damage:	Destroyed
Defining Event:	Aerodynamic stall/spin	Injuries:	2 Fatal
Flight Conducted Under:	Part 91: General aviation - Personal

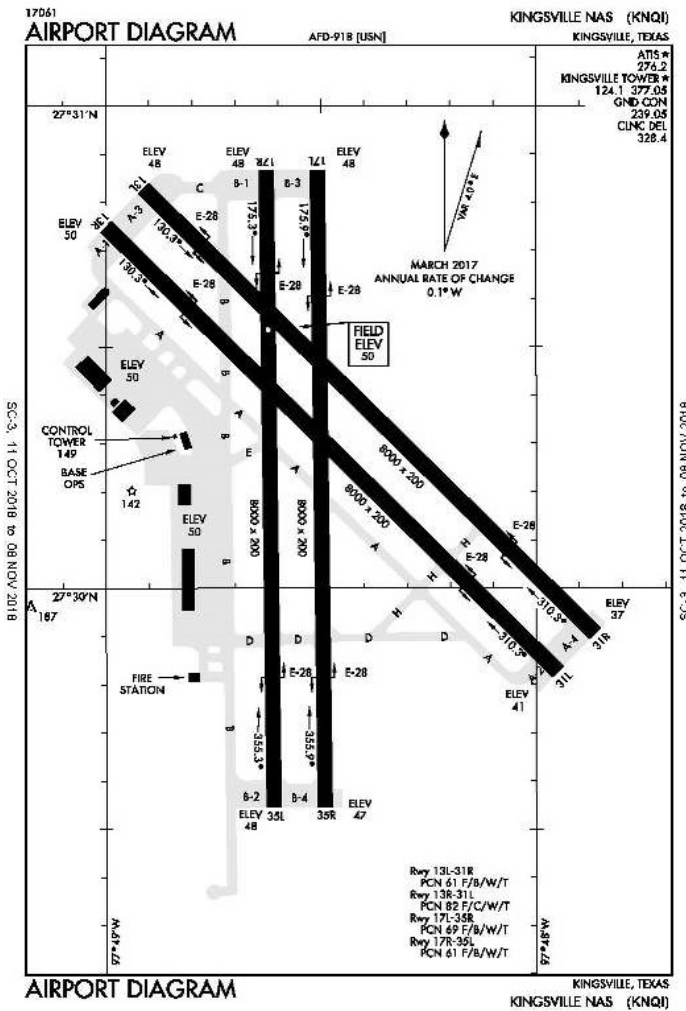
Figure 1. Airport diagram showing the layout of Kingsville NAS

Air traffic control tower personnel reported that the airplane took off on runway 13R and had requested a right teardrop turn for a departure toward the north. Several witnesses reported seeing the airplane in a steep right bank; some witnesses reporting that the bank angle exceeded 90° and the maximum altitude achieved was 200-300 ft above ground level. The airplane descended nose low and the right bank angle decreased before the airplane impacted the ground between runway 17R/35L and taxiway B just south of the intersection of taxiways B and E (Figure 1.).
