# Aviation Investigation Final Report

<b>Location:</b>	Kingsville, Texas	<b>Accident Number:</b>	CEN18FA147
<b>Date &amp; Time:</b>	April 25, 2018, 12:25 Local	<b>Registration:</b>	N12377
<b>Aircraft:</b>	North American SNJ 5	<b>Aircraft Damage:</b>	Destroyed
<b>Defining Event:</b>	Aerodynamic stall/spin	<b>Injuries:</b>	2 Fatal
<b>Flight Conducted Under:</b>	Part 91: General aviation - Personal

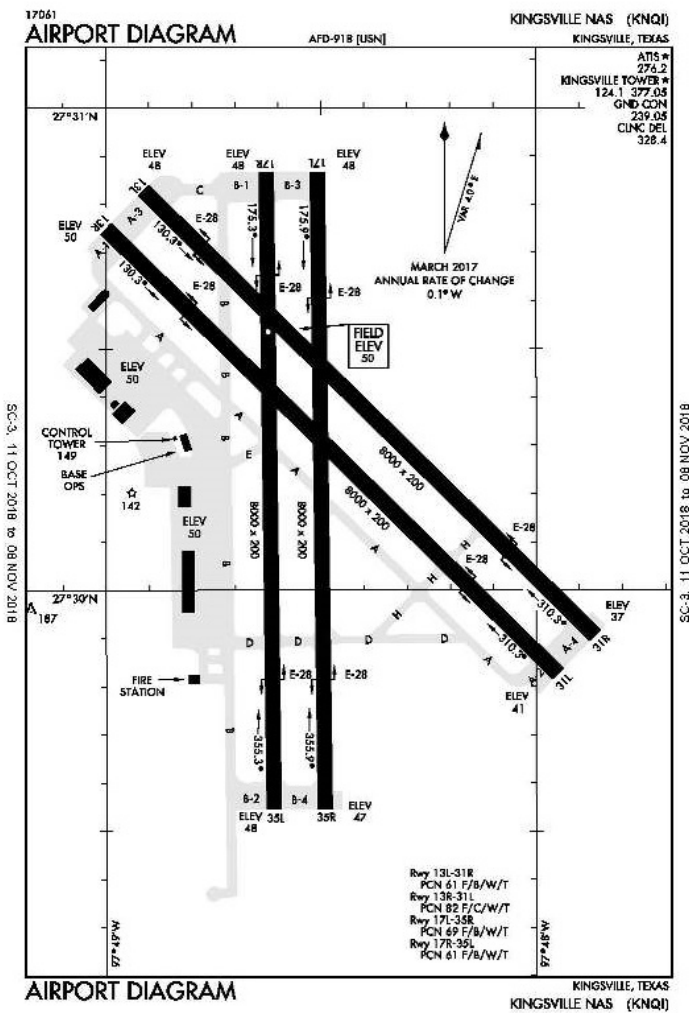
Air traffic control tower personnel reported that the airplane took off on runway 13R and had requested a right teardrop turn for a departure toward the north. Several witnesses reported seeing the airplane in a steep right bank; some witnesses reporting that the bank angle exceeded 90° and the maximum altitude achieved was 200-300 ft above ground level. The airplane descended nose low and the right bank angle decreased before the airplane impacted the ground between runway 17R/35L and taxiway B just south of the intersection of taxiways B and E (Figure 1.).

Figure 1. Airport diagram showing the layout of Kingsville NAS

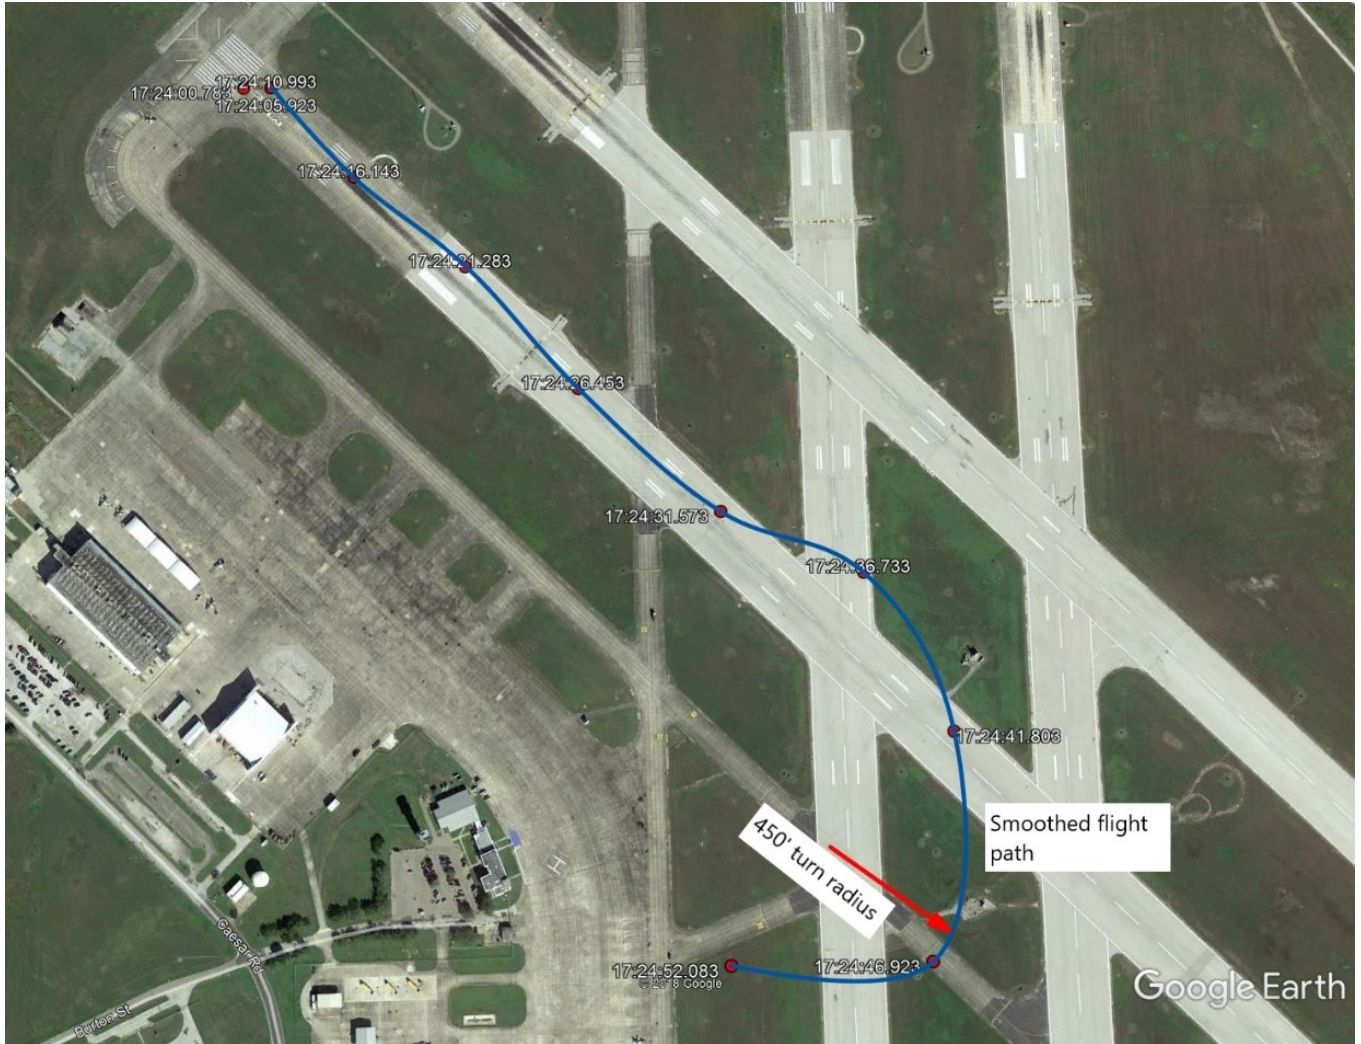
Review of radar data showed that the airplane began its takeoff roll from runway 13R at 1224:01. The accident flight was captured in 11 radar returns, with the final return at 1224:52. No altitude data was recorded. The airplane's ground track continued along the runway centerline from the takeoff position for about 2,000 ft before making a slight left turn followed by a right turn. The right turn continued to the end of the data and the final recorded position was about 100 ft east of the initial impact point. Based on the final 3 recorded radar returns, the turn radius was estimated to be about 450 ft and the calculated average groundspeed was 87 mph. Based on this information, the calculated bank angle was about 56° during the final portion of the flight. For a level, 56°-banking turn, the calculated flight load factor was 1.8g. Based on the velocity versus load factor (V-N) diagram for the accident airplane, a load factor of 1.8g equated to an accelerated stall speed about 95 mph. The airplane's ground track is depicted in Figure 2.

Figure 2. Overhead view of the airplane's ground track
