Aviation Investigation Final Report

Location:	Galliano, Louisiana	Accident Number:	CEN16LA401
Date & Time:	April 7, 2016,	Registration:	N639NA
Aircraft:	AGUSTAWESTLAND PHILADELPHIA AW139	Aircraft Damage:	Substantial
Defining Event:	Part(s) separation from AC	Injuries:	9 None
Flight Conducted Under:	Part 91: General aviation - Other work use

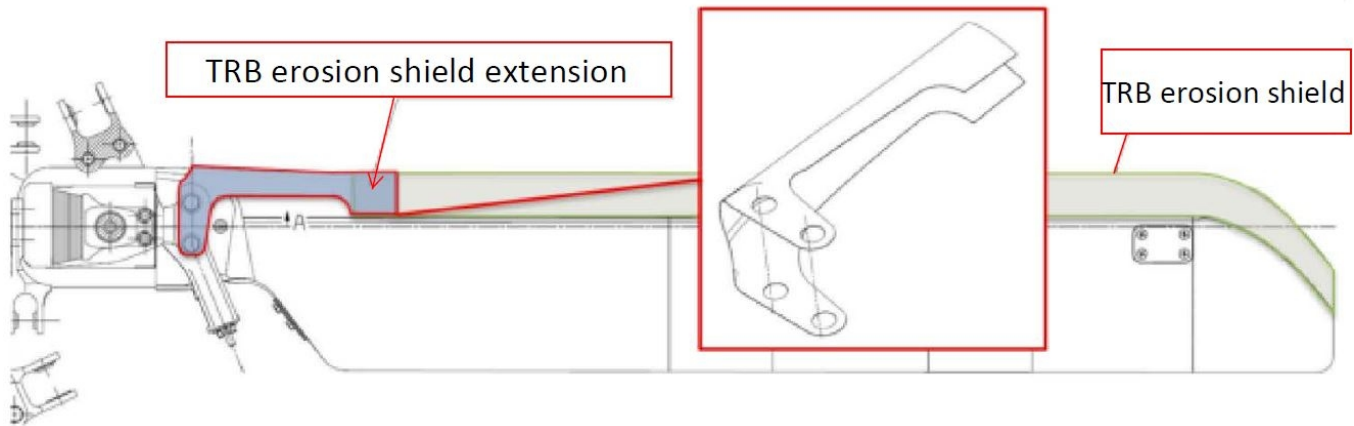
Figure 1 – TRB erosion shield extension diagram with notations (Courtesy of Leonardo)

On May 9, 2018, the Chevron aviation department reported the accident to the NTSB and stated that during the flight the crew felt a slight vibration of the tail rotor. After landing at GAO during a post flight inspection, one of the tail rotor blade (TRB) erosion shield extensions (figure 1) commonly known as a lightning strip (LS) was missing and only its side tabs remained attached to the blade. Additionally, a main rotor blade (MRB) tip was damaged.

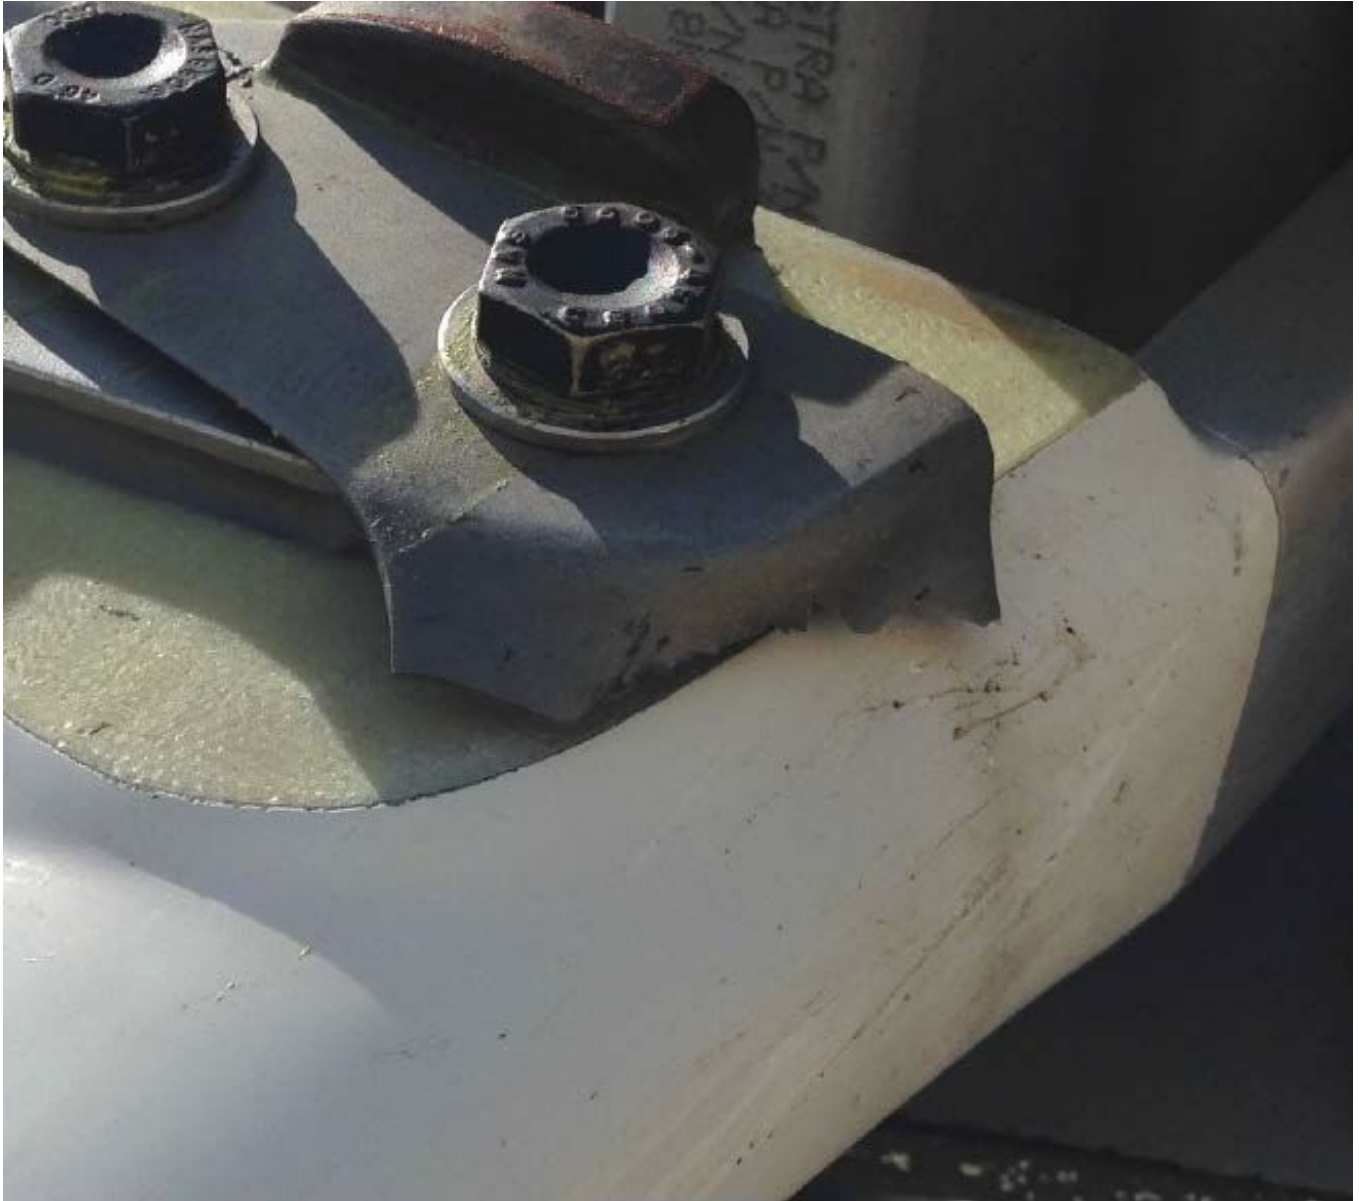
Figure 2 – Damaged Tail Rotor Erosion Shield Extension (Courtesy of Chevron)

A Chevron post flight inspection of the helicopter revealed that the LS on the white TRB was fractured and most of the component was missing. Only the side tabs, where the tail rotor damper bracket bushings pass through, remained attached (figure 2).

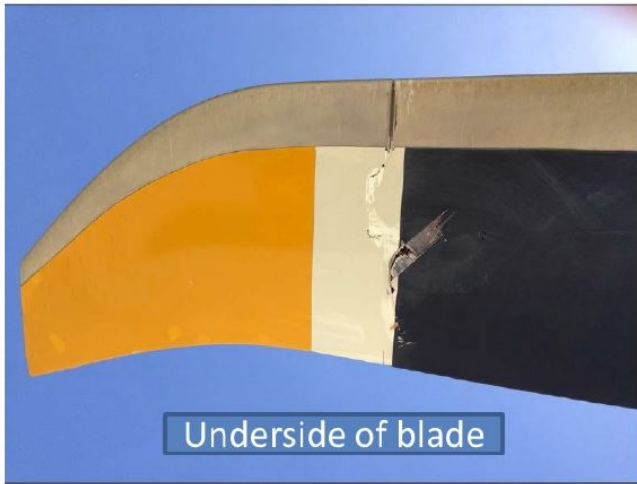
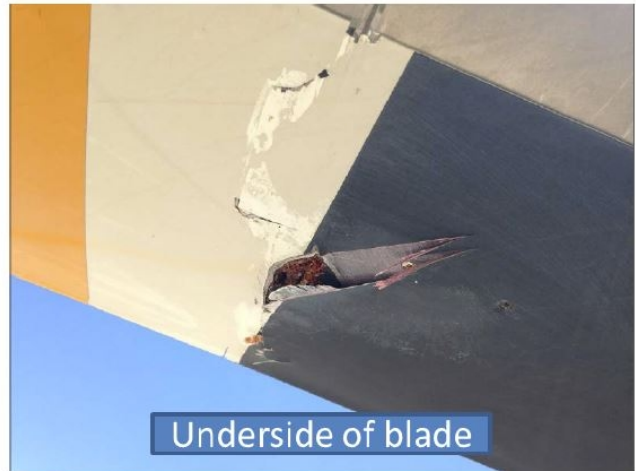
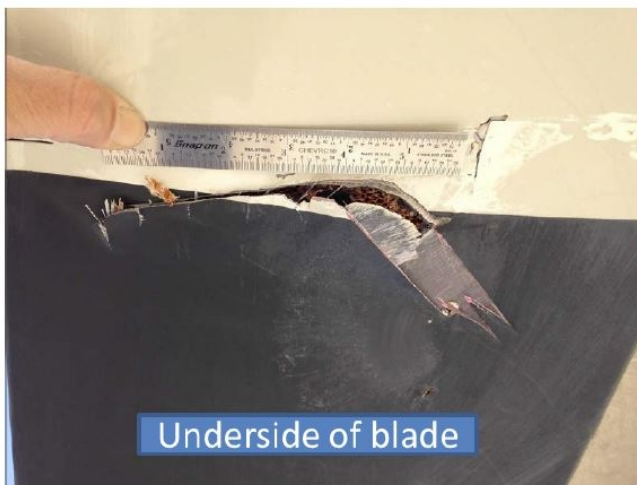
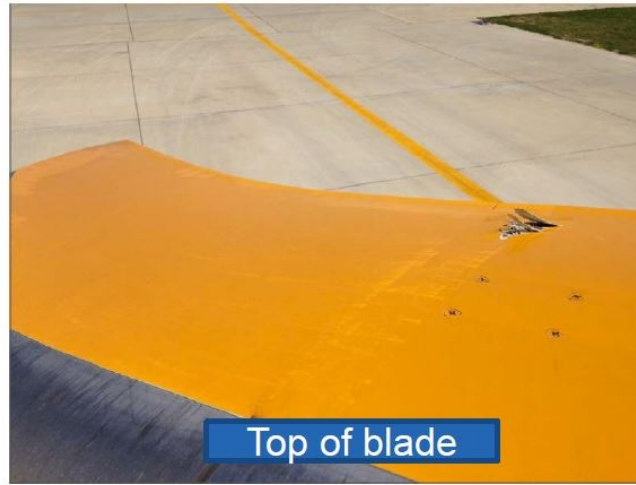
Figure 3 – Damaged Main Rotor Blade (Courtesy of Chevron)

The inspection also found damage to one of the main rotor blades; the blue MRB tip sustained damage mostly on the under side of the blade (figure 3). No additional damage was observed on the remainder of the helicopter.

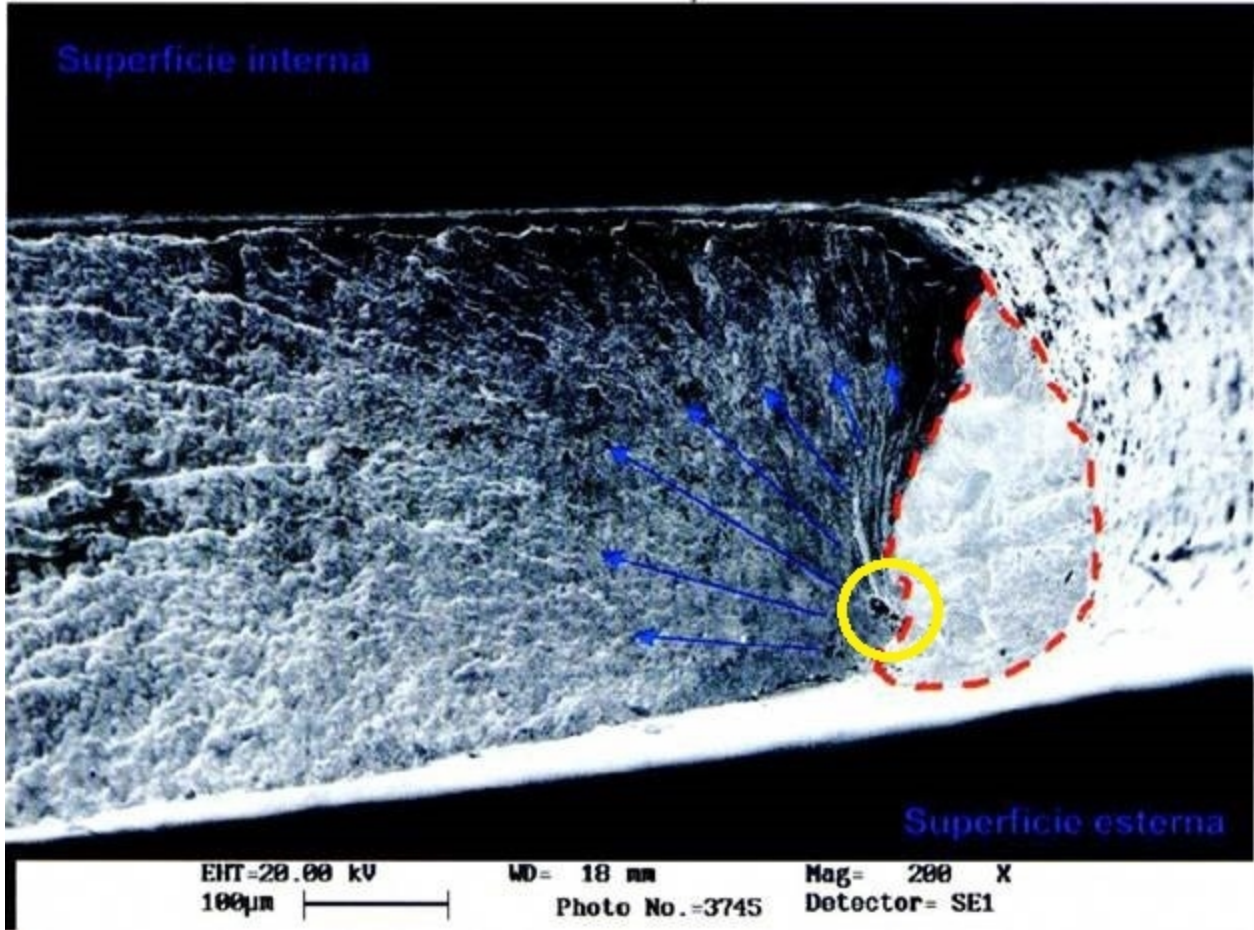
Figure 4 – SEM image of the fatigue propagation from a micro-cavity, yellow circle (Courtesy of Leonardo)

Metallurgical analysis of the fractured LS revealed microcavities in the metal, which resulted in a fatigue fracture. The helicopter manufacturer concluded that the microcavities were a direct result of the electroplating manufacturing process. Finite element modeling (FEM) of an exemplar LS revealed that the maximum stress values expected during flight were considerably lower than the fatigue limit specified for the electroplated nickel material. The microcavity observed on the accident LS could not be replicated by the FEM model, but the presence of a microcavity could adversely influence the in-flight stresses and reduce the overall strength of the LS. Additional flight testing with strain gauges did not reveal any load condition that would lead to similar LS failures that were experienced during the accident flight. It is likely the LS separated in flight due to a fatigue fracture that was the result of increased stress in the presence of a material flaw that had existed since its manufacture.

Leonardo, the current AW139 helicopter manufacturer, performed a failure analysis on the remaining portion of the LS, using a scanning electron microscope (SEM), which revealed the presence of microcavity spots or porosity on the surface of the fractured section. Leonardo concluded that the microcavities were a direct result of the electroplating manufacturing process. In figure 4, the area circled in yellow is the microcavity, the red dashes indicate the crack initiation, and the blue arrows indicate the direction of the fatigue crack propagation.

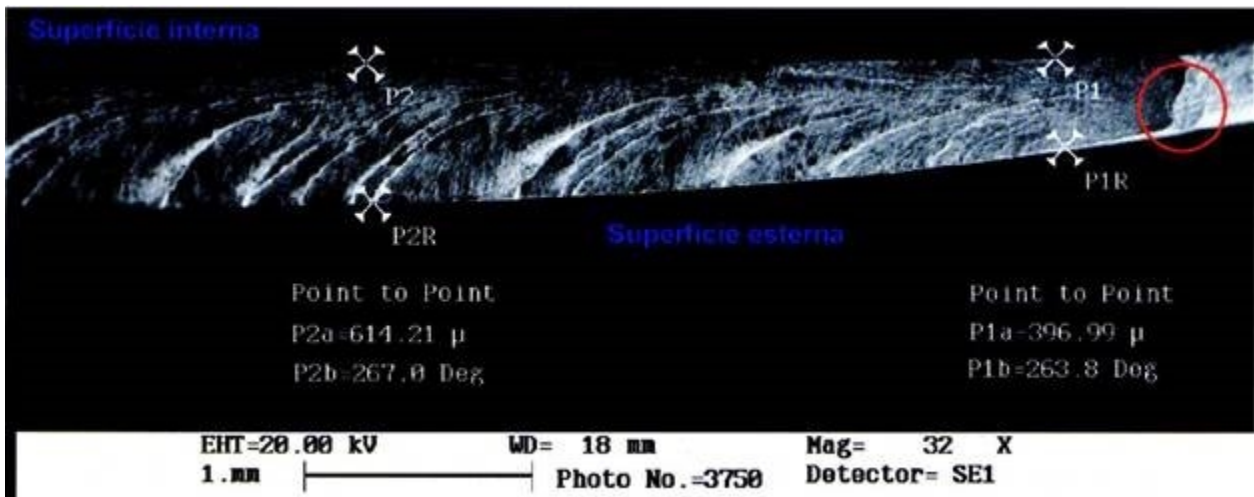
Figure 5 – SEM image, wide view of fracture surface (Courtesy of Leonardo)

Figure 5 shows a wide view of the fracture surface with the crack origination circled in red.
