Aviation Investigation Final Report

Location:	Galliano, Louisiana	Accident Number:	CEN16LA401
Date & Time:	April 7, 2016,	Registration:	N639NA
Aircraft:	AGUSTAWESTLAND PHILADELPHIA AW139	Aircraft Damage:	Substantial
Defining Event:	Part(s) separation from AC	Injuries:	9 None
Flight Conducted Under:	Part 91: General aviation - Other work use

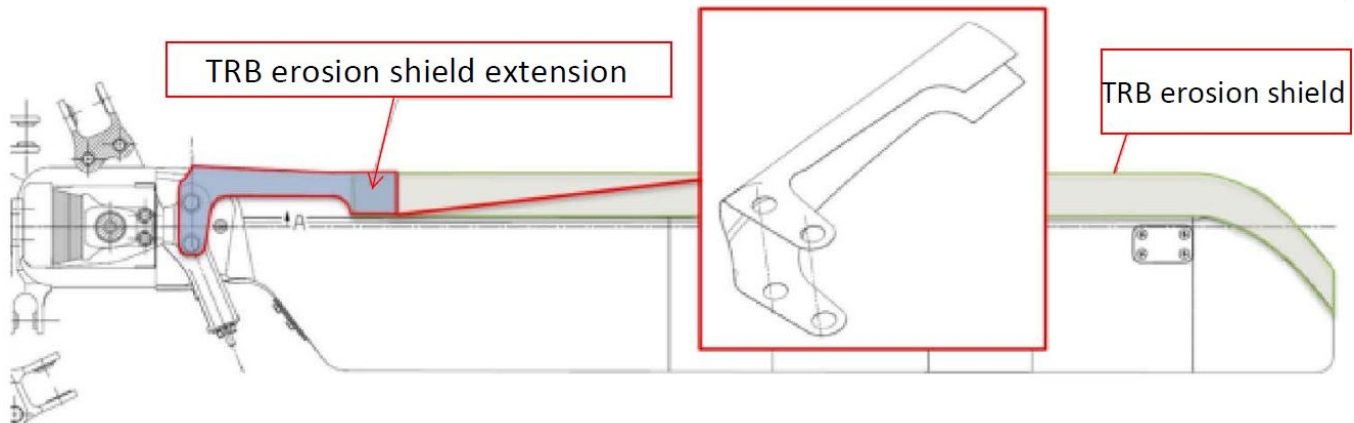
Figure 1 – TRB erosion shield extension diagram with notations (Courtesy of Leonardo)

On May 9, 2018, the Chevron aviation department reported the accident to the NTSB and stated that during the flight the crew felt a slight vibration of the tail rotor. After landing at GAO during a post flight inspection, one of the tail rotor blade (TRB) erosion shield extensions (figure 1) commonly known as a lightning strip (LS) was missing and only its side tabs remained attached to the blade. Additionally, a main rotor blade (MRB) tip was damaged.

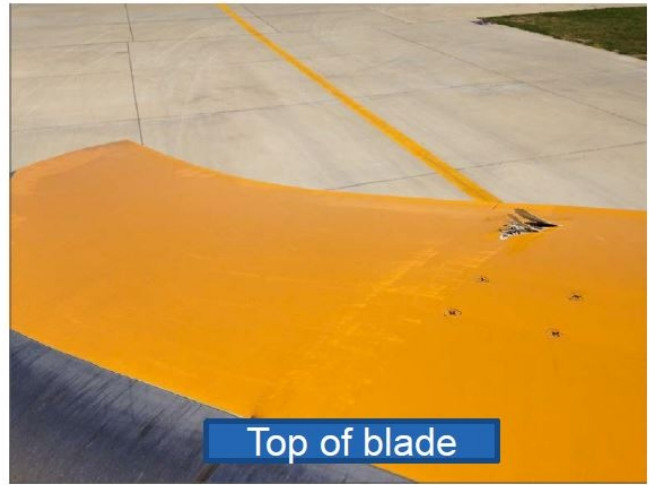
Figure 3 – Damaged Main Rotor Blade (Courtesy of Chevron)

The inspection also found damage to one of the main rotor blades; the blue MRB tip sustained damage mostly on the under side of the blade (figure 3). No additional damage was observed on the remainder of the helicopter.
